LOSS REPORT

Insured: Wile E. Coyote
123 Roadrunner Rd
Starlight, IN 47106

Date of Loss: 4/13/2025

Cause of Loss: Wind/Fallen Tree Debris/Hail/BSD

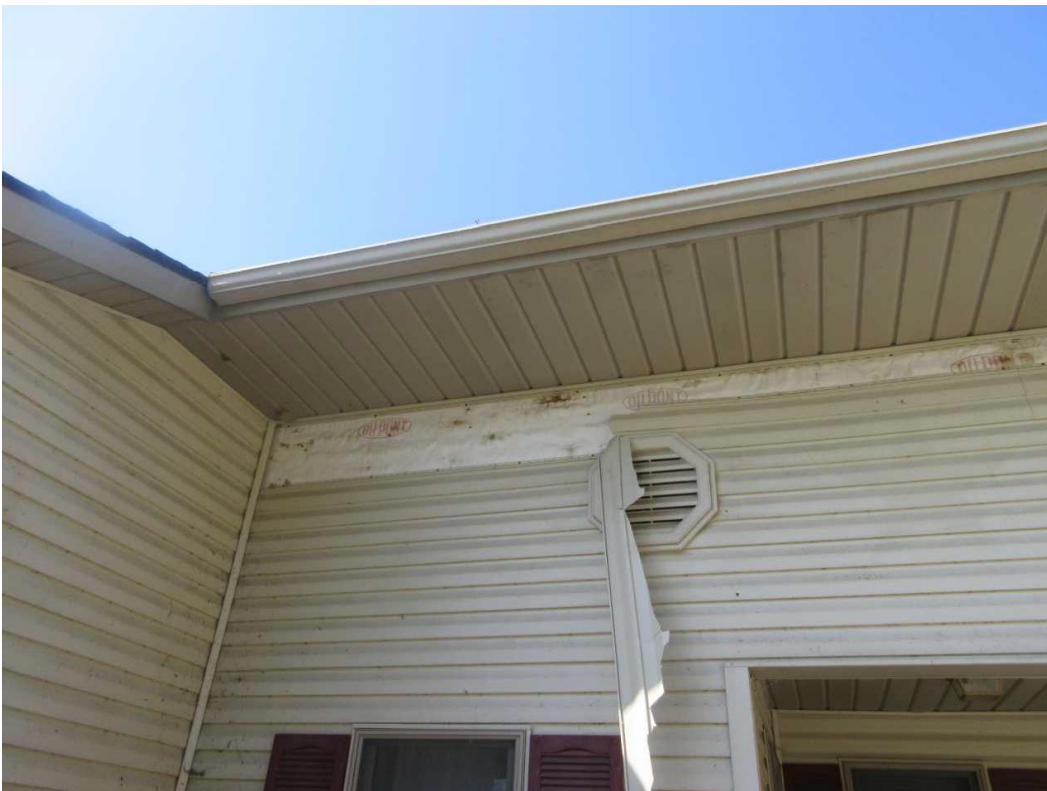
2-Front Elevation

Front Elevation: Wind damaged the vinyl siding.

Wind damage to vinyl siding.

CAT	SEL	ACT DESCRIPTION	REMOVE	REPLACE	TAX	TOTAL
	CALC	QTY				
13. SDG	MN	+ Siding - Labor Minimum				
	1	1.00 EA	0.00+	392.32 =	0.00	392.32
14. SDG	VINYL	M Material Only Siding - vinyl				
	200	200.00 SF	0.00+	2.21 =	30.94	472.94
Totals: Front Elevation					30.94	865.26

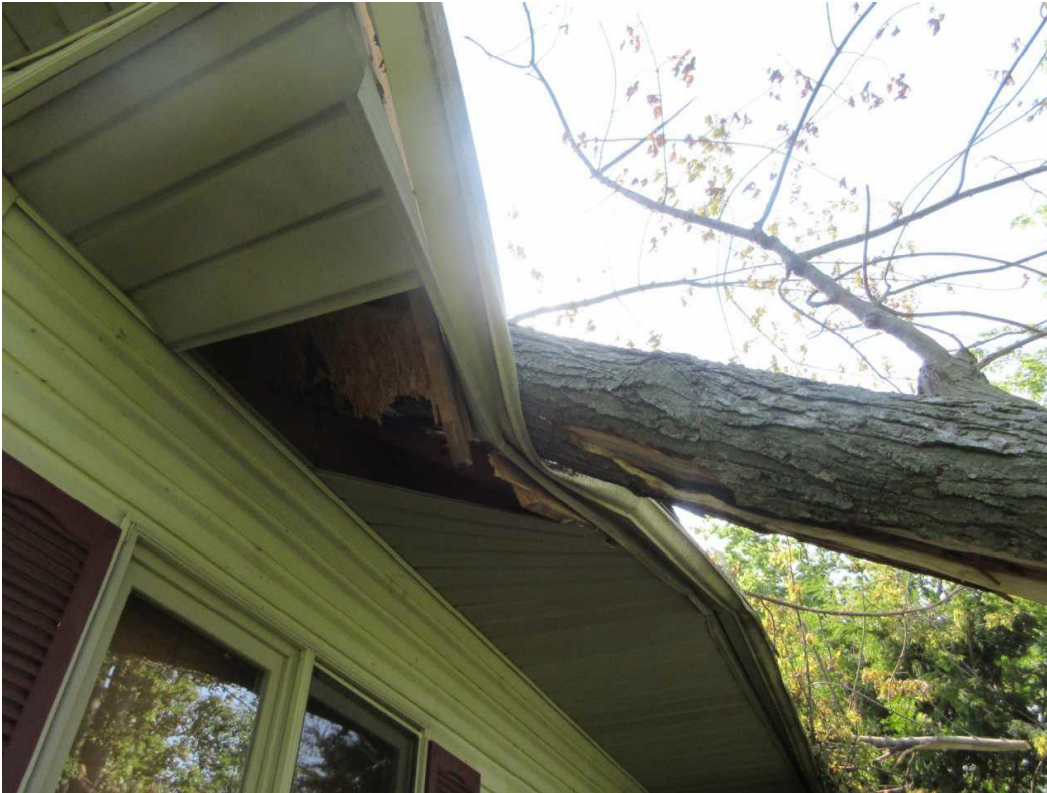
7-Rear Elevation

Rear Elevation: Wind-felled tree damaged the gutters, gutter screen, fascia, fascia board, soffit, and soffit framing.

Fallen tree debris damage to gutters, fascia, soffit, and roof framing.

CAT	SEL	ACT DESCRIPTION	REMOVE	REPLACE	TAX	TOTAL
	CALC	QTY				
15. SFG	FACM6	& R&R Fascia - metal - 6"				
	24	24.00 LF	0.40+	7.20 =	4.12	186.52
16. SFG	FACW6-	& R&R Fascia - 1" x 6" - #2 pine				
	24	24.00 LF	0.40+	8.98 =	2.57	227.69
17. SFG	SFTM	& R&R Soffit - metal				
	24*2'9	66.00 SF	0.35+	8.69 =	18.20	614.84
18. SFG	WFRM3	& R&R Soffit - box framing - 3' overhang				
	24	24.00 LF	2.42+	11.11 =	3.06	327.78
Totals: Rear Elevation					27.95	1,356.83

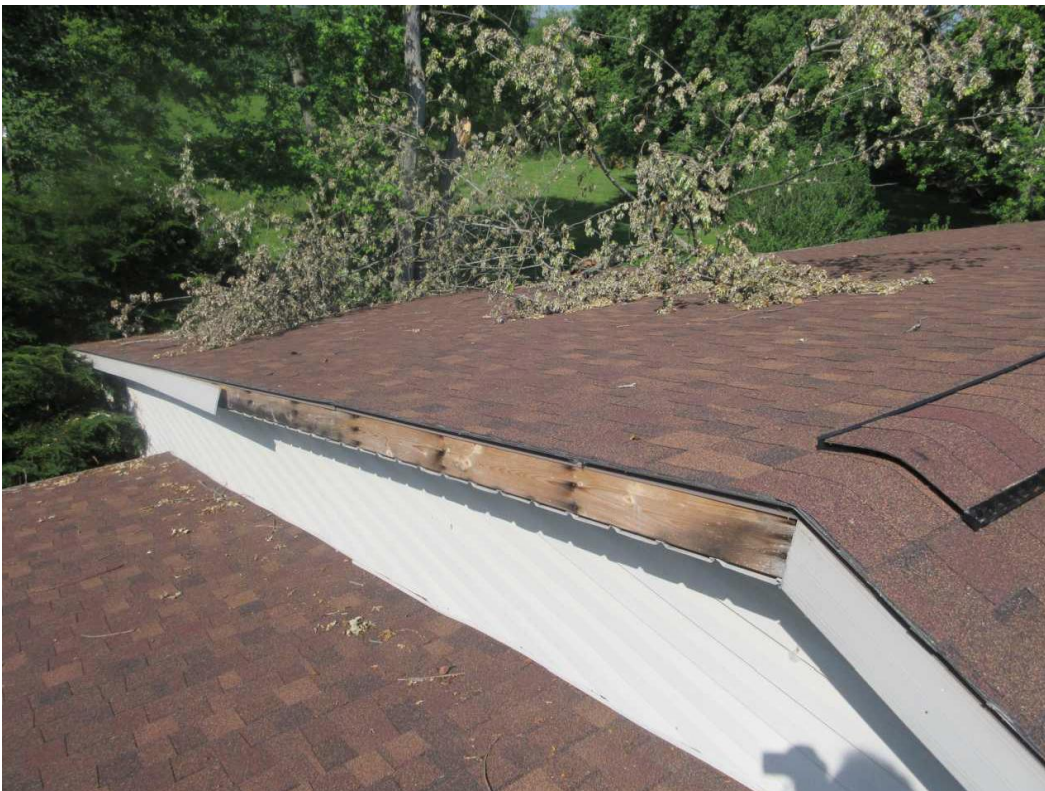
10-Left Elevation

Left Elevation: Wind damaged the fascia.

Wind damage to fascia.

CAT	SEL	ACT DESCRIPTION					
	CALC	QTY	REMOVE	REPLACE	TAX	TOTAL	
19. SFG	FACM6	& R&R Fascia - metal - 6"					
	33	33.00 LF	0.40+	7.20 =	5.66	256.46	
Totals: Left Elevation						5.66	256.46
Total: Exterior						157.89	6,415.15

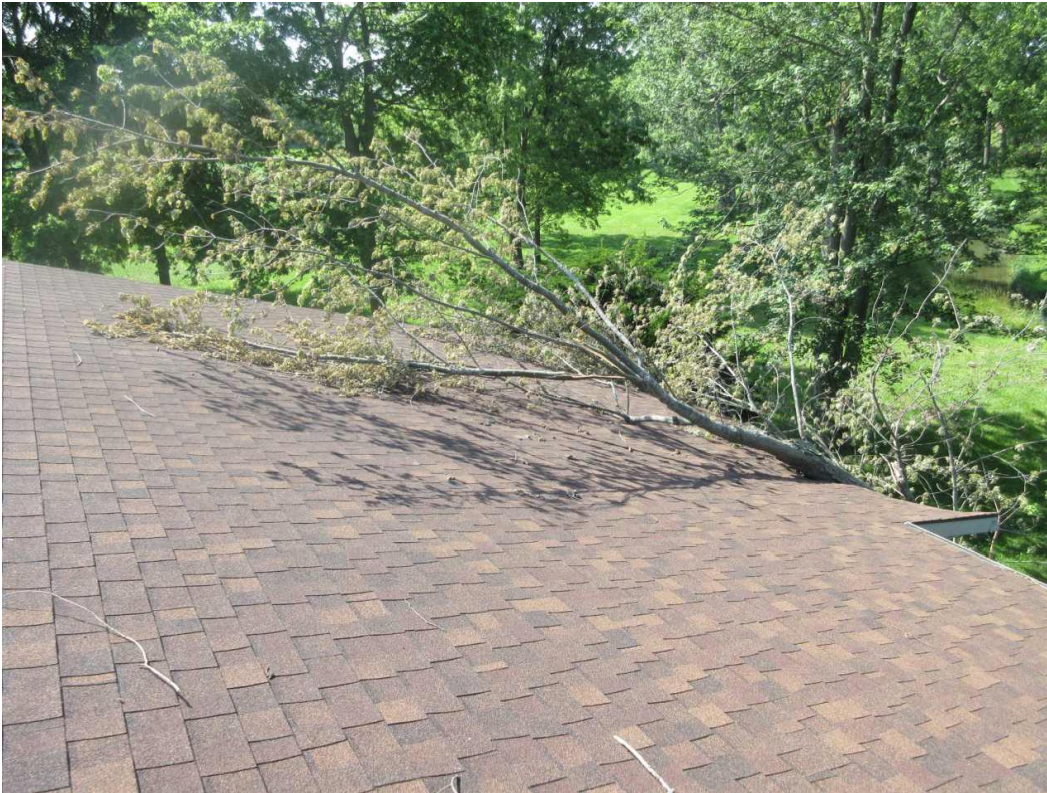
25-Back Slope

There is no hail damage to the Dwelling Roof from the claimed date of loss. The hail from the claimed date of loss was not large enough to cause damage to the shingles. A wind-felled tree damaged the shingles and roof framing. The roof is 1 year old, and the shingles are flexible and repairable.

Slope overview, fallen tree debris damage to shingles, sheathing, and rafters.

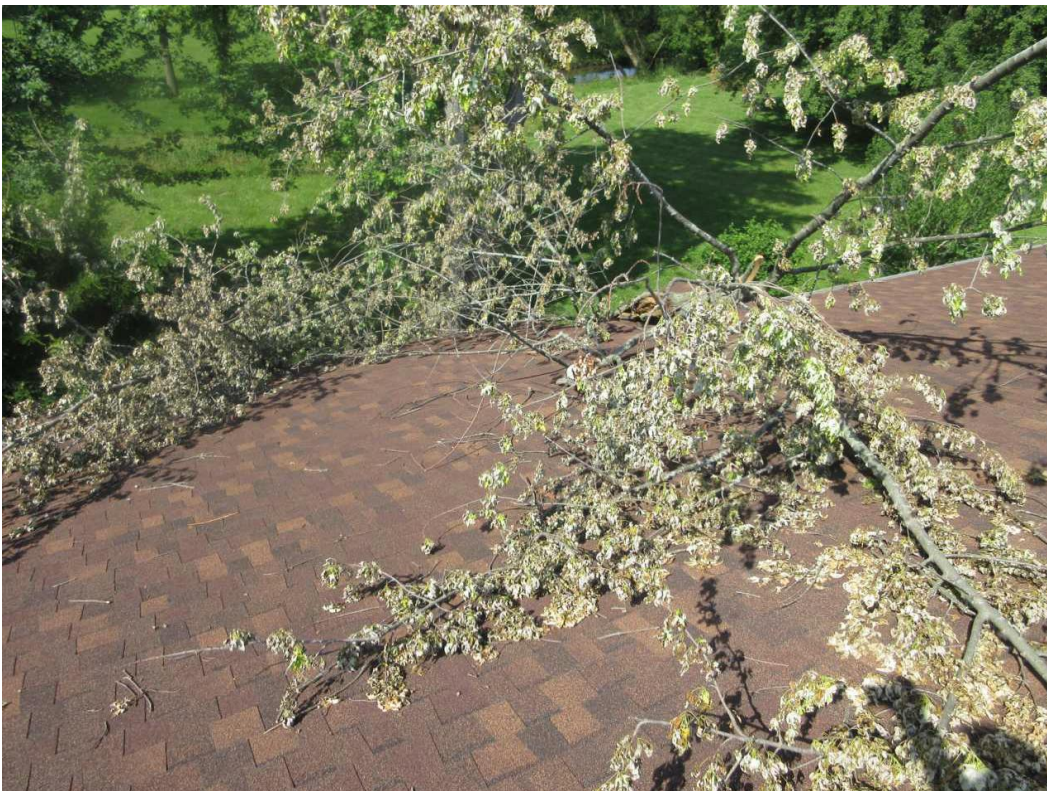
26-Back Slope

Slope overview, fallen tree debris damage to shingles, sheathing, and rafters.

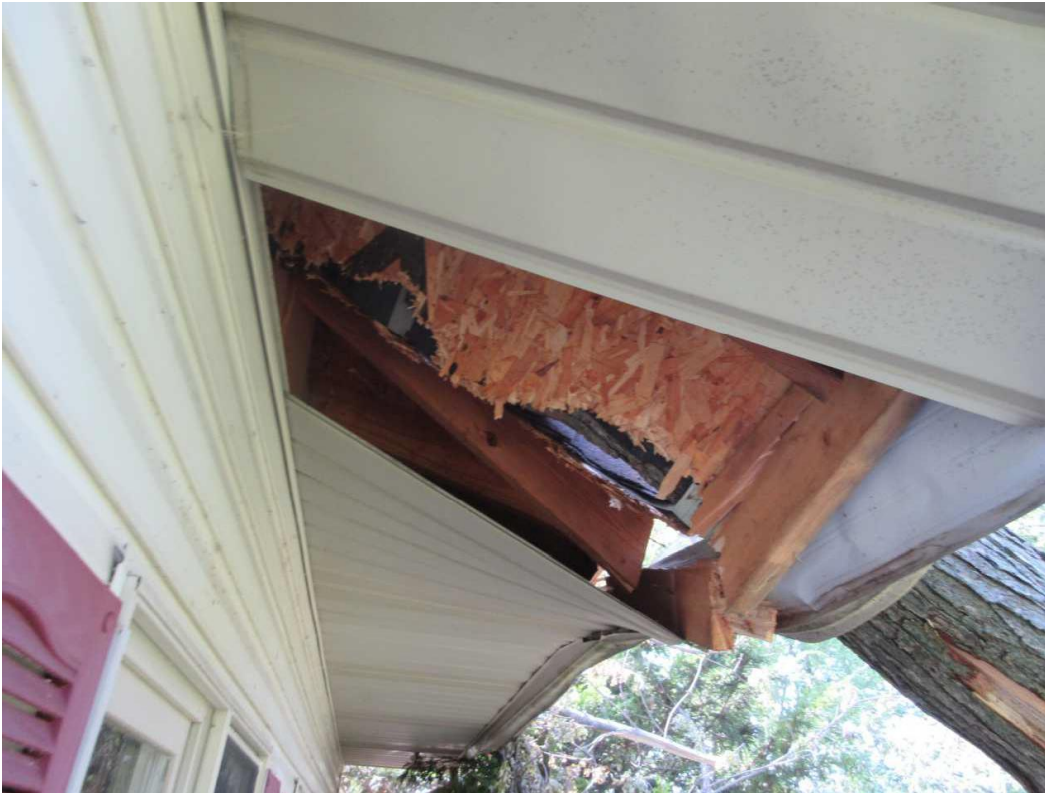
27-Back Slope

Fallen tree debris damage to roof framing.

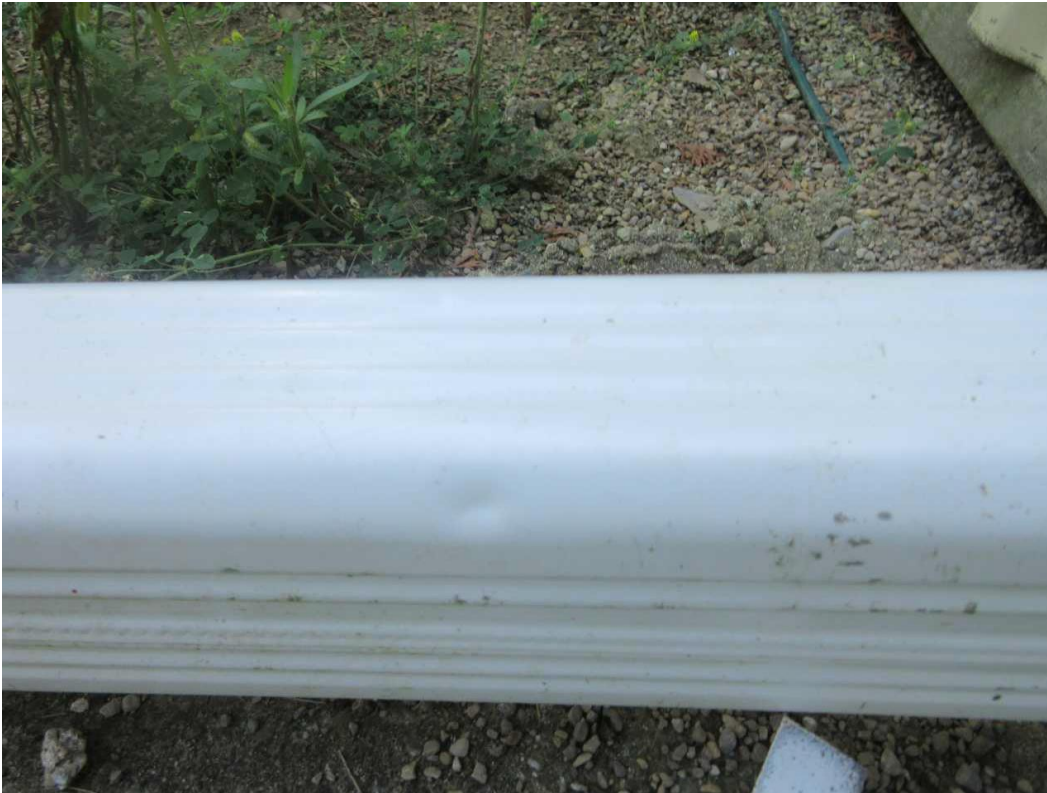
35-Right Elevation

W Right Elevation: Hail damaged the gutters and downspouts.

Hail damage to downspout.

CAT	SEL CALC	ACT DESCRIPTION QTY	REMOVE	REPLACE	TAX	TOTAL
33. SFG	GUTA> 321.45+30	& R&R Gutter / downspout - aluminum - 6" 351.45 LF	0.60+	13.95 =	201.49	5,315.09
<i>Gutters - all gutters. Downspouts - 20 LF (Right Elevation) + 10 LF (Rear Elevation).</i>						
Totals: Gutters and Downspouts					201.49	5,315.09
Total: Exterior					1,215.75	56,893.61
Total: Barn					1,215.75	56,893.61

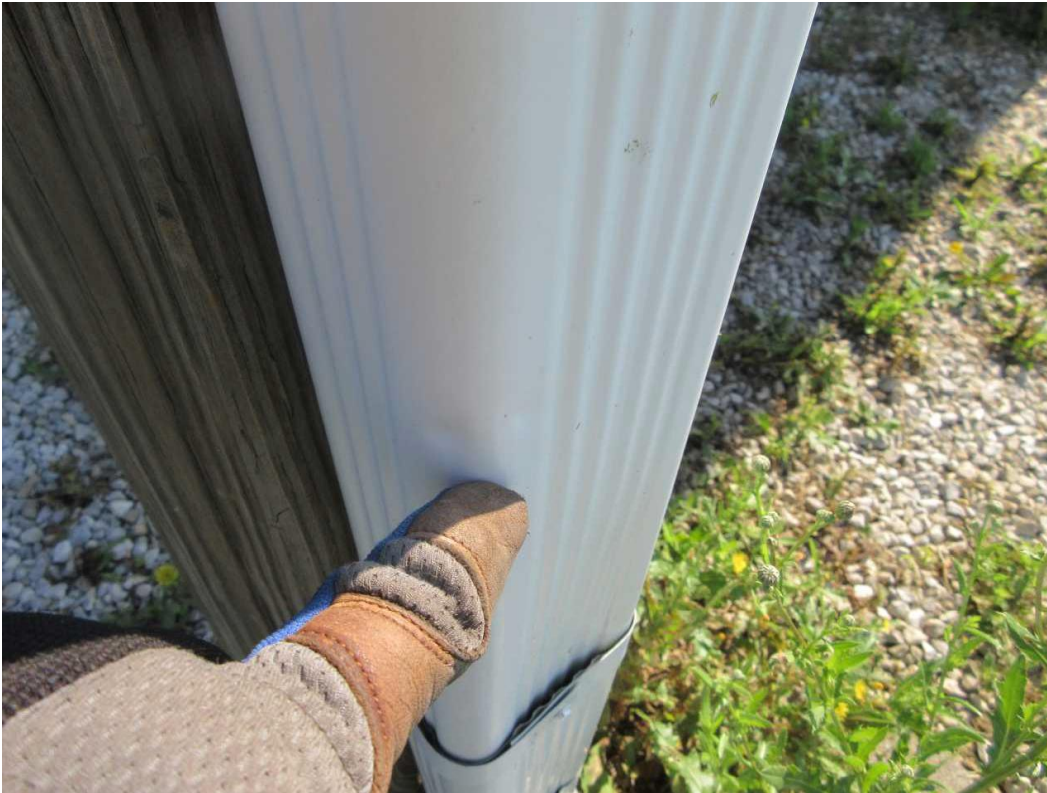
41-Rear Elevation

S Rear Elevation: Hail damaged the gutters and downspout.

Hail damage to downspout.

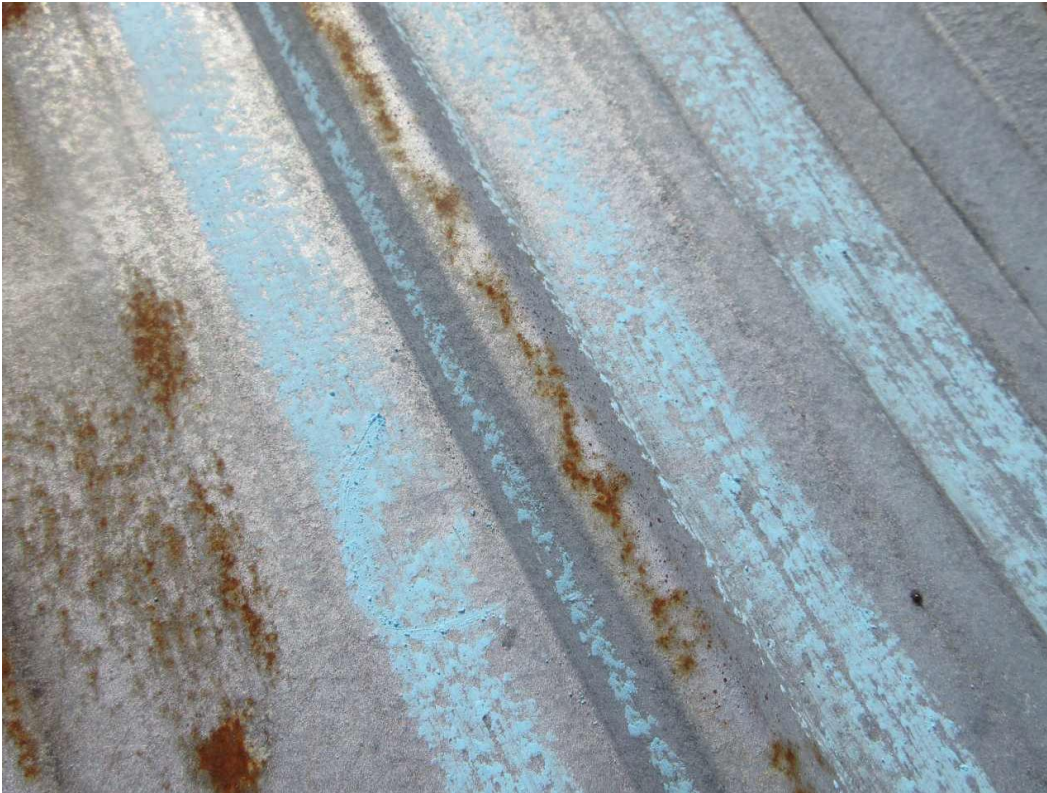
47-Right Slope

Small (approximately 1/2") hail spatter was observed on the metal roofing. Hail damaged the ribbed metal roofing and furnace cap.

Close up of hail damage.

CAT	SEL	ACT DESCRIPTION				TAX	TOTAL
	CALC	QTY	REMOVE	REPLACE			
26. RFG	MTLR-SF	& R&R Metal roofing - ribbed - 29 gauge - up to 1"					
		6262.21 SF	0.60+	6.71 =	920.54		46,697.30
27. RFG	RIDGM-R	& R&R Hip / Ridge cap - metal roofing					
		130.18 LF	3.50+	6.59 =	26.43		1,339.95
28. RFG	MTLREC-4	& R&R Ridge end cap for metal roofing					
		4.00 EA	6.39+	27.70 =	3.44		139.80
29. RFG	STLRT-RAKE	& R&R Steel rake/gable trim - mill finish					
		152.00 LF	0.70+	5.39 =	18.09		943.77
30. RFG	MTLET-EAVE	& R&R Eave trim for metal roofing - 29 gauge					
		321.45 LF	0.98+	5.11 =	31.95		1,989.58
31. RFG	VMTLW-VAL	& R&R Valley metal - (W) profile					
		44.11 LF	0.71+	7.17 =	10.25		357.84
32. HVC	VENTCP6-1	& R&R Furnace vent - rain cap and storm collar, 6"					
		1.00 EA	12.76+	93.96 =	3.56		110.28
Totals: Roof					1,014.26		51,578.52

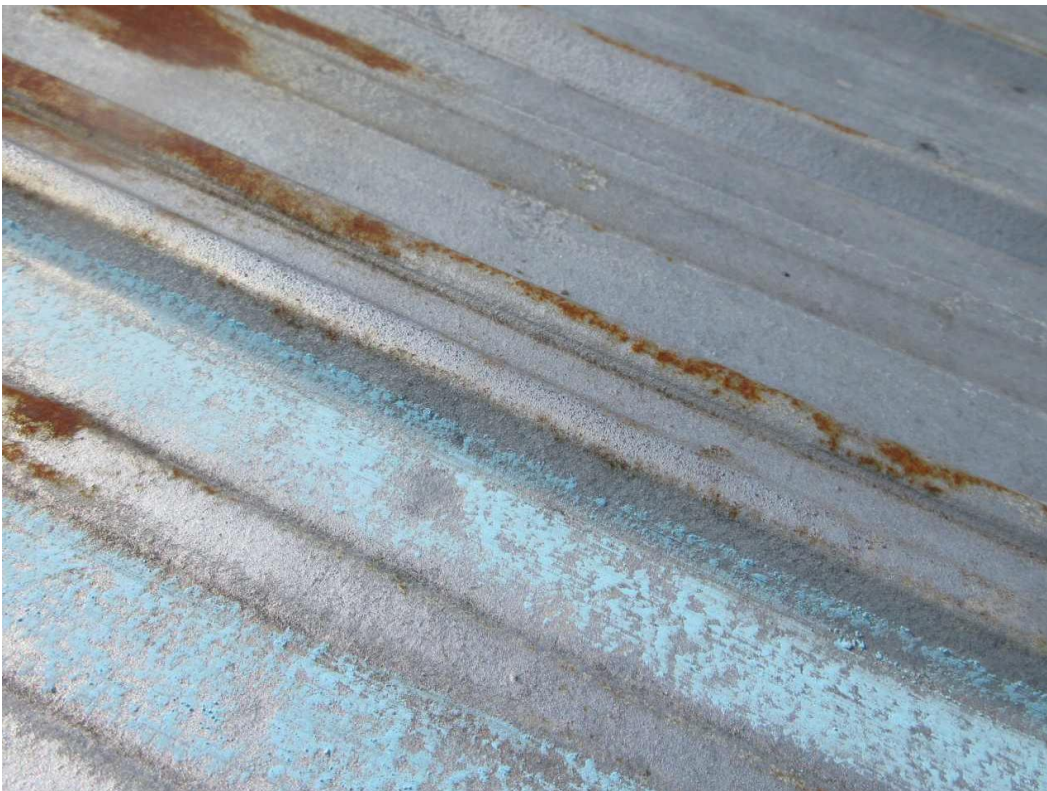
48-Right Slope

Close up of hail damage.

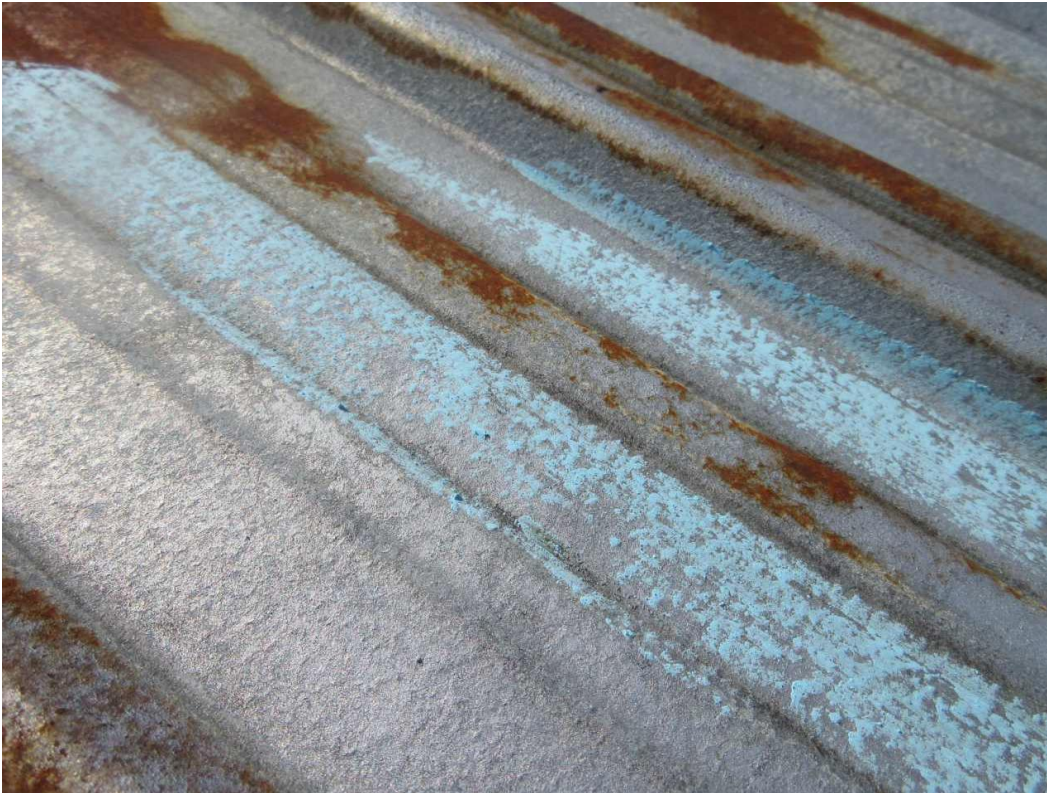
49-Right Slope

Close up of hail damage.

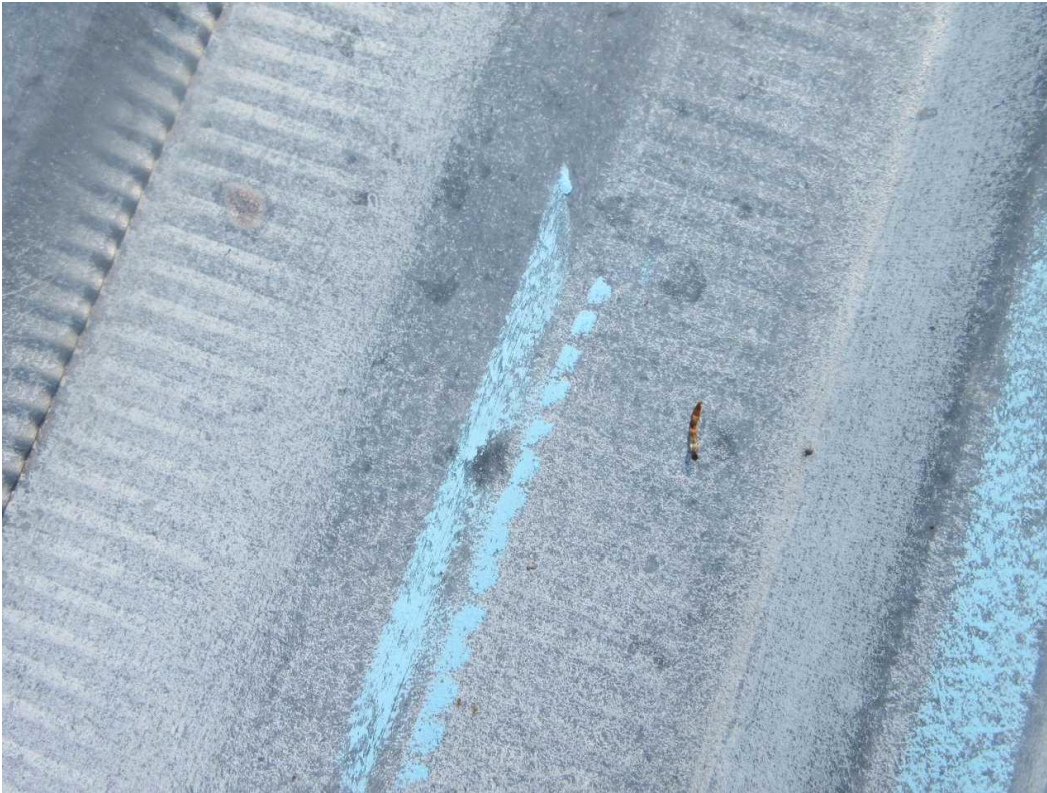
51-Left Slope

Close up of hail damage.

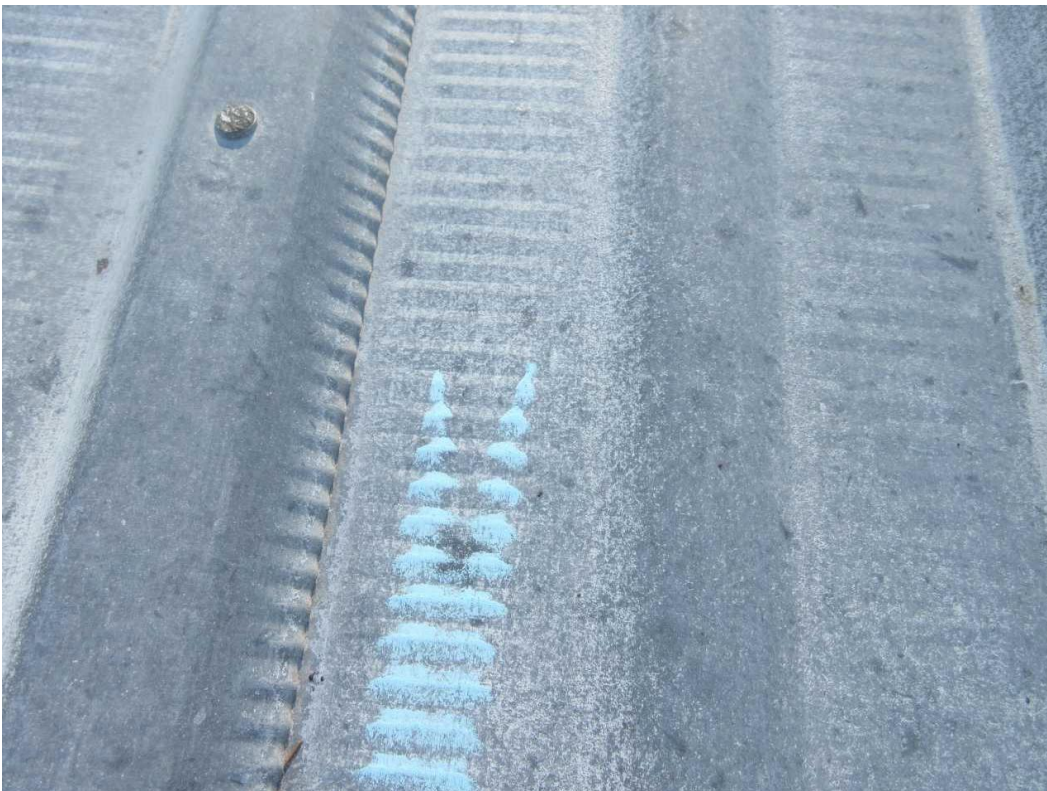
52-Left Slope

Close up of hail damage.

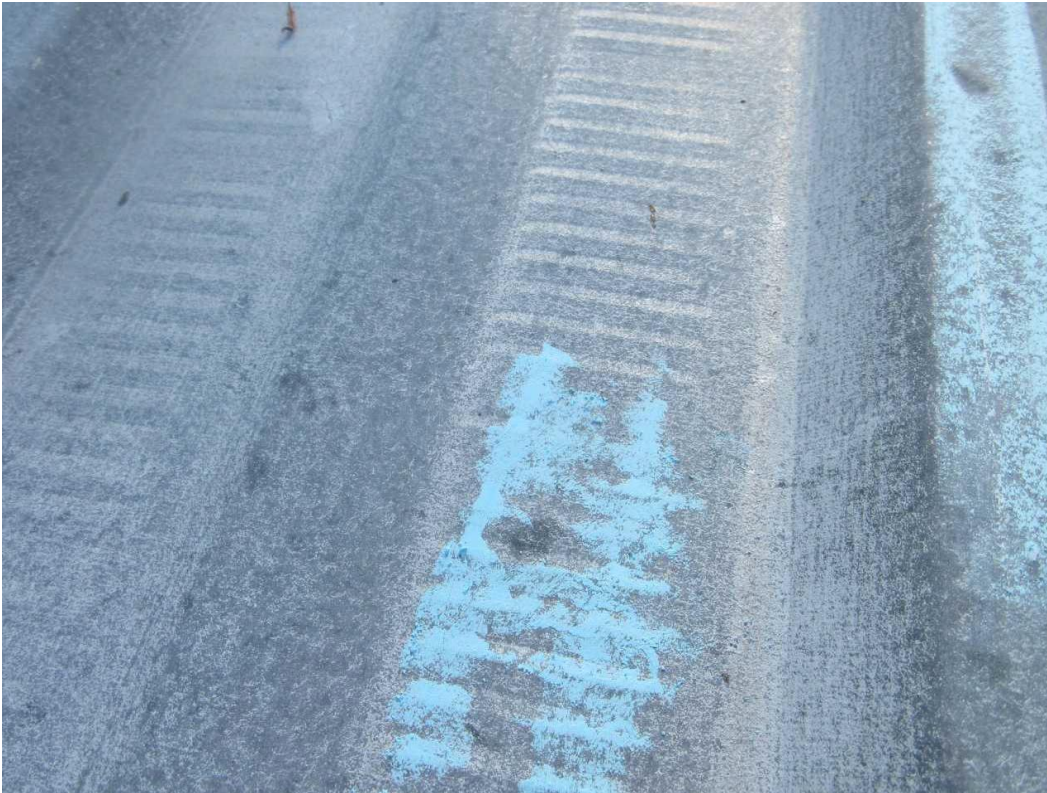
53-Left Slope

Close up of hail damage.

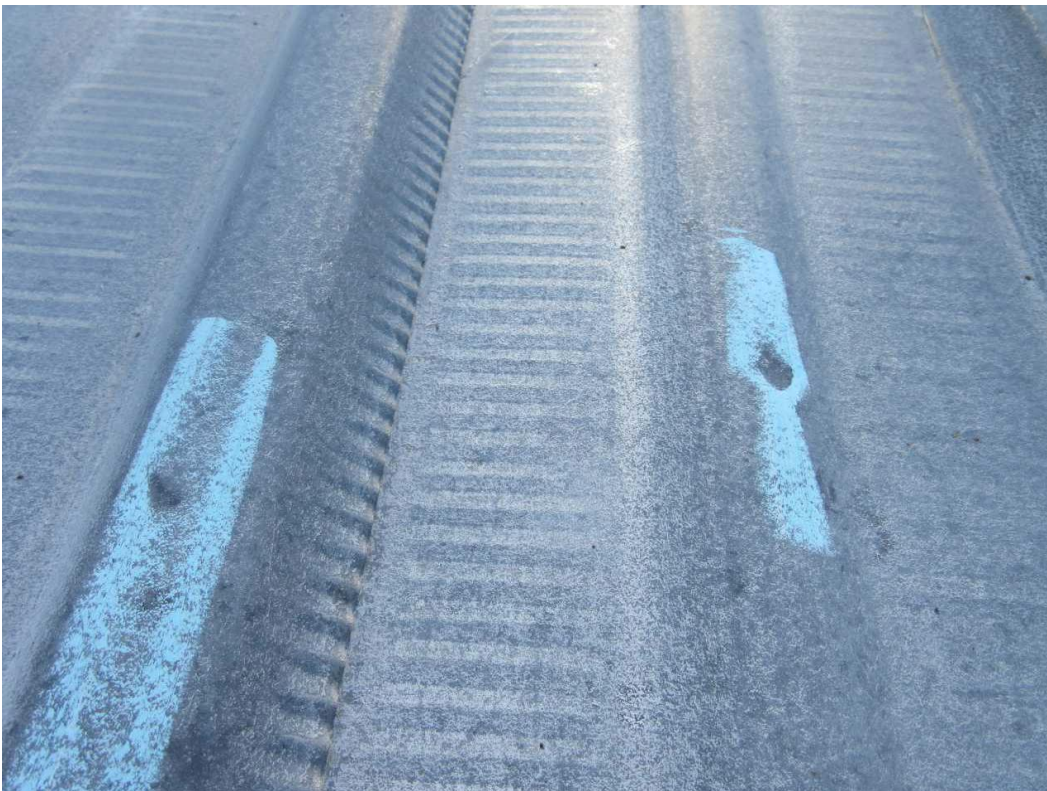
54-Left Slope

Close up of hail damage.

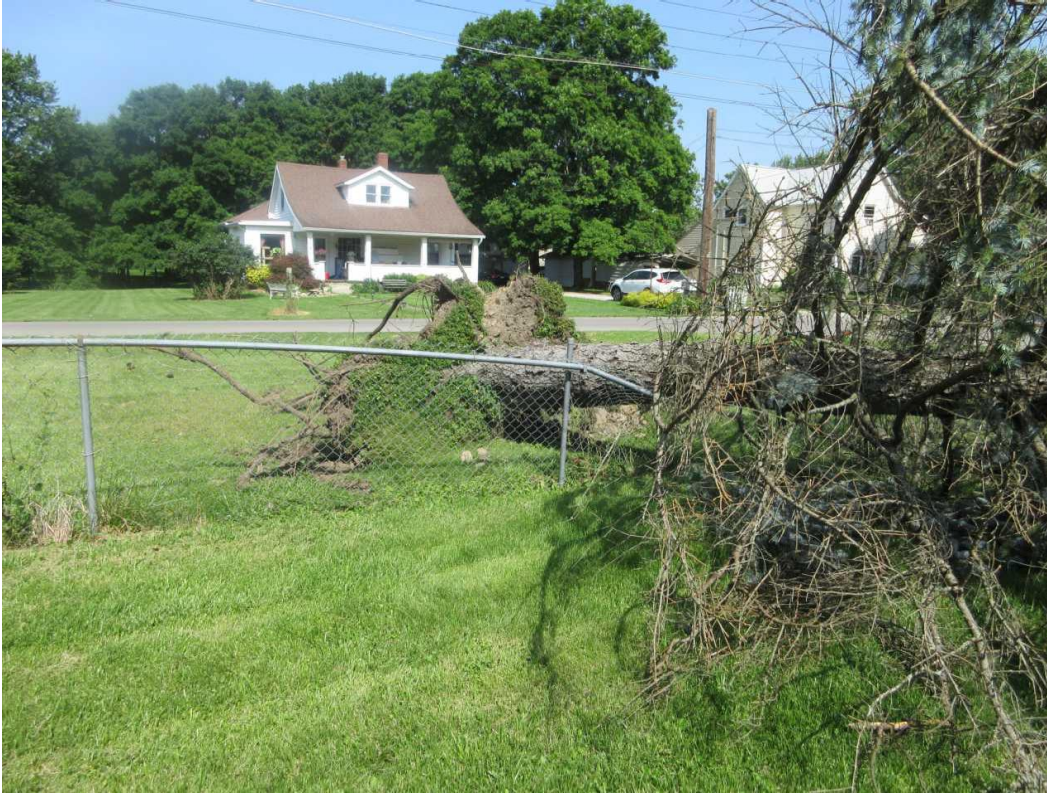
55-Fence

A large tree was wind-blown onto the fence that runs along the South side of the property, damaging 40' of the chain link fencing.

Tree debris damage to fence.

CAT	SEL CALC	ACT DESCRIPTION QTY	REMOVE	REPLACE	TAX	TOTAL
34. FEN	CL4 40	& R&R Chain link fence w/posts & top rail - 4' high - 11 gauge 40.00 LF	3.19+	19.45 =	29.65	935.25
Totals: Fence					29.65	935.25
