## **Activity Log**

LOSS REPORT

Date of Loss: 5/16/2025 Type of Loss: WIND File Number: R191105

Cause of Loss: Tornado

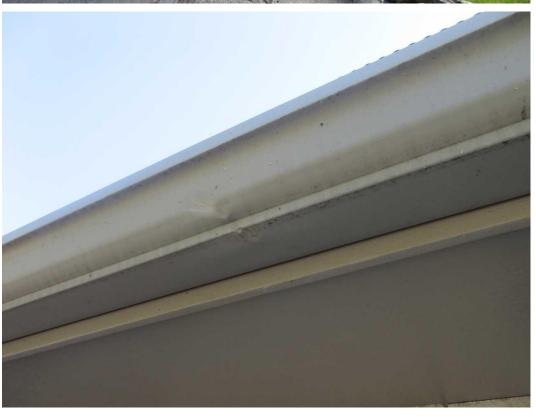
### 2-SW Front Elevation

Debris damage to gutters, no damage to gutter screens; however, screens need

detached and reset.

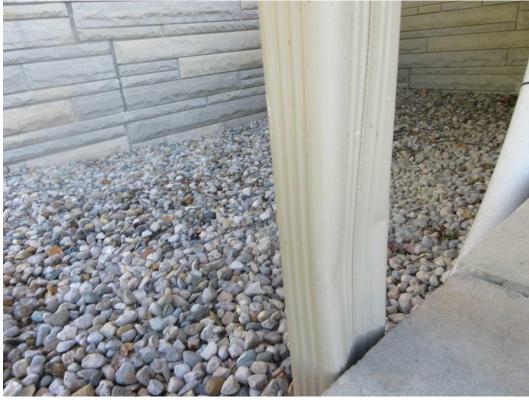
### 10-SW Front Elevation

Debris damage to downspout.

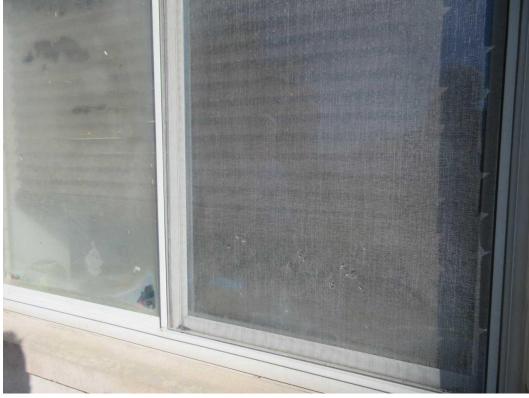
## 18-SE Right Elevation

Debris damage to window screens.

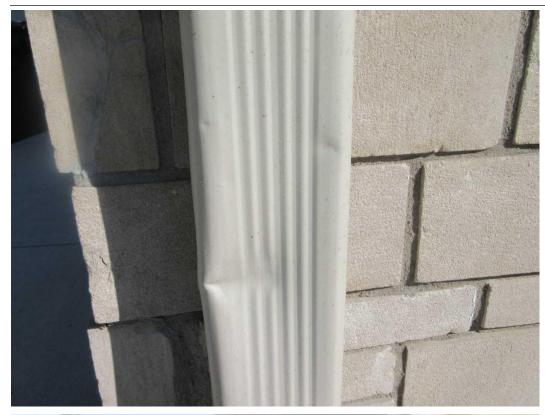
## 19-SE Right Elevation

Debris damage to downspout.

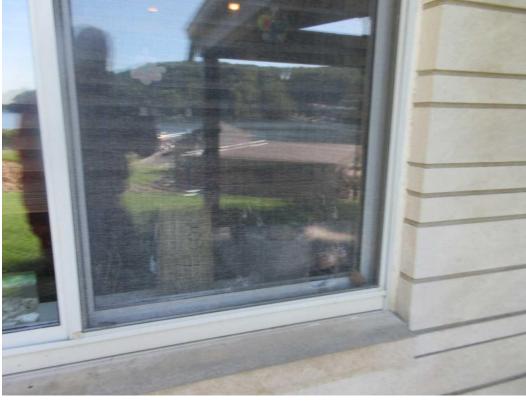
### 20-SE Right Elevation

Debris damage to window screens.

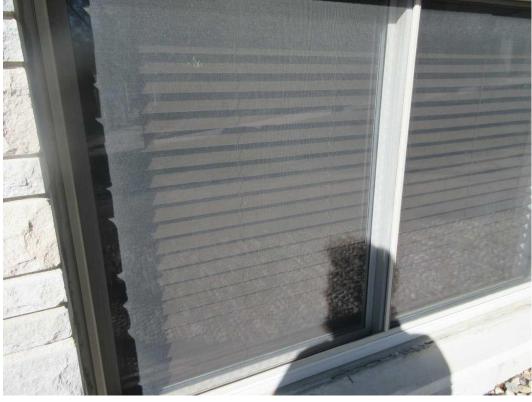
### 26-NE Rear Elevation

Debris damage to 1 window screen

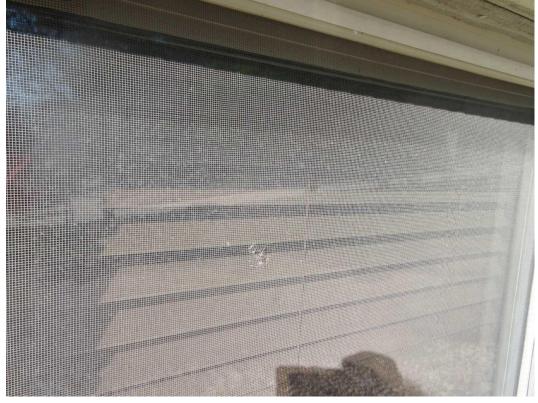
### 27-NE Rear Elevation

Debris damage to 1 window screen

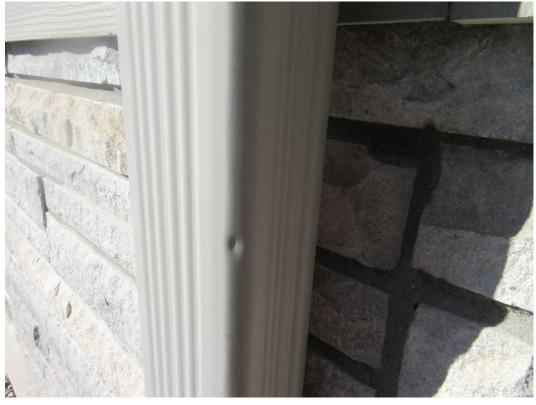
### 28-NE Rear Elevation

Debris damage to downspout.

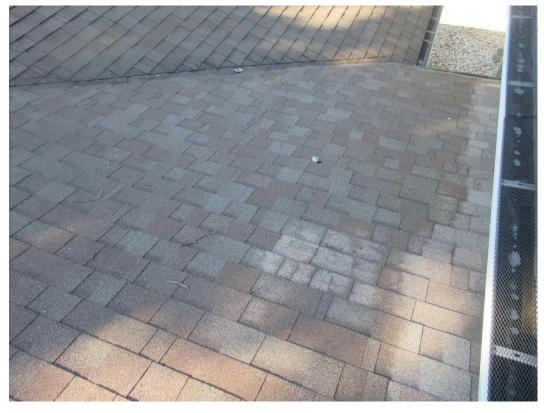
### **48-SW Front Slope**

Granule loss is not storm related.

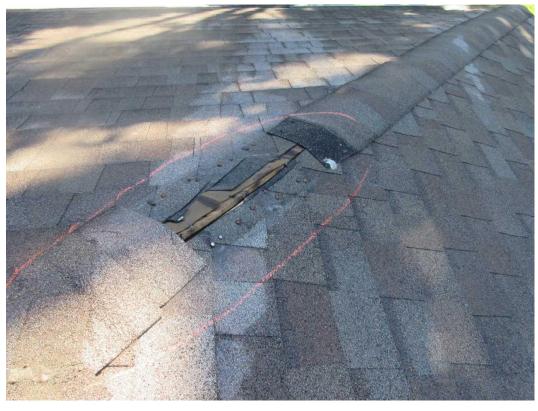
### 52-SE Right Slope

Wind damage to ridge shingles only, no

damage to field shingles.

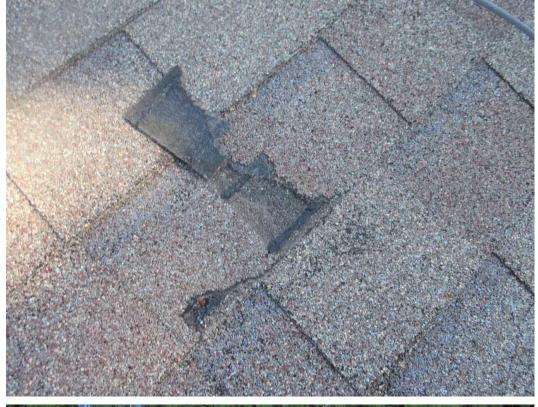
## 57-SE Right Slope

Debris damage to shingle.

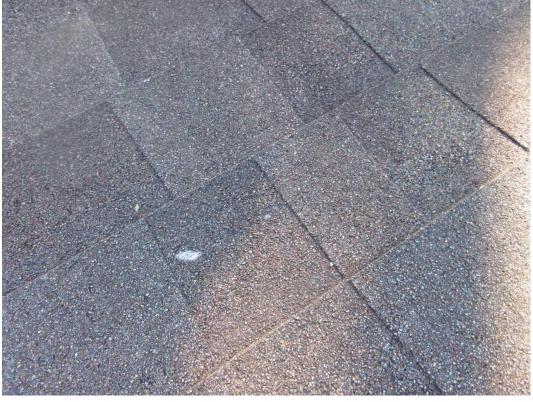
### 64-NE Rear Slope

Mechanical damage to shingle, granule loss is not storm-related and is

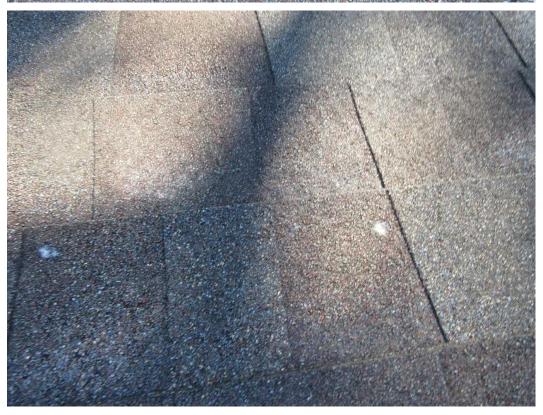
#### 66-NE Rear Slope

Mechanical damage to shingle, granule loss is not storm-related and is pre-existing, evident by clean fiberglass.

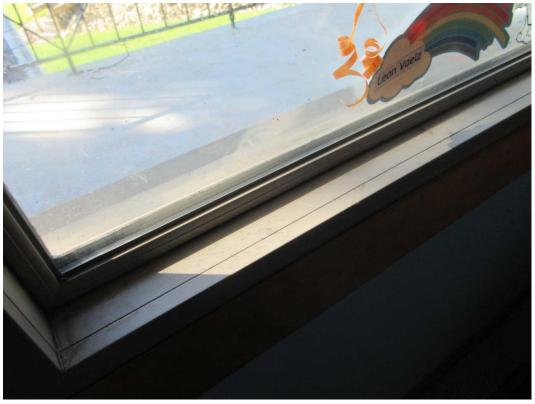
#### 73-Bedroom

Leak through window, no damage to

finished materials.

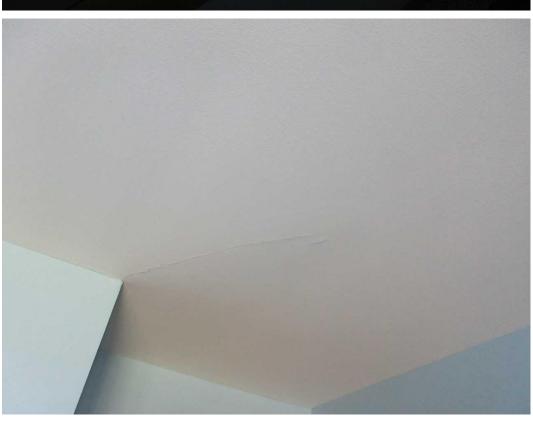
#### 74-Bedroom

Settlement crack.

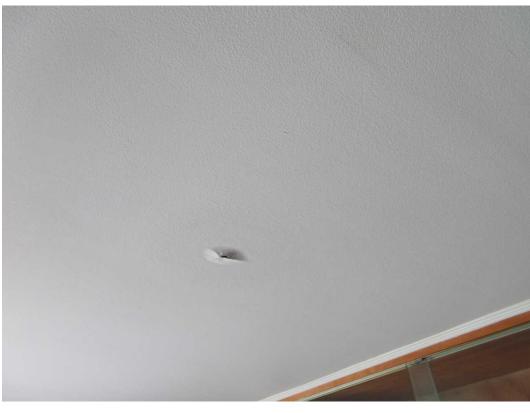
#### 76-Kitchen

Bedroom: Wind-driven rain entered the interior around the window; however, there is no damage to finished materials. Kitchen: There is minor wind-driven rain damage to the drywall ceiling. Estimate includes a drywall minimum and a paint minimum to make the necessary repairs.

Minor water damage to drywall ceiling.

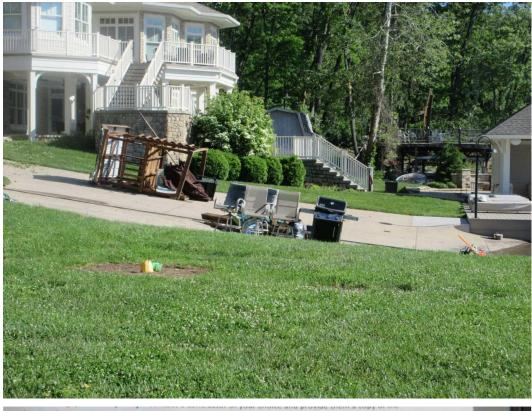
#### 99-Personal Property

Tornado damage to Personal Property, insured is making a list to submit later.
