File # R192712  
 Claim # 300- [REDACTED]-2025  
 Insured [REDACTED] Automotive Services

## LOSS REPORT

Cause of Loss: Hail

Damaged items include: Location 1 Building 1 Roof/Elevations, Location 3 Building 1 Roof/Elevations, Location 3 Building 2 Roof, Location 5 Building 1 Roof/Elevations, Location 6 Building 1 Roof/Elevations, Location 6 Building 2 Roof/Elevations

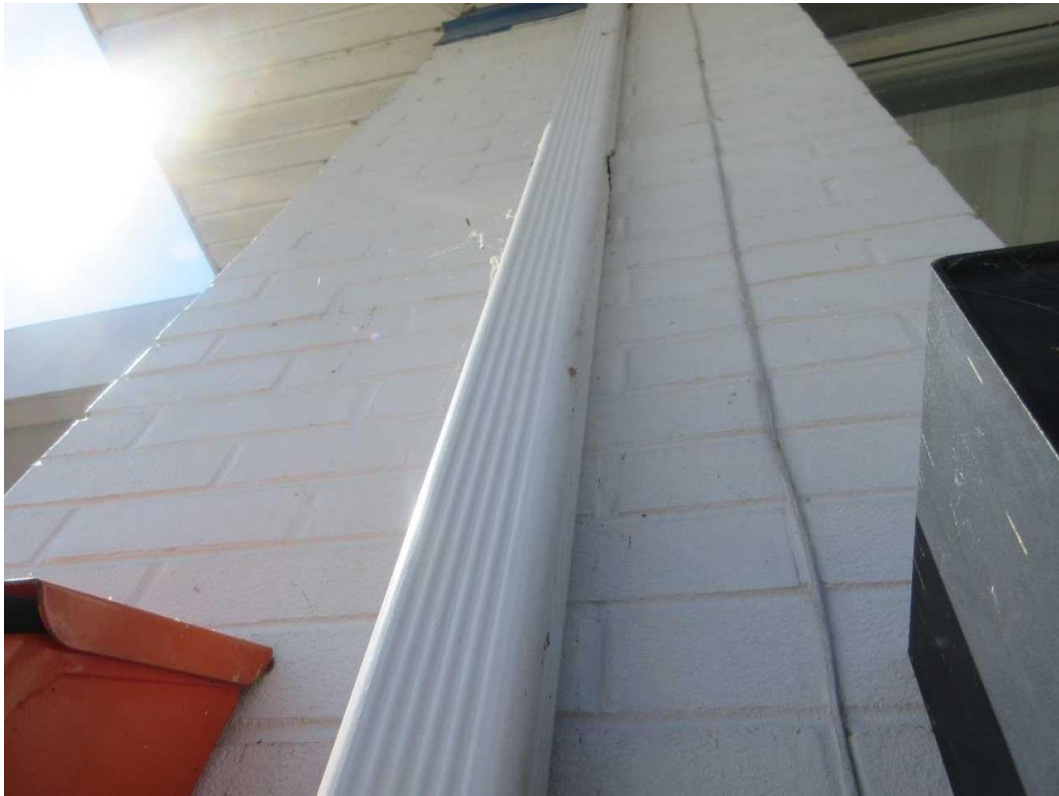
**3-N Right Elevation**

Date Taken: 6/27/2025  
Taken By: Michael Wallen  
No storm damage to downspout from the  
claimed date of loss.

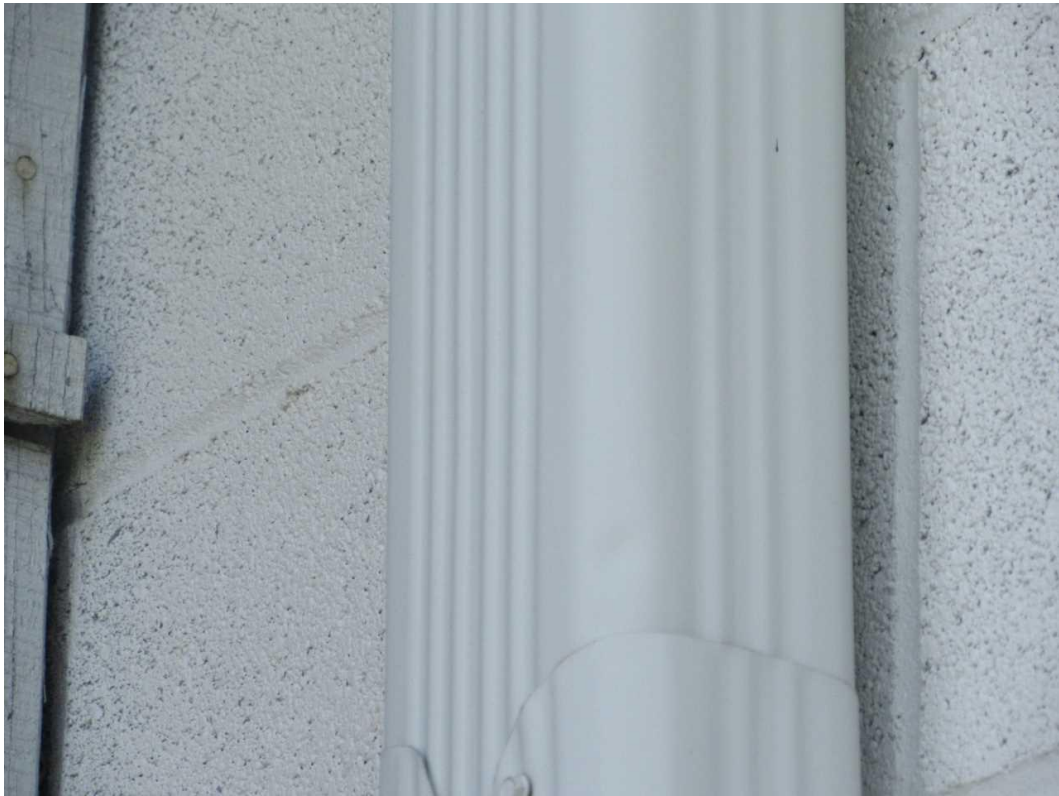
**5-W Rear Elevation**  
Date Taken: 6/27/2025  
Taken By: Michael Wallen  
Hail damage to downspout.

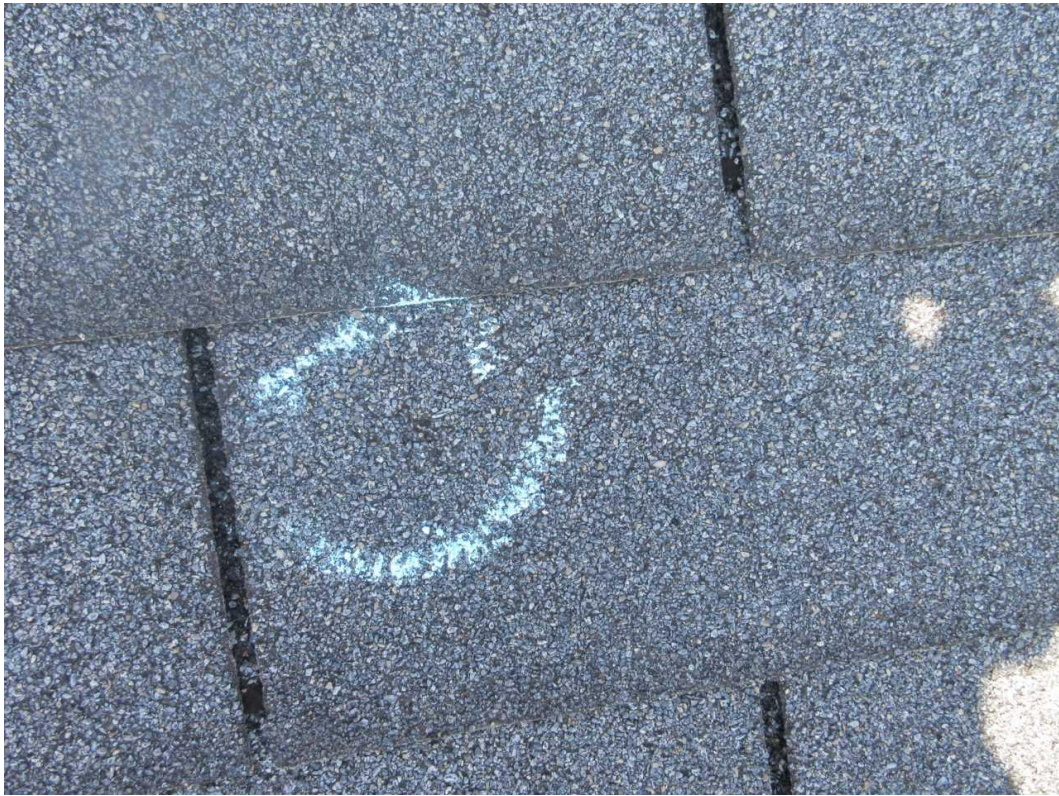
Date Taken: 6/27/2025  
Taken By: Michael Wallen  
Close up of hail damage inside the test square.

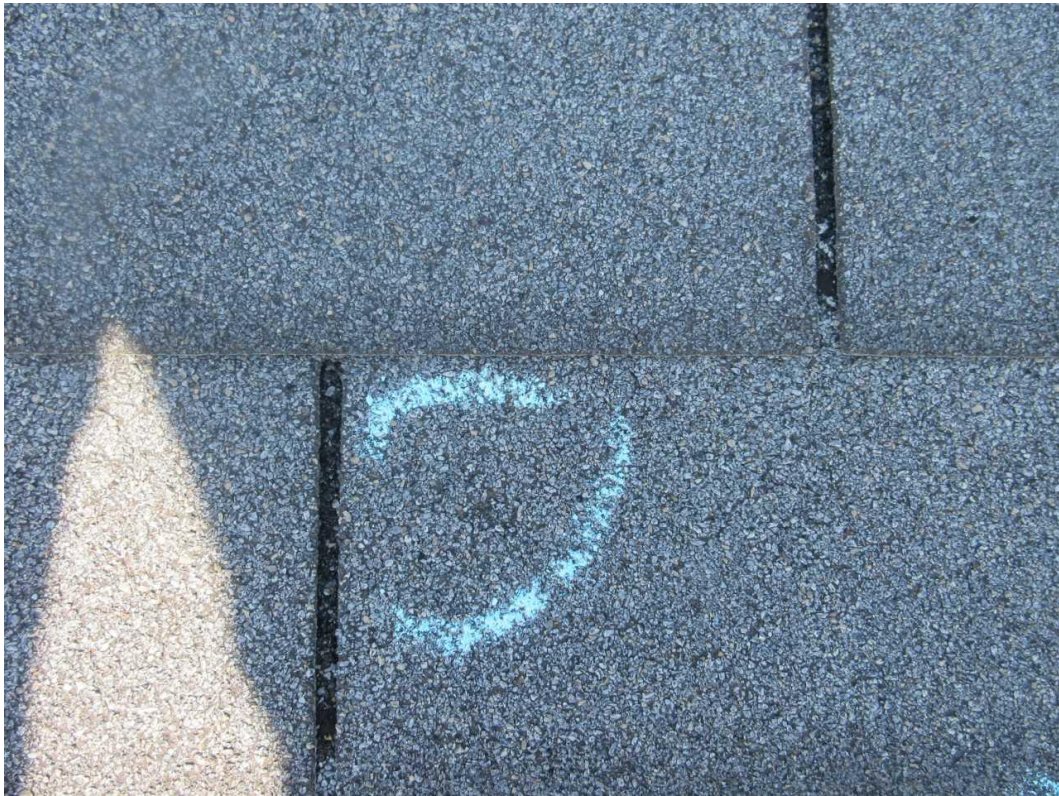
**15-E Front Slope**  
Date Taken: 6/27/2025  
Taken By: Michael Wallen  
Close up of hail damage inside the test square.

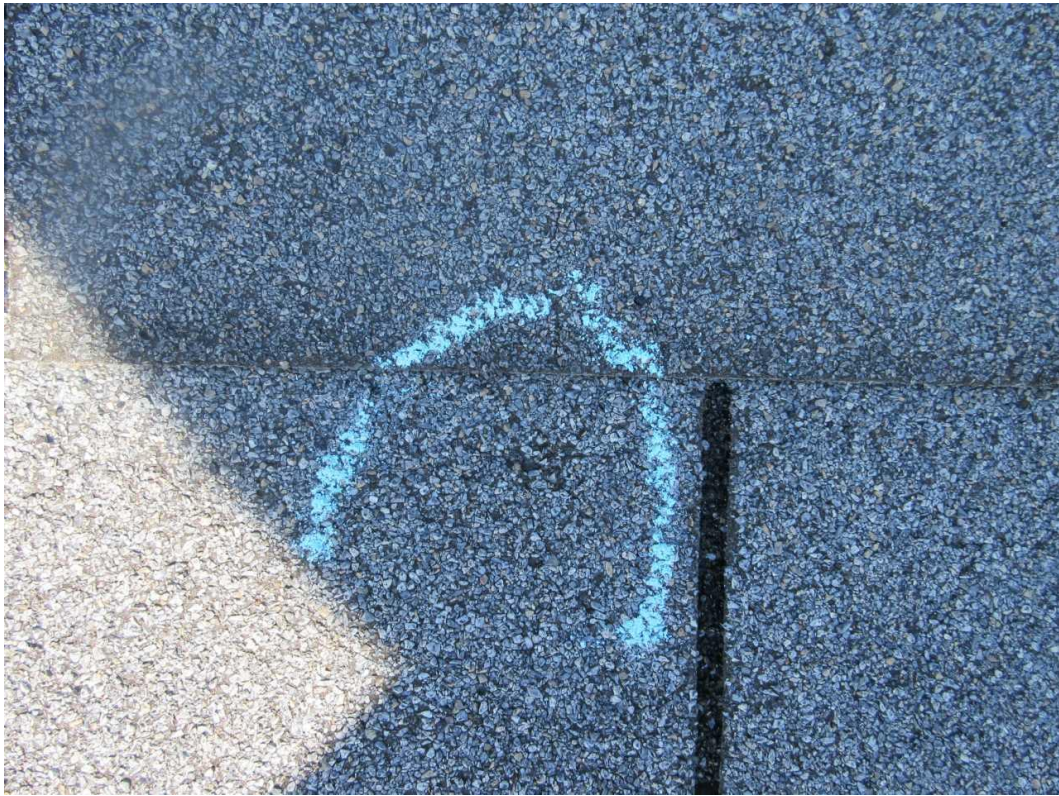
**16-E Front Slope**  
Date Taken: 6/27/2025  
Taken By: Michael Wallen  
Close up of hail damage inside the test square.

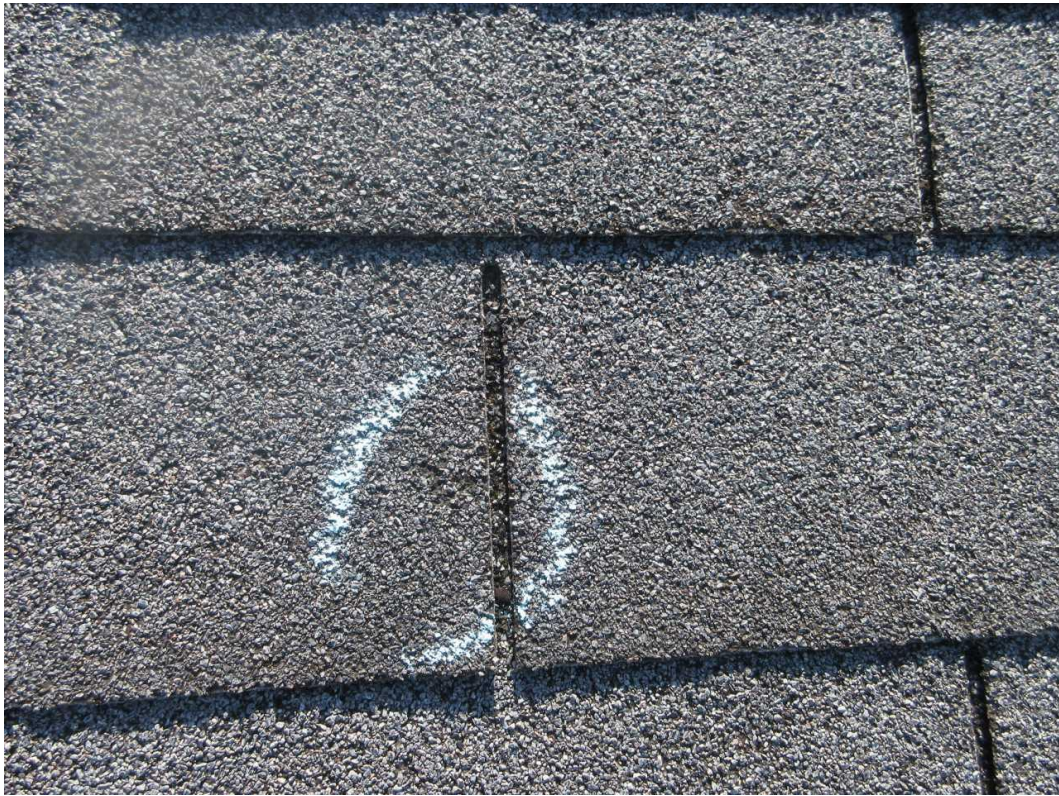
**18-W Back Slope**  
Date Taken: 6/27/2025  
Taken By: Michael Wallen  
Close up of hail damage inside the test square.

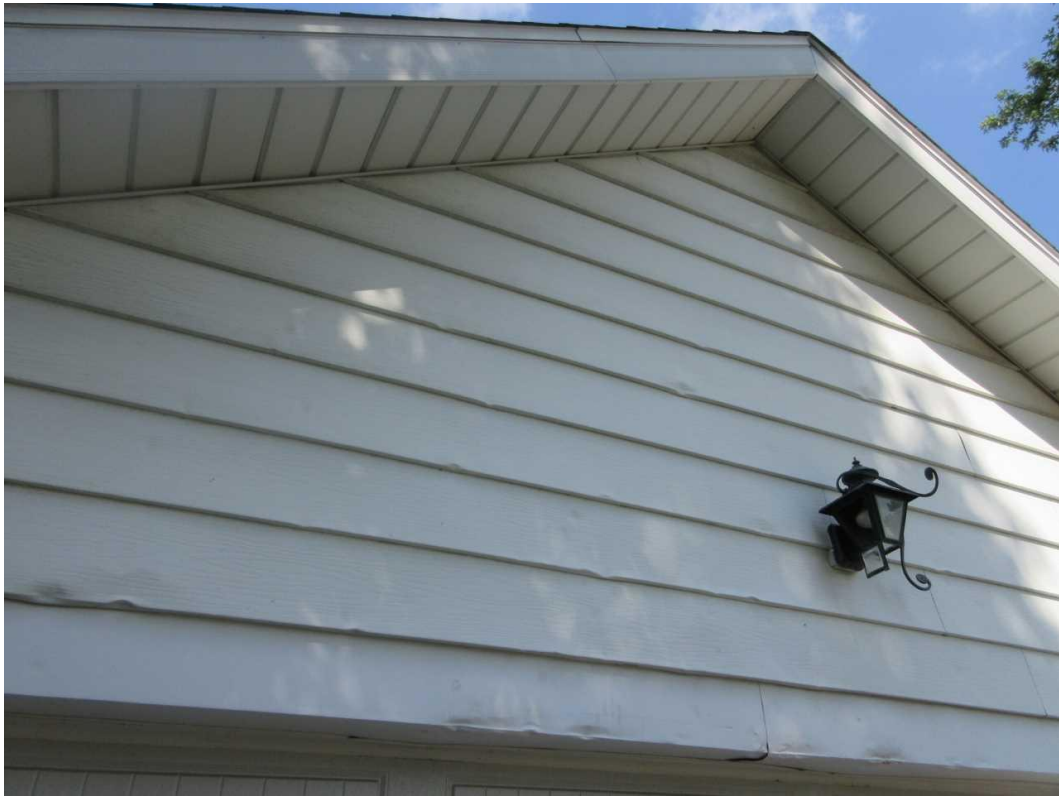
**29-E Front Elevation**  
Date Taken: 6/27/2025  
Taken By: Michael Wallen  
Mechanical damage to aluminum siding.

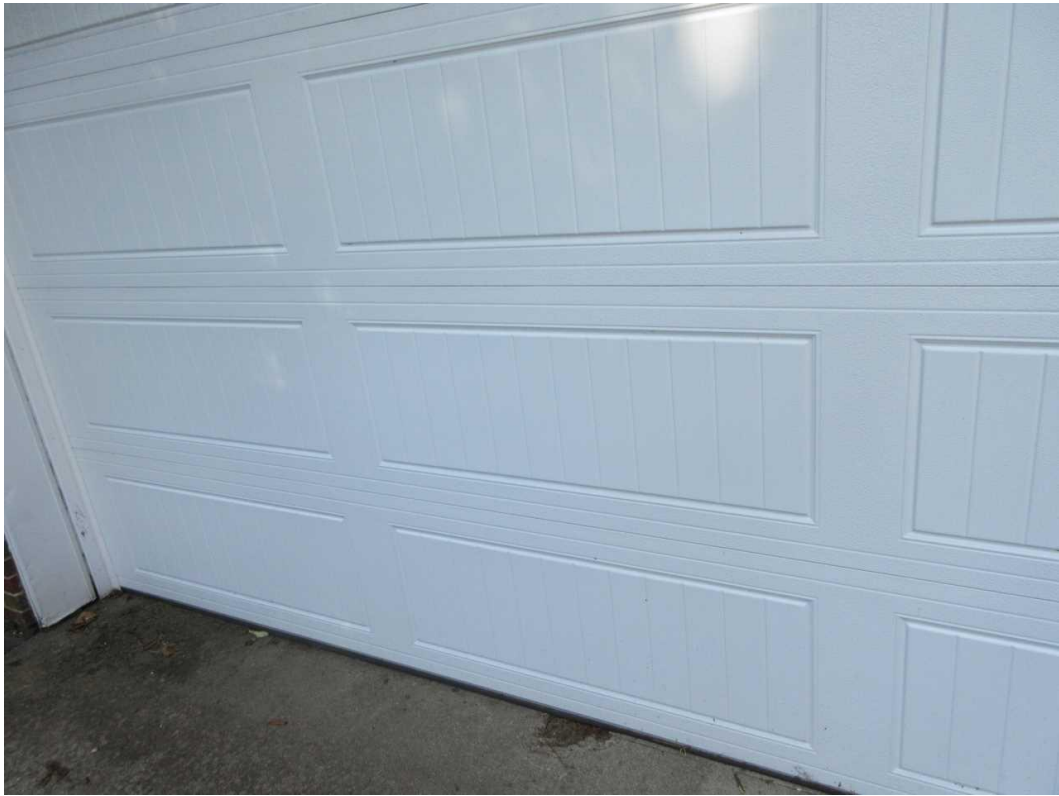
**30-E Front Elevation**  
Date Taken: 6/27/2025  
Taken By: Michael Wallen  
No storm damage to overhead door from the claimed date of loss.

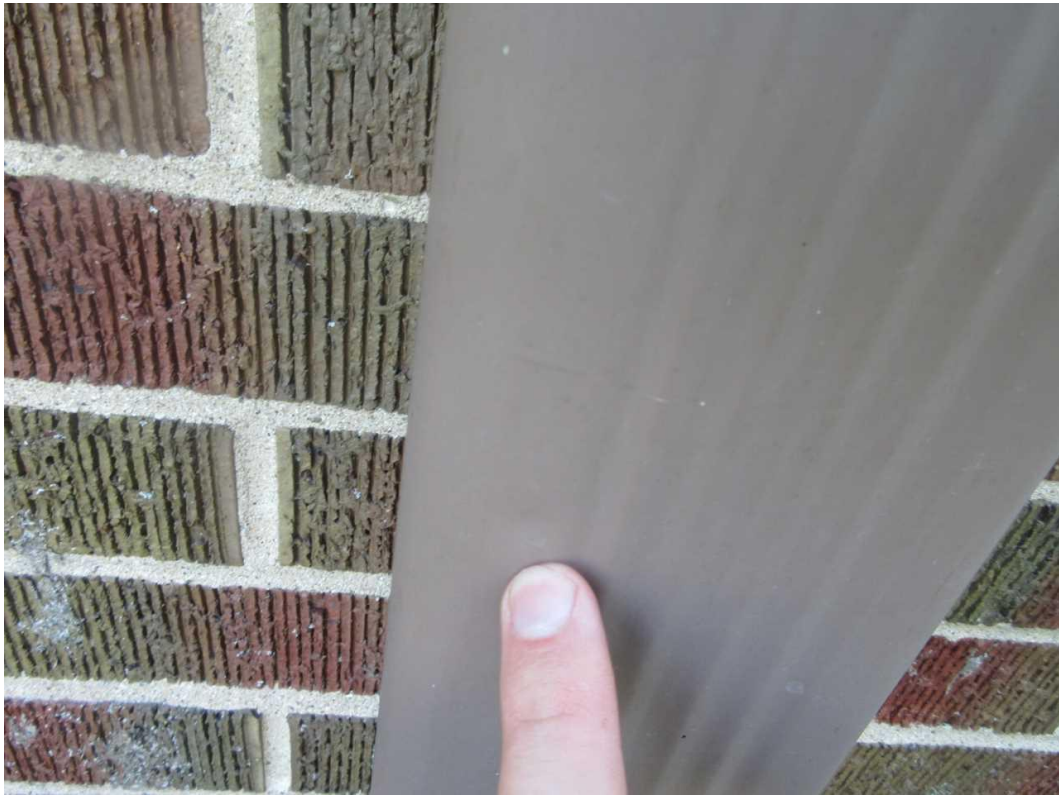
**34-W Rear Elevation**  
Date Taken: 6/27/2025  
Taken By: Michael Wallen  
Hail damage to downspout.

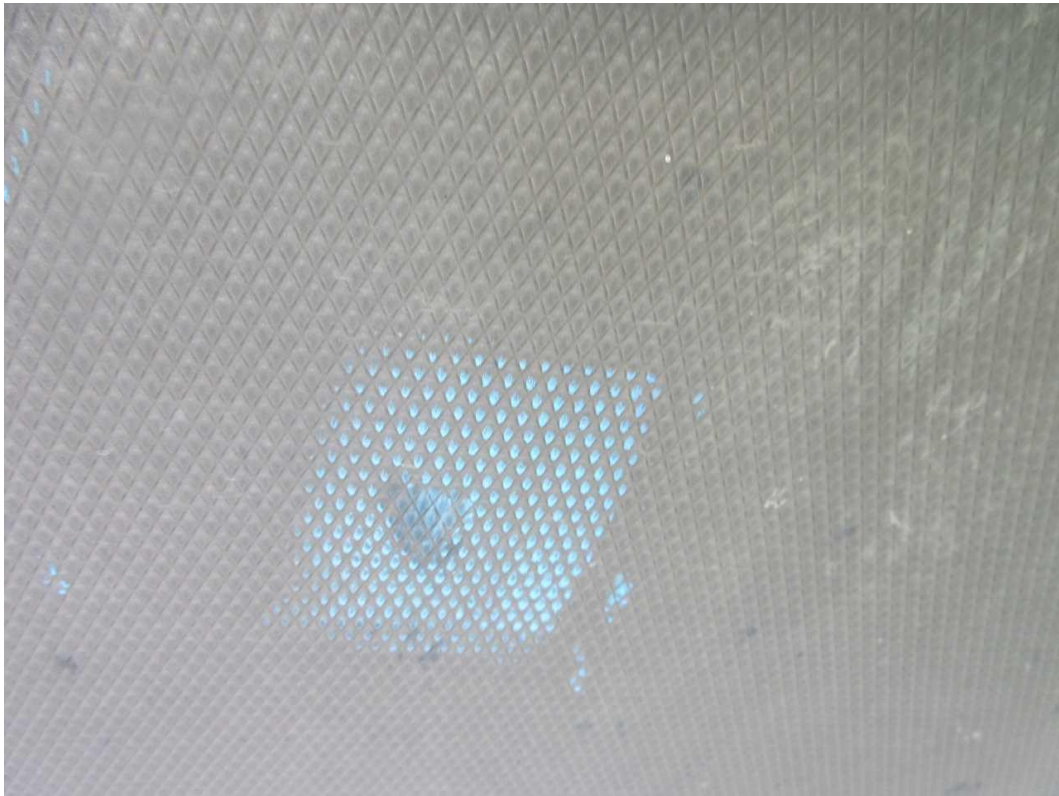
**37-W Rear Elevation**  
Date Taken: 6/27/2025  
Taken By: Michael Wallen  
Hail damage to storm door.

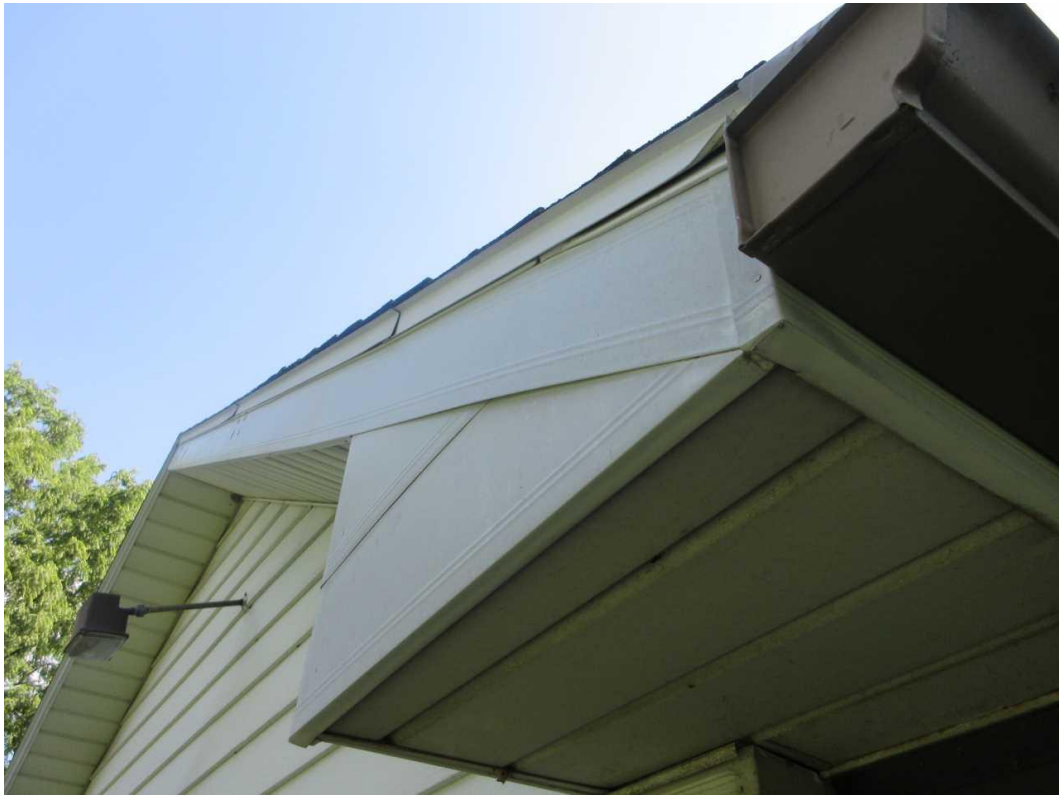
**38-W Rear Elevation**  
Date Taken: 6/27/2025  
Taken By: Michael Wallen  
Hail damage to fascia.

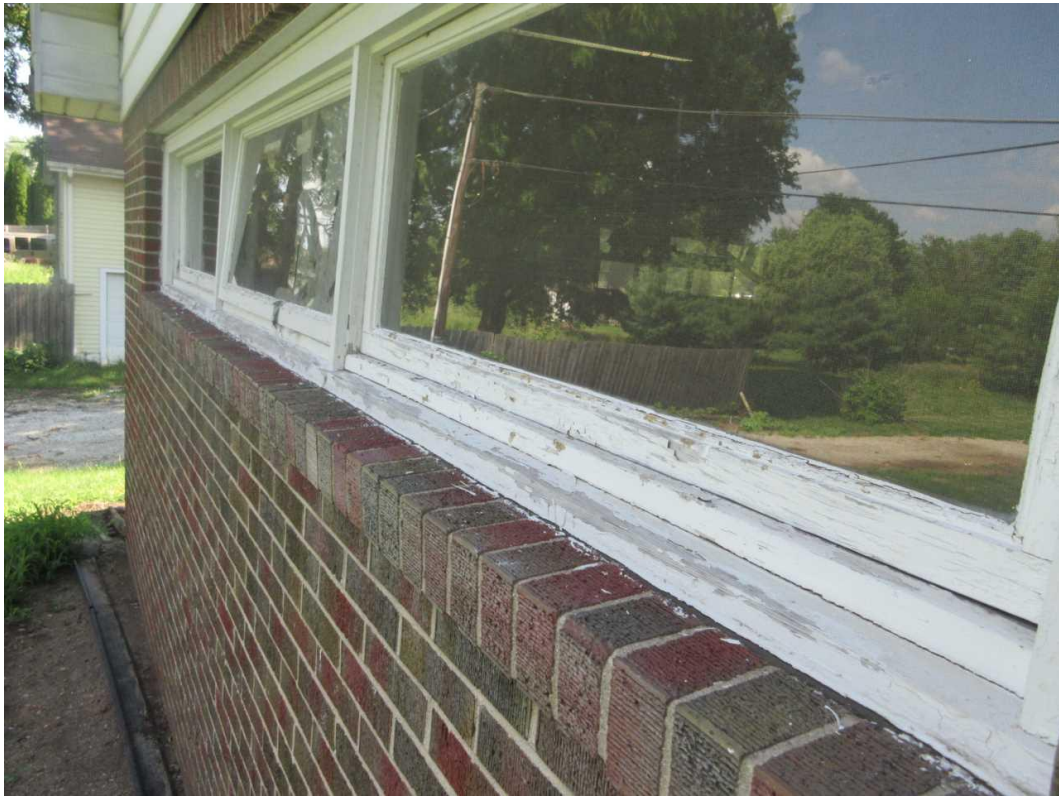
**41-W Rear Elevation**  
Date Taken: 6/27/2025  
Taken By: Michael Wallen  
Hail damage to paint on the wood windows.

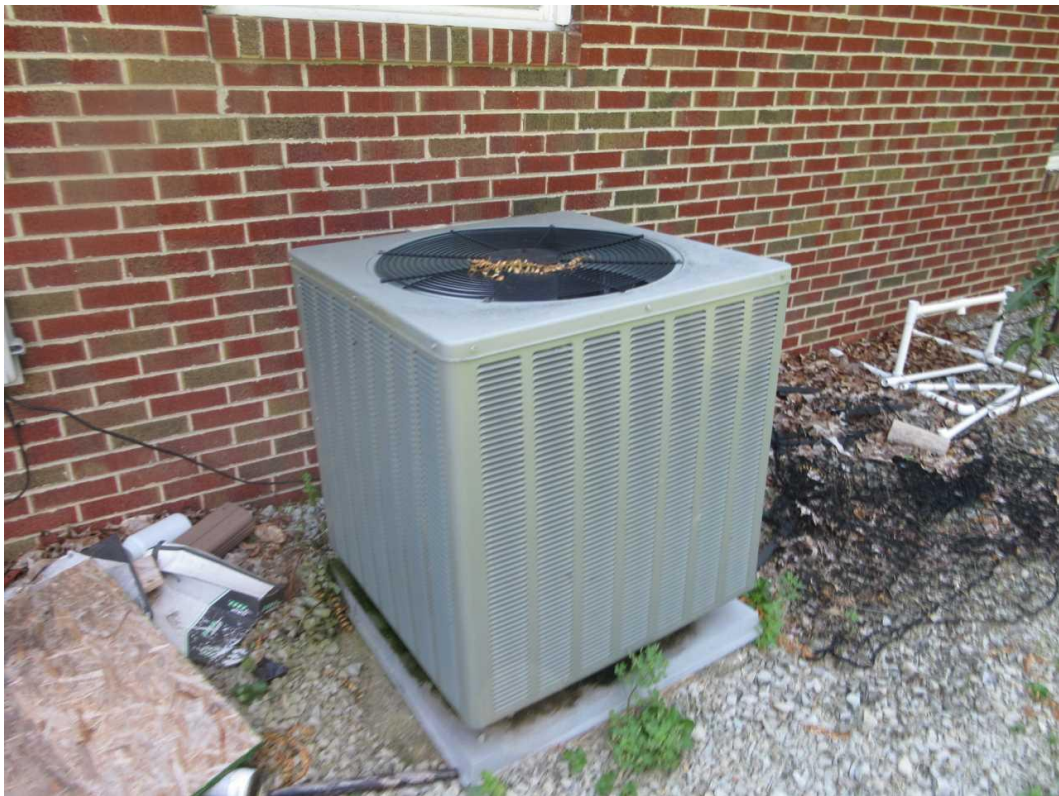
**42-W Rear Elevation**  
Date Taken: 6/27/2025  
Taken By: Michael Wallen  
No storm damage to A/C unit from the claimed date of loss.

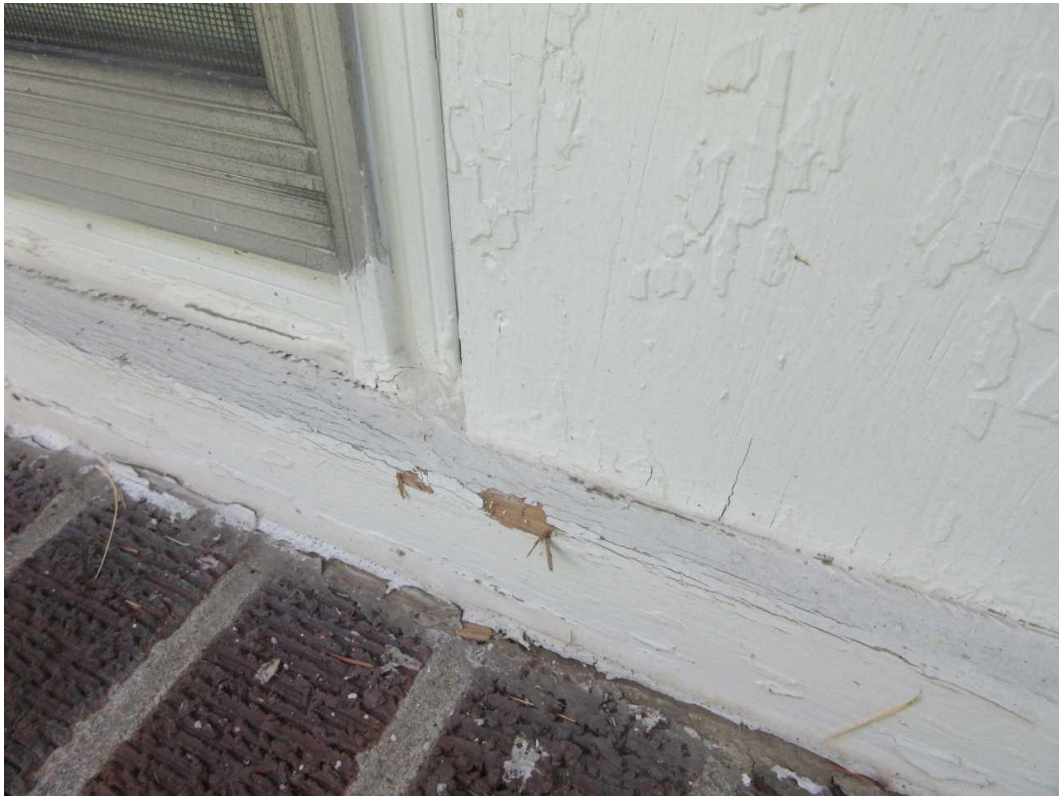
**45-W Rear Elevation**  
Date Taken: 6/27/2025  
Taken By: Michael Wallen  
Hail damage to paint on the wood windows.

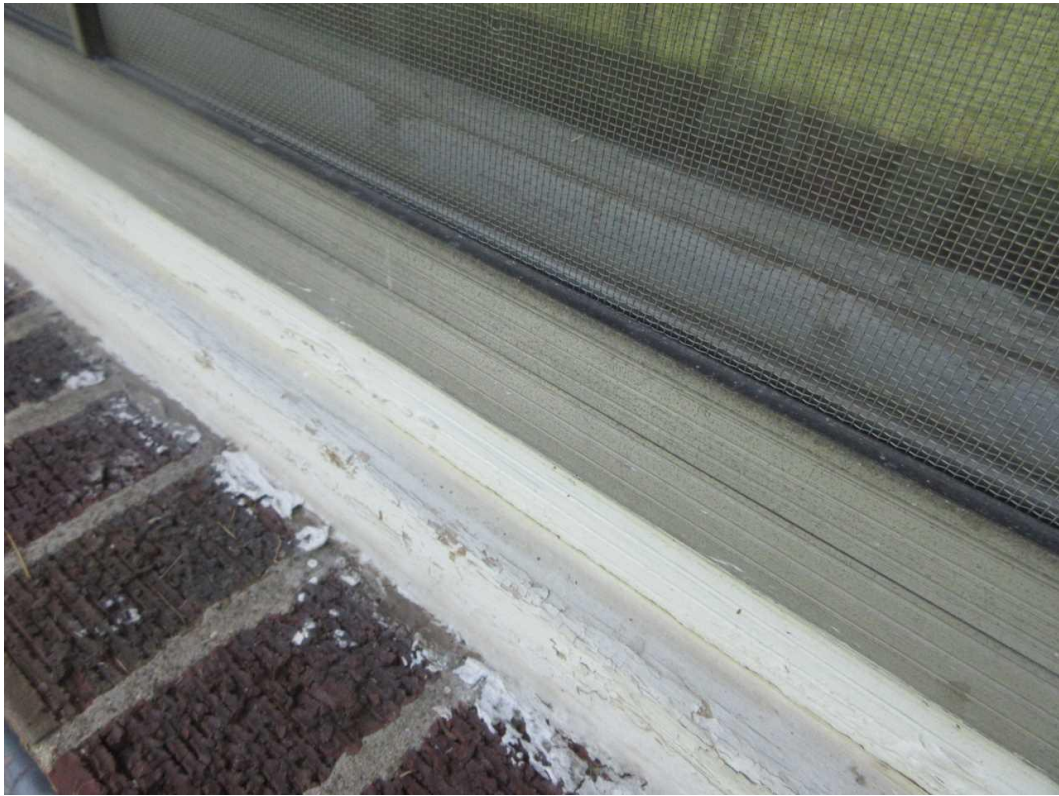
**46-W Rear Elevation**  
Date Taken: 6/27/2025  
Taken By: Michael Wallen  
Hail damage to paint on the wood windows.

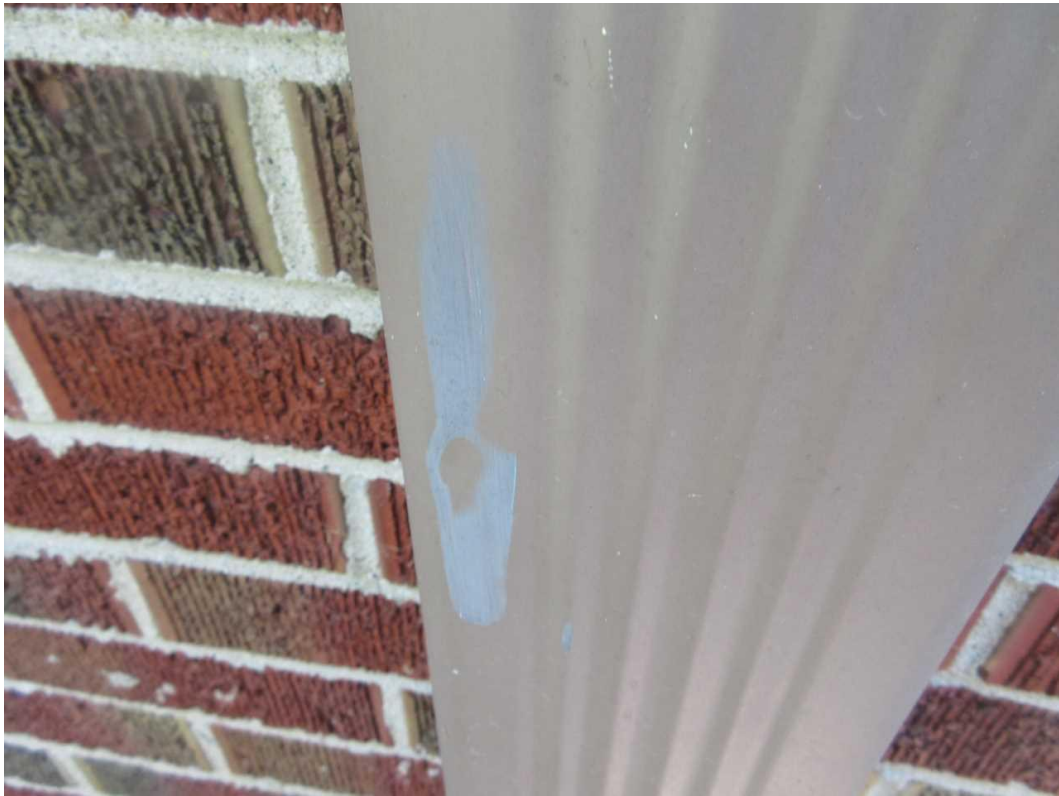
**47-W Rear Elevation**  
Date Taken: 6/27/2025  
Taken By: Michael Wallen  
Hail damage to downspout.

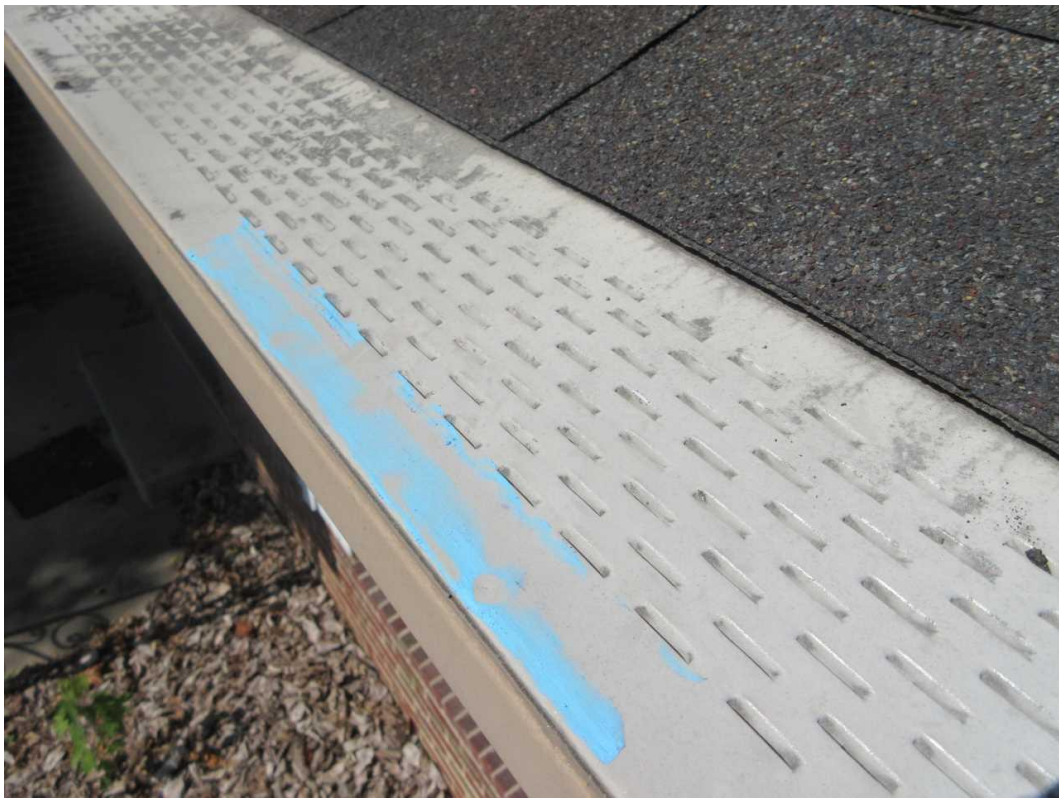
**61-Gutters**  
Date Taken: 6/27/2025  
Taken By: Michael Wallen  
Hail damage to gutter guard.

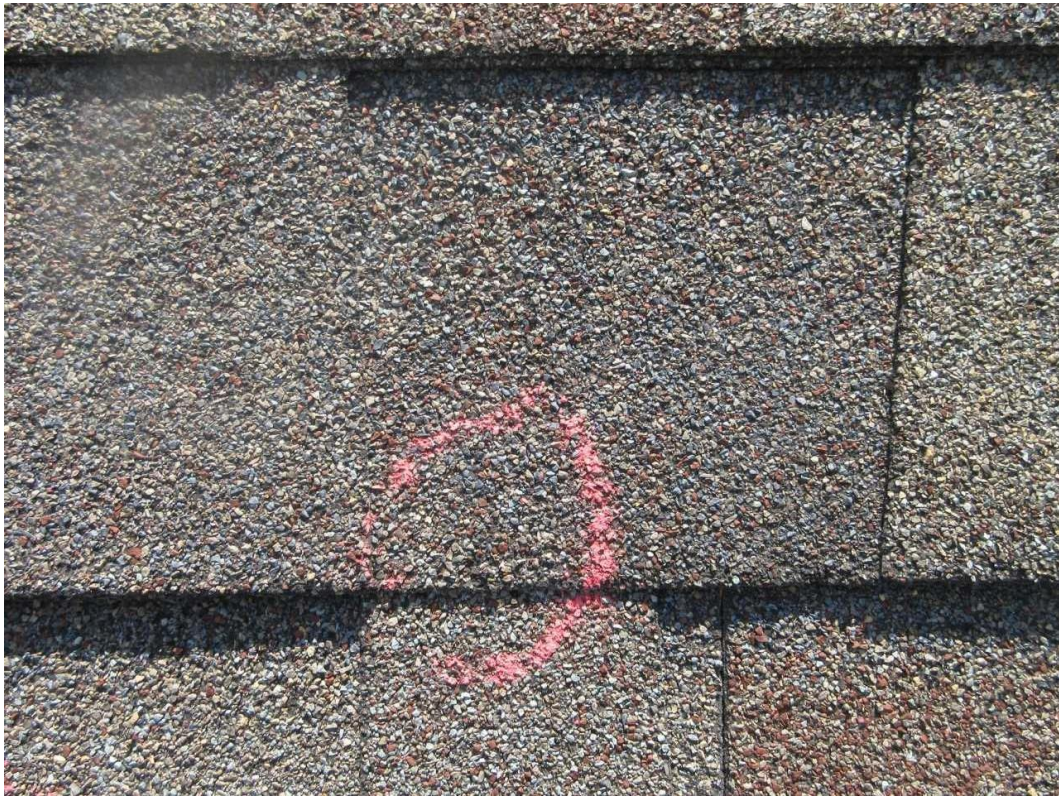
**71-W Back Slope**  
Date Taken: 6/27/2025  
Taken By: Michael Wallen  
Close up of hail damage inside the test square.

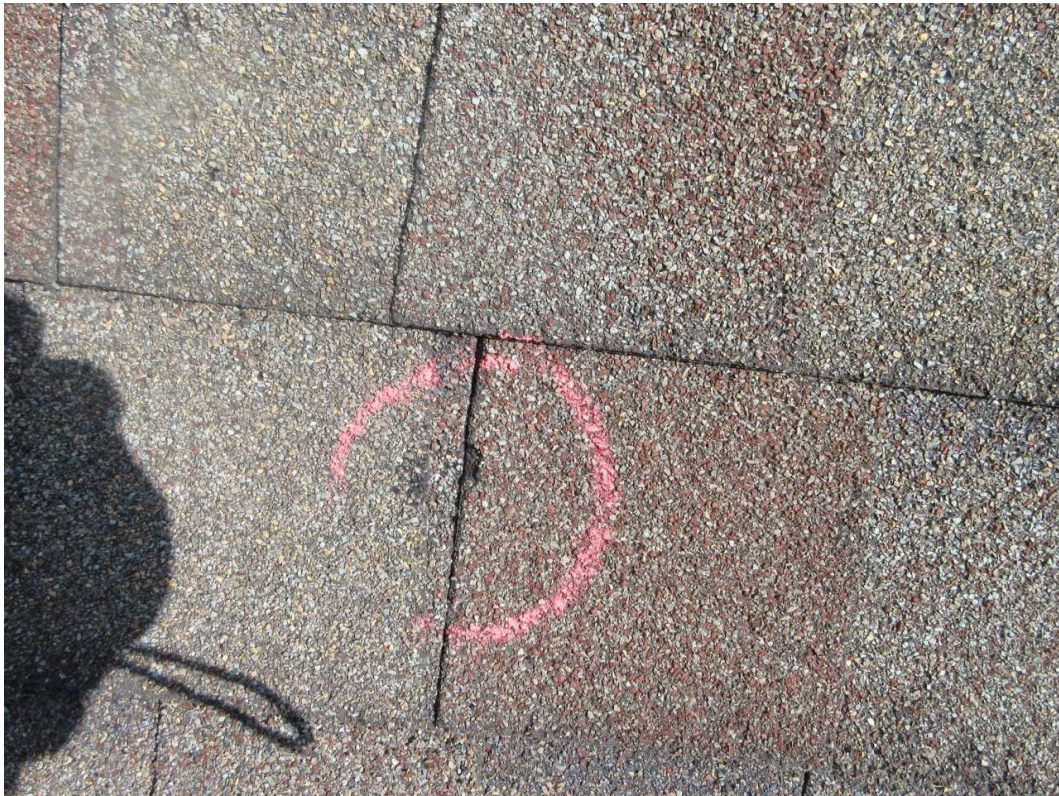
**77-S Left Slope**  
Date Taken: 6/27/2025  
Taken By: Michael Wallen  
Close up of hail damage inside the test square.

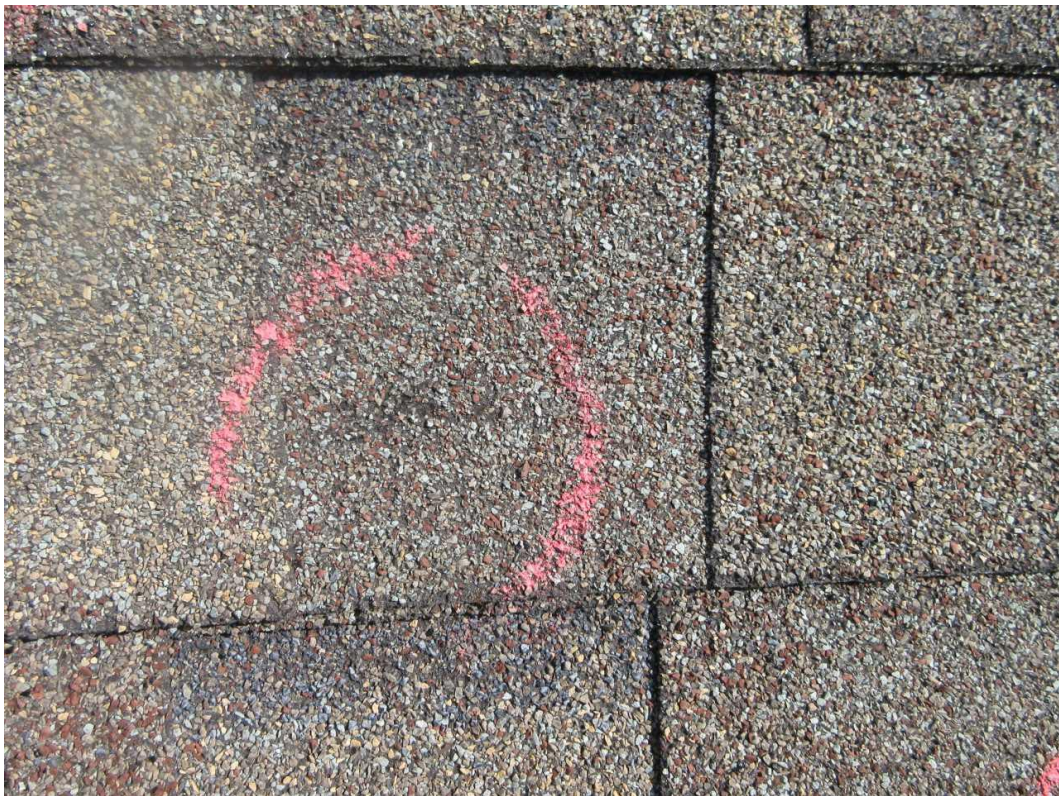
**78-S Left Slope**  
Date Taken: 6/27/2025  
Taken By: Michael Wallen  
Close up of hail damage inside the test square.

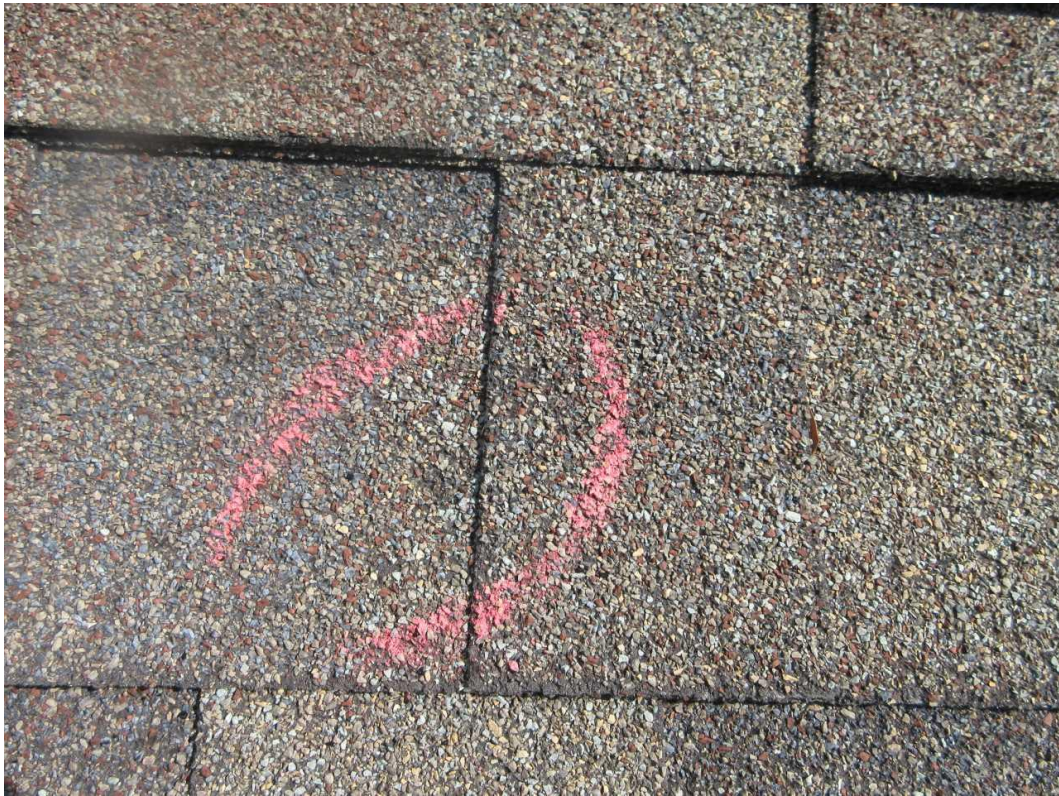
**79-S Left Slope**  
Date Taken: 6/27/2025  
Taken By: Michael Wallen  
Close up of hail damage inside the test square.

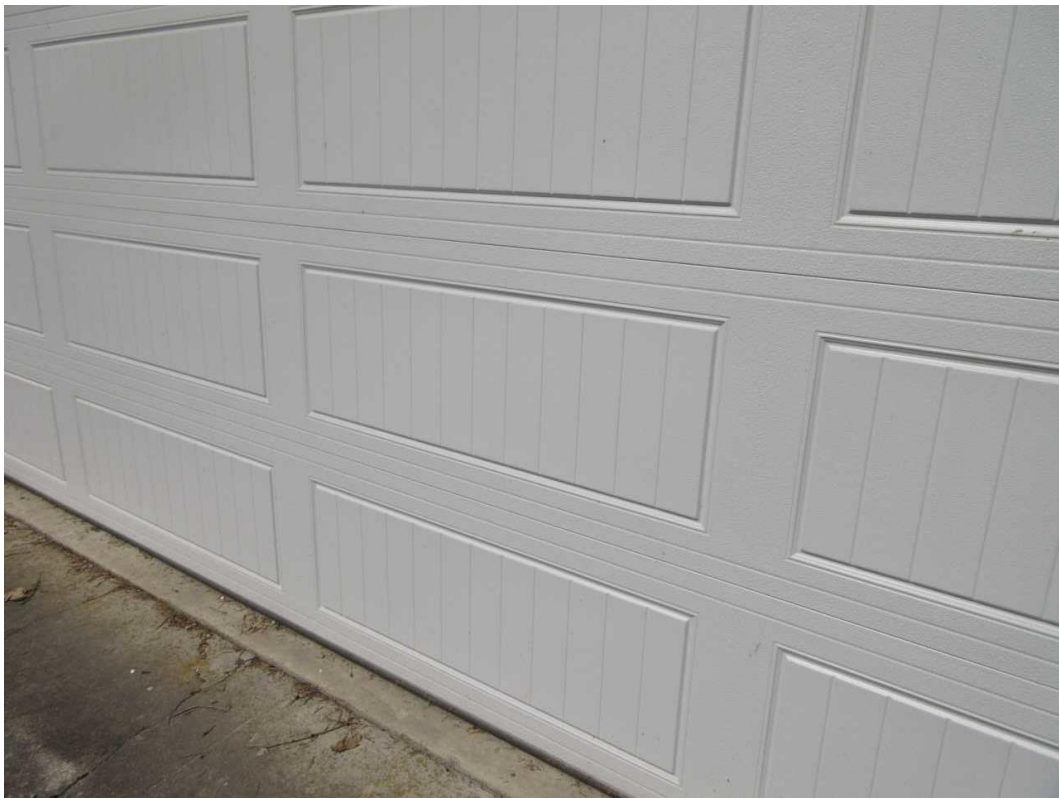
**81-E Front Elevation**  
Date Taken: 6/27/2025  
Taken By: Michael Wallen  
No storm damage to overhead door from the claimed date of loss.

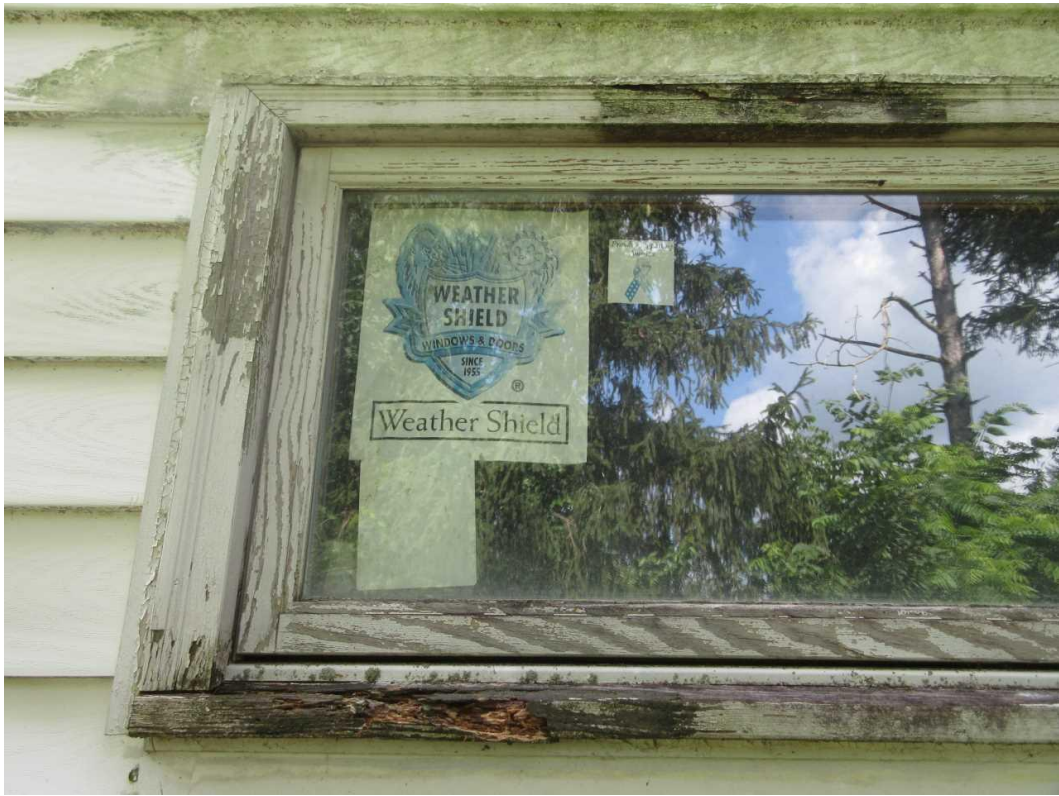
**84-W Rear Elevation**  
Date Taken: 6/27/2025  
Taken By: Michael Wallen  
Pre-existing condition of window, not storm related.

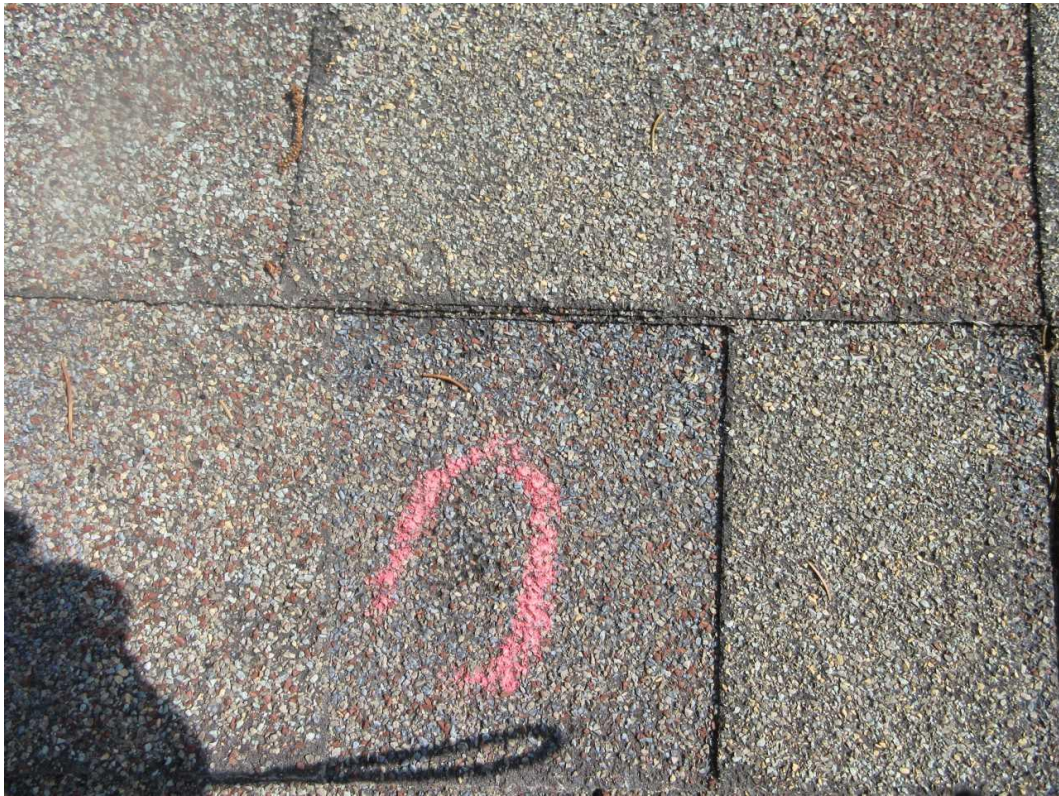
**95-S Left Slope**  
Date Taken: 6/27/2025  
Taken By: Michael Wallen  
Close up of hail damage inside the test square.

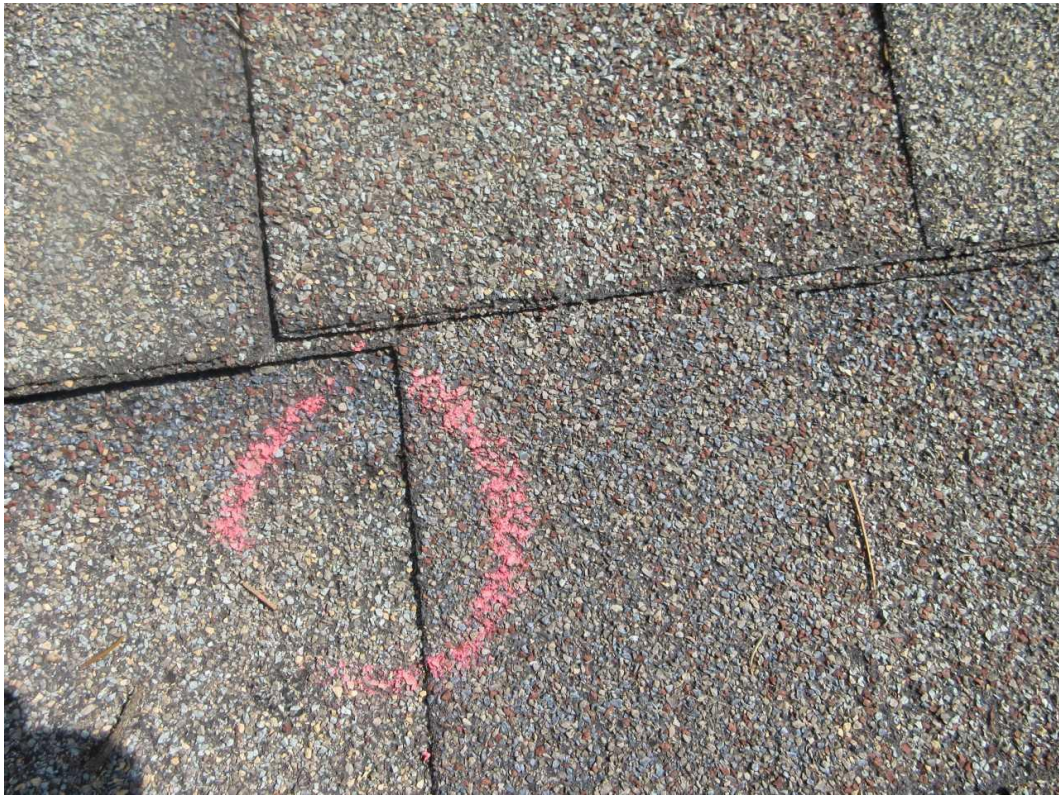
**96-S Left Slope**  
Date Taken: 6/27/2025  
Taken By: Michael Wallen  
Close up of hail damage inside the test square.

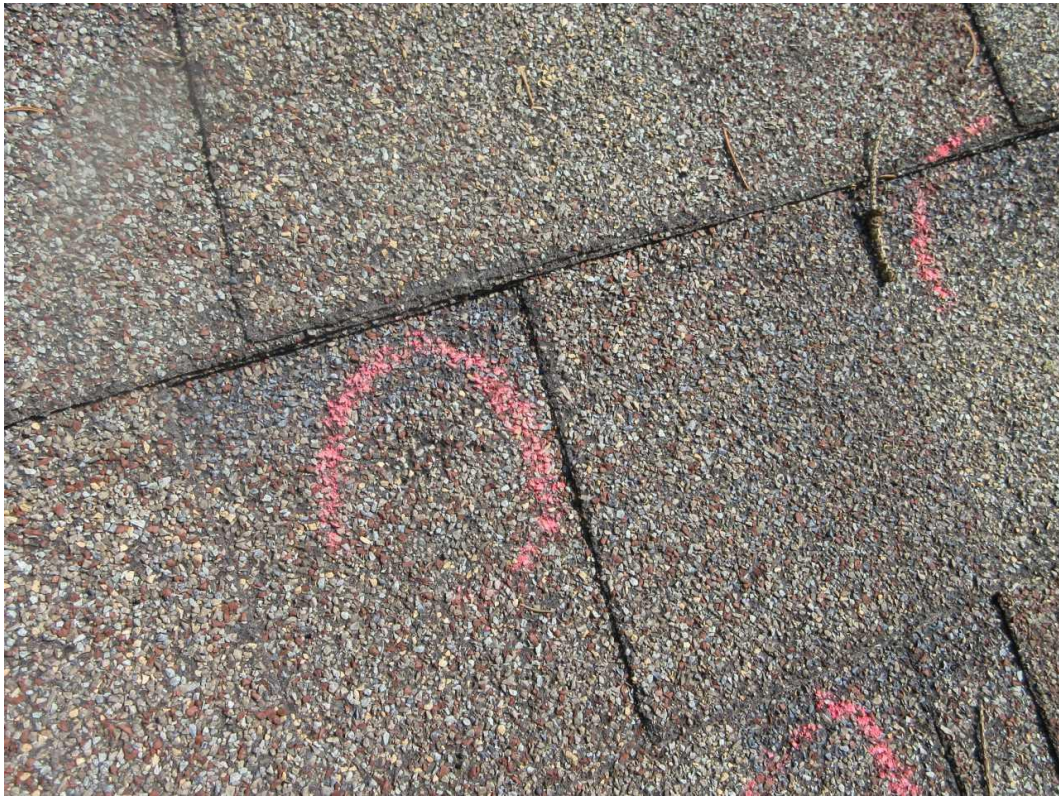
**97-S Left Slope**  
Date Taken: 6/27/2025  
Taken By: Michael Wallen  
Close up of hail damage inside the test square.
