File # R192712  
 Claim # 300- [REDACTED]-2025  
 Insured [REDACTED] Automotive Services

## LOSS REPORT

Cause of Loss: Hail

Damaged items include: Location 1 Building 1 Roof/Elevations, Location 3 Building 1 Roof/Elevations, Location 3 Building 2 Roof, Location 5 Building 1 Roof/Elevations, Location 6 Building 1 Roof/Elevations, Location 6 Building 2 Roof/Elevations

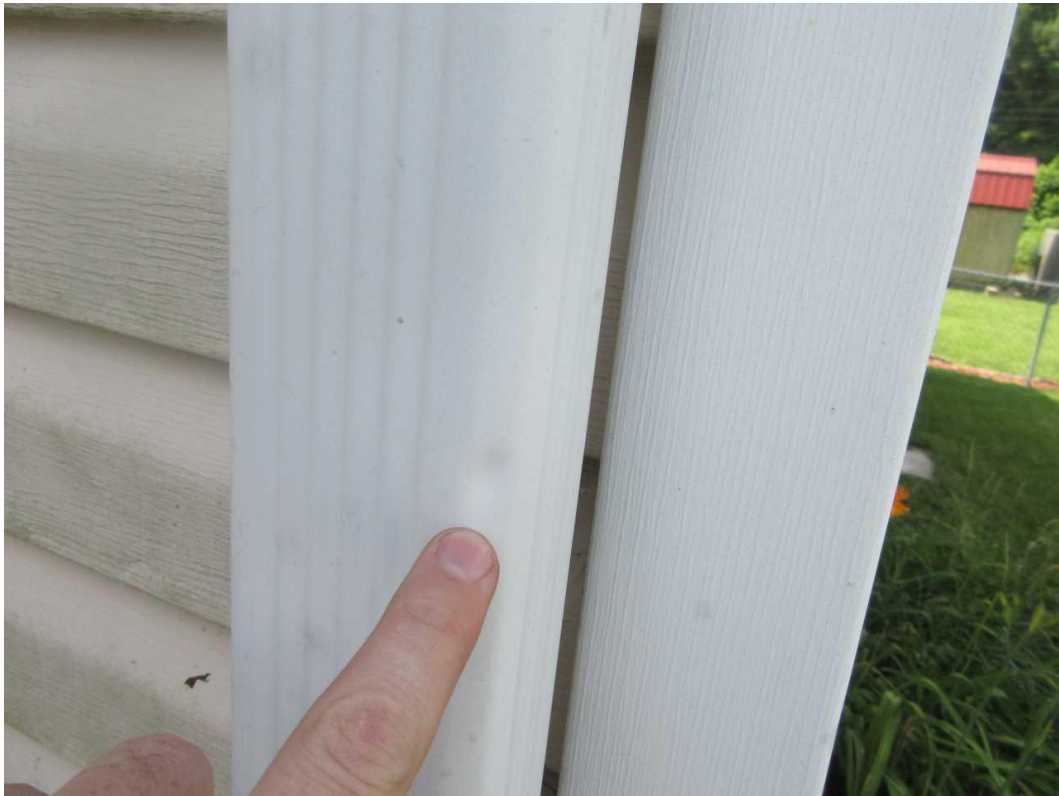
**101-N Front Elevation**  
Date Taken: 6/27/2025  
Taken By: Michael Wallen  
Hail damage to downspout.

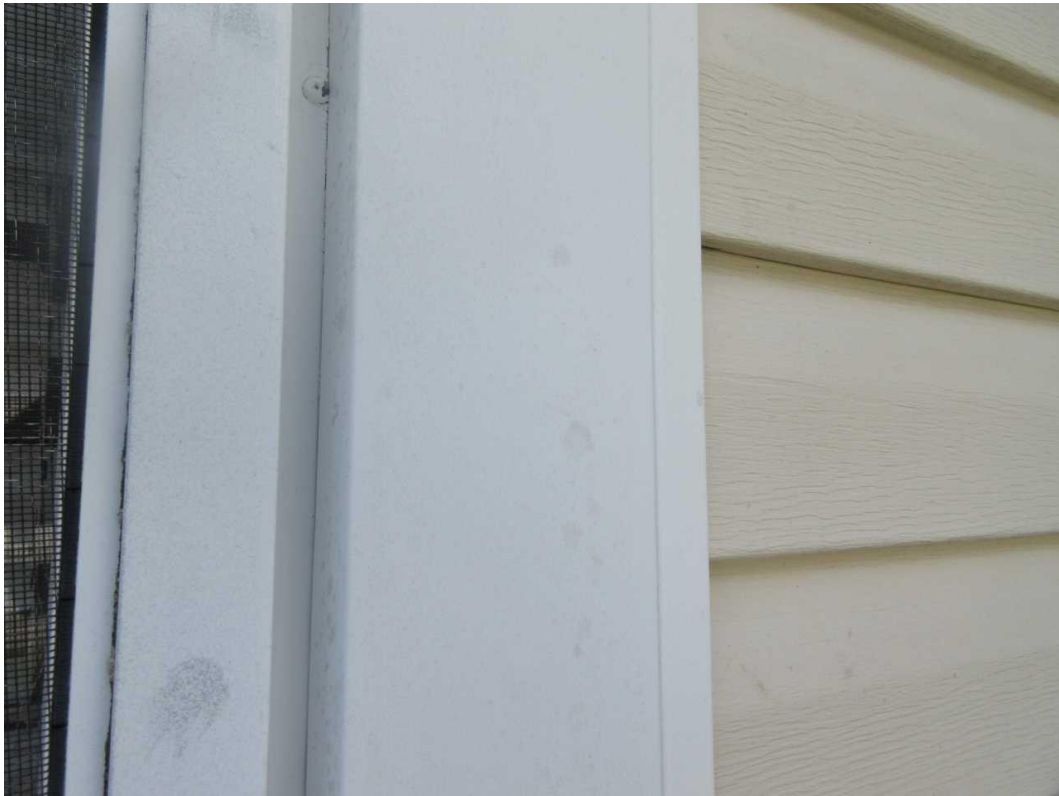
**103-W Right Elevation**  
Date Taken: 6/27/2025  
Taken By: Michael Wallen  
Hail damage to window wrap.

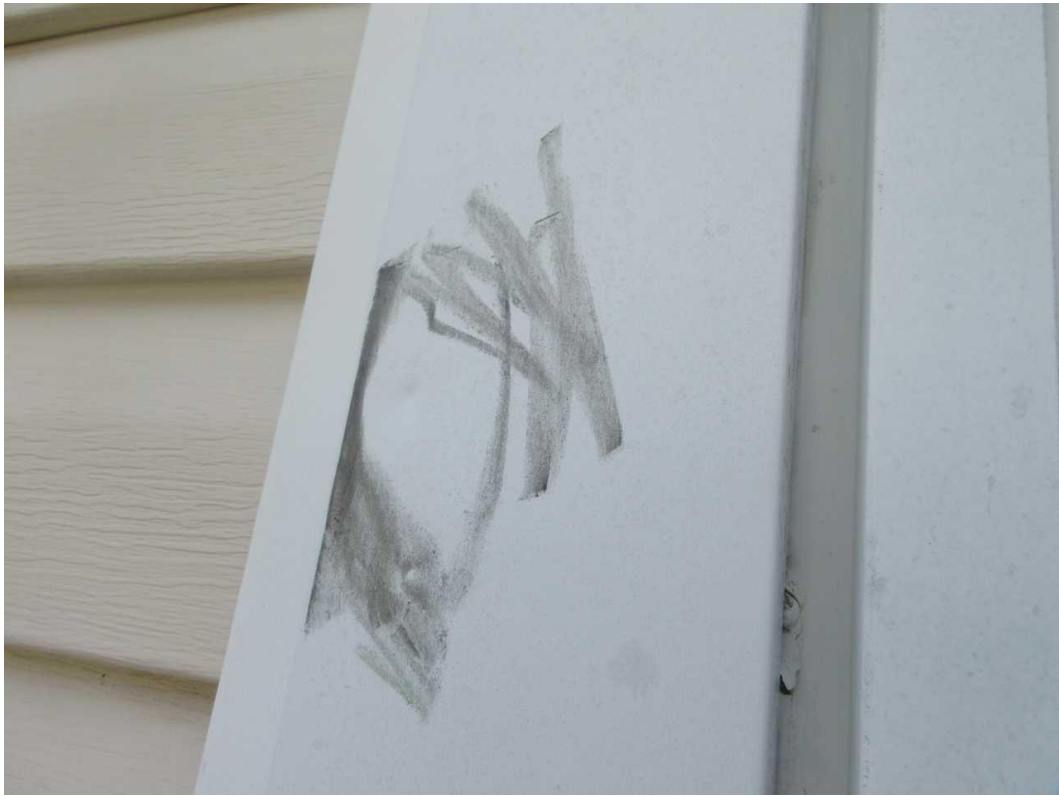
**104-W Right Elevation**  
Date Taken: 6/27/2025  
Taken By: Michael Wallen  
Hail damage to window wrap.

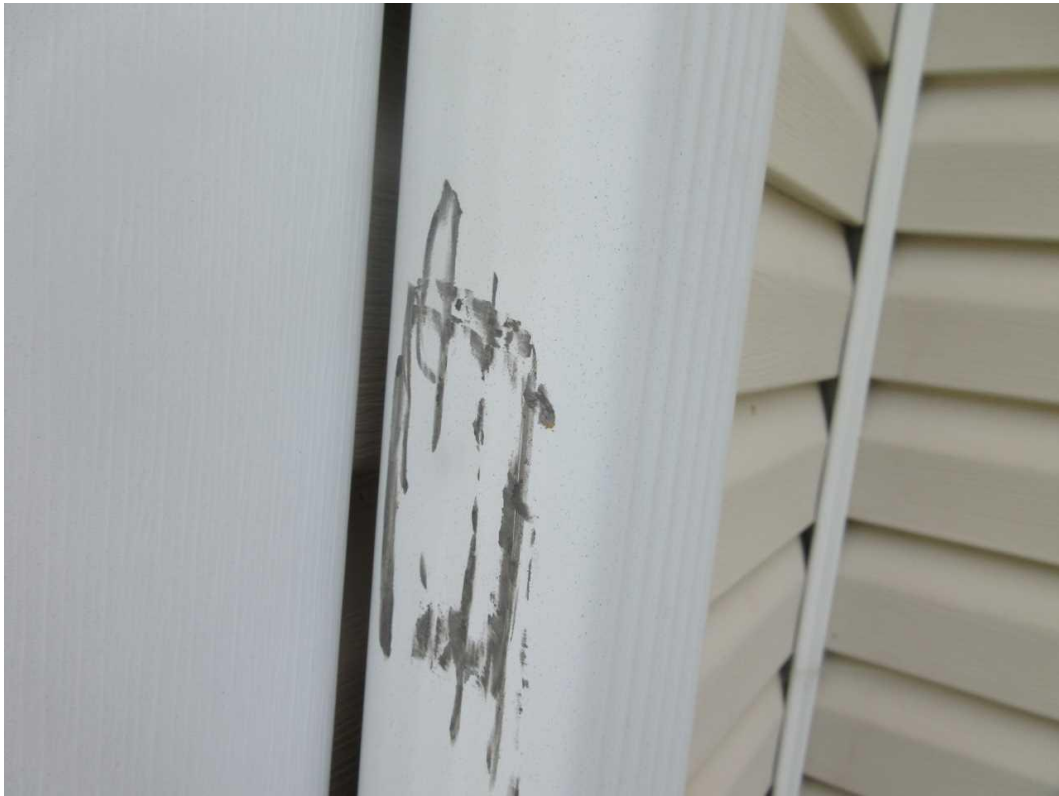
**107-W Right Elevation**  
Date Taken: 6/27/2025  
Taken By: Michael Wallen  
Hail damage to downspout.

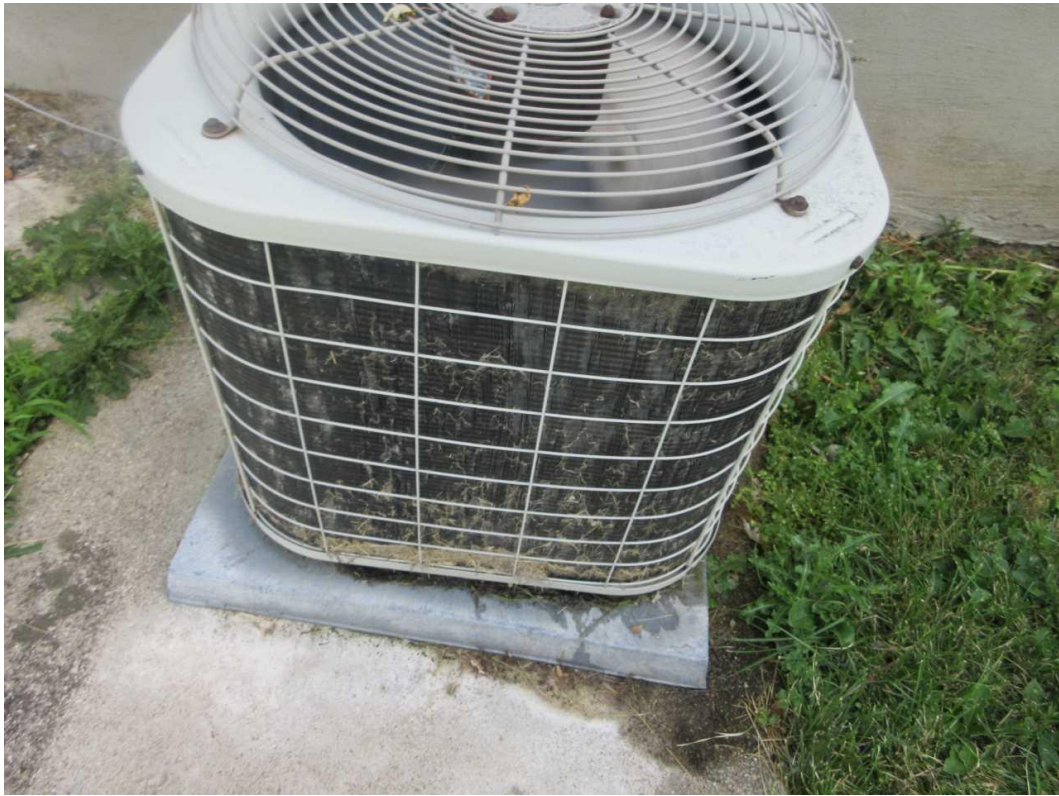
**108-W Right Elevation**  
Date Taken: 6/27/2025  
Taken By: Michael Wallen  
Hail damage to A/C fins.

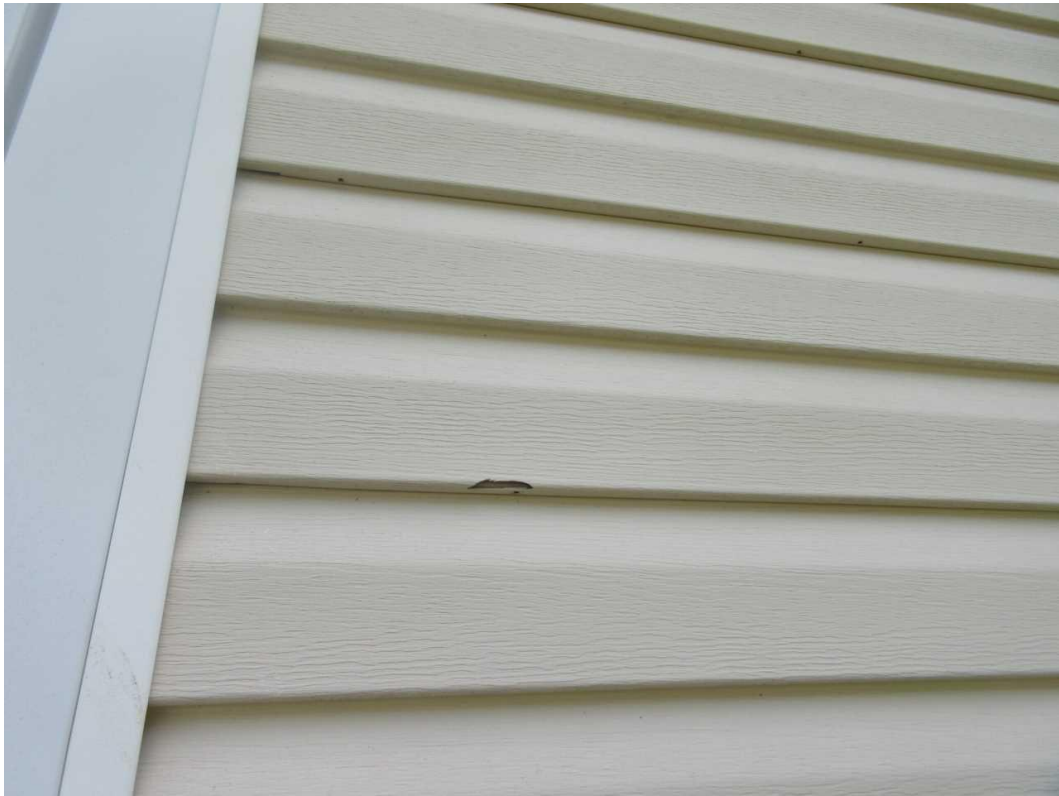
**109-W Right Elevation**  
Date Taken: 6/27/2025  
Taken By: Michael Wallen  
Hail damage to vinyl siding.

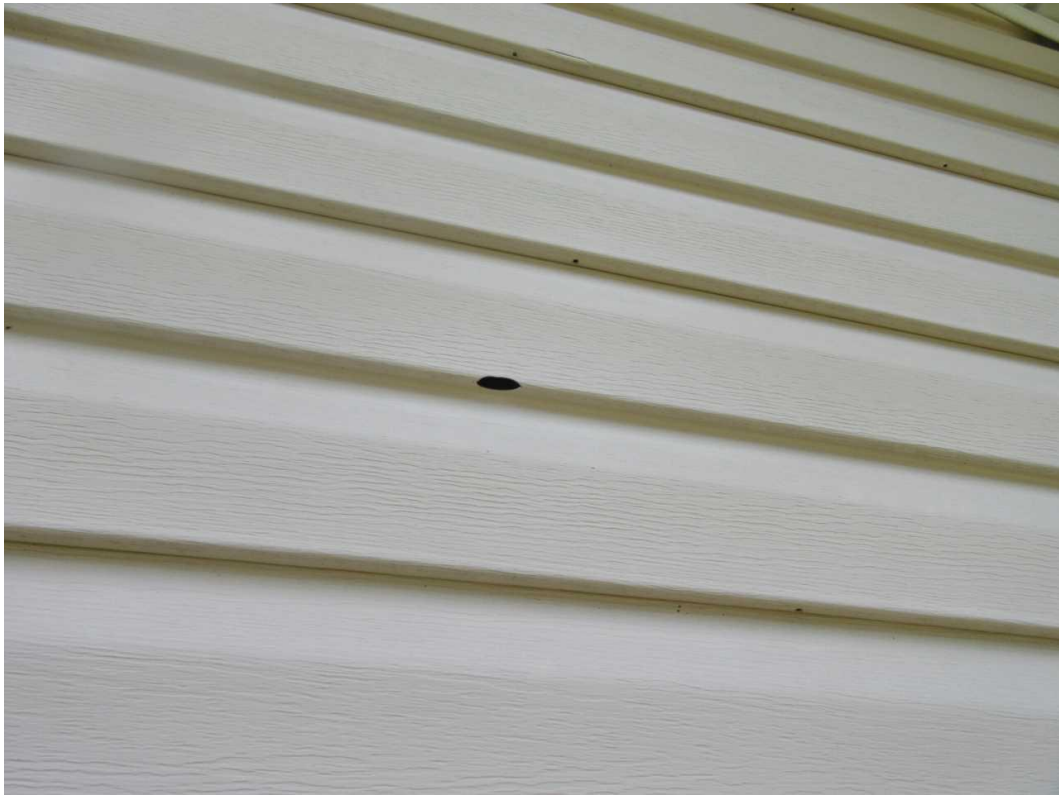
**110-W Right Elevation**  
Date Taken: 6/27/2025  
Taken By: Michael Wallen  
Hail damage to vinyl siding.

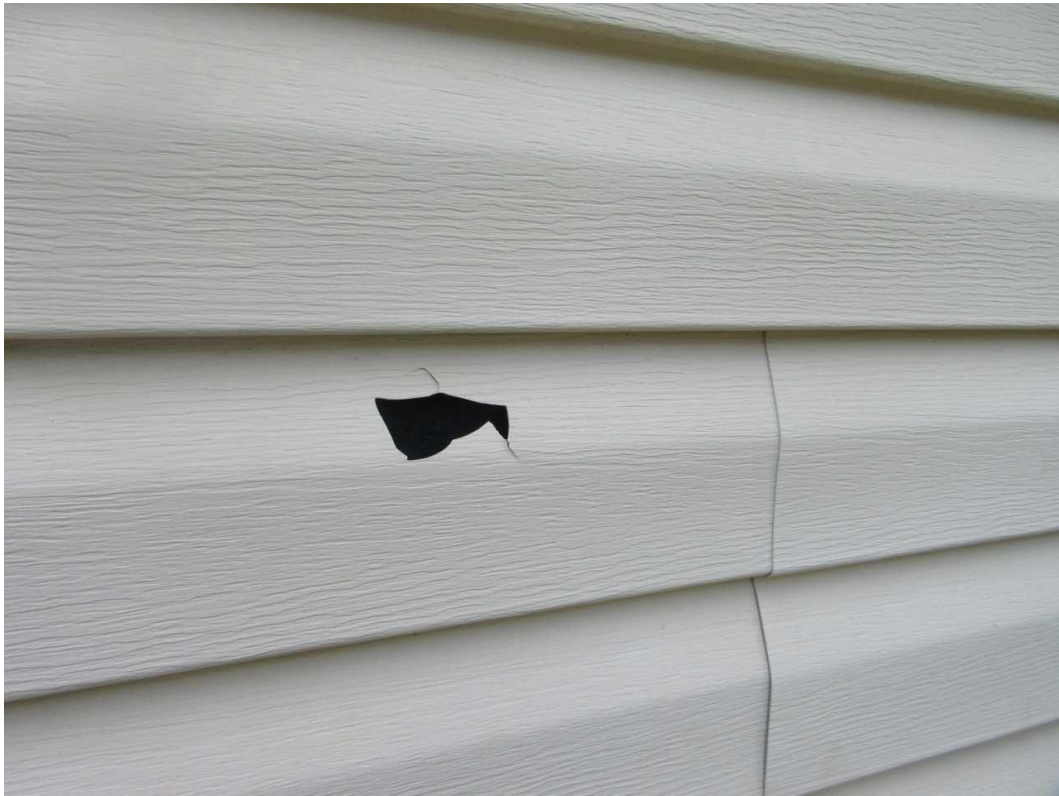
**111-W Right Elevation**  
Date Taken: 6/27/2025  
Taken By: Michael Wallen  
Hail damage to vinyl siding.

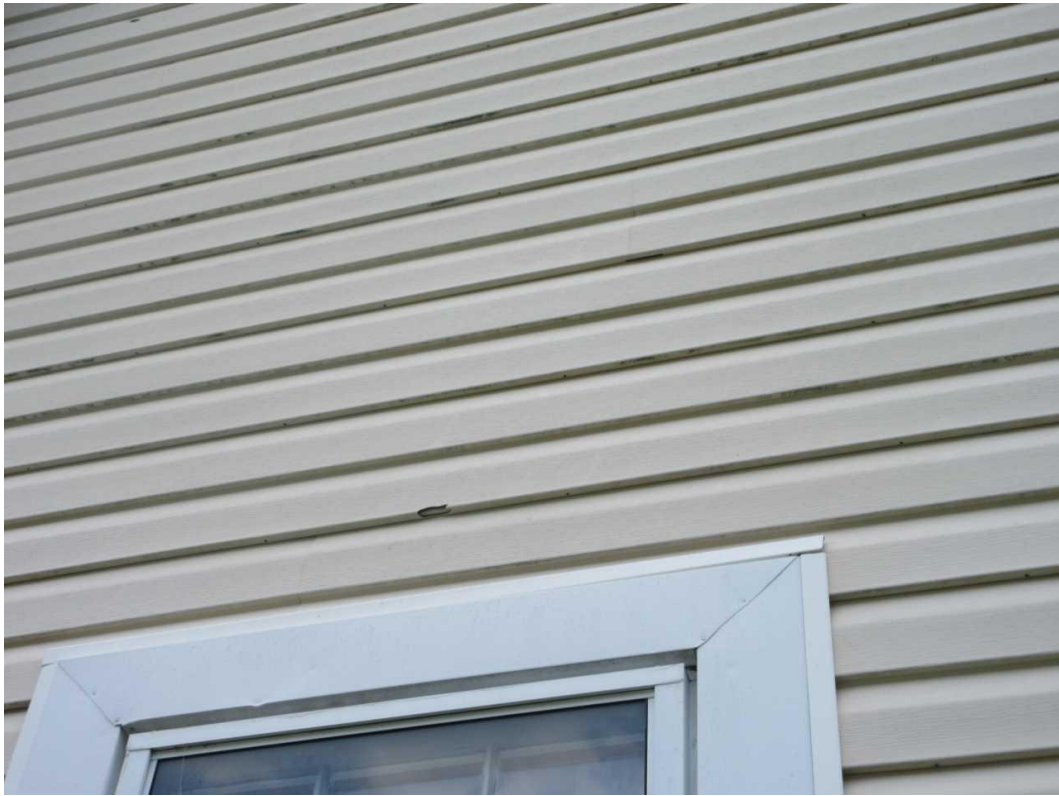
**112-W Right Elevation**  
Date Taken: 6/27/2025  
Taken By: Michael Wallen  
Hail damage to vinyl siding.

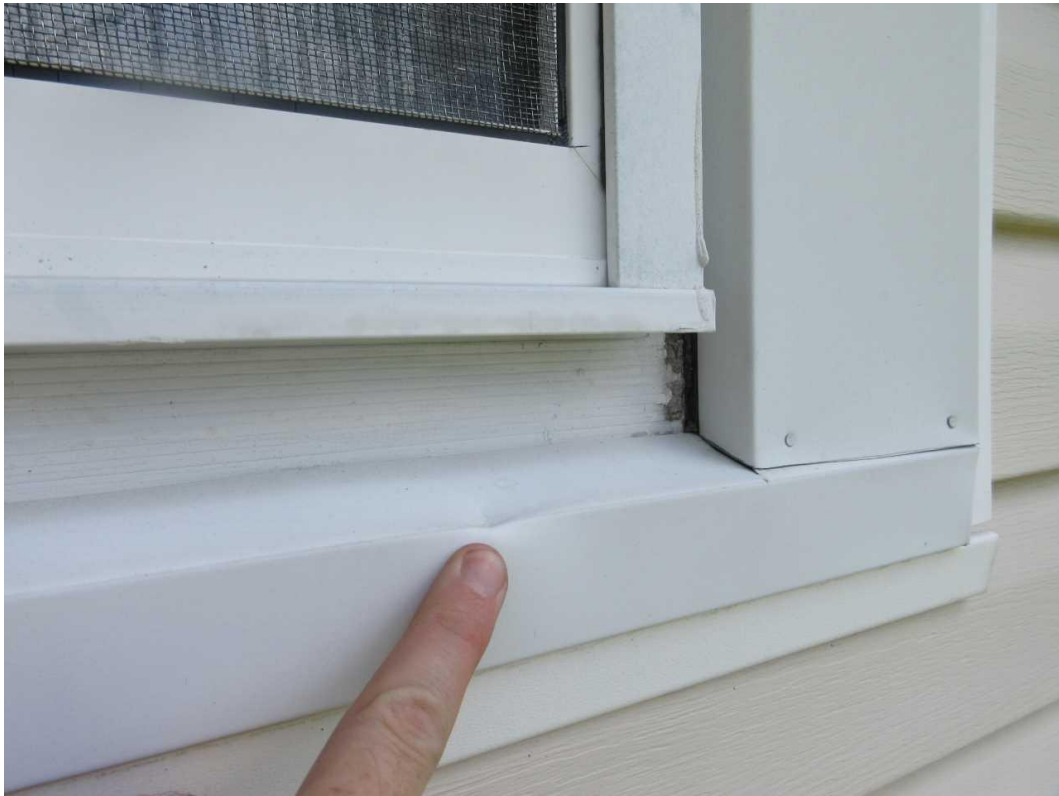
**119-S Rear Elevation**  
Date Taken: 6/27/2025  
Taken By: Michael Wallen  
Hail damage to window wrap.

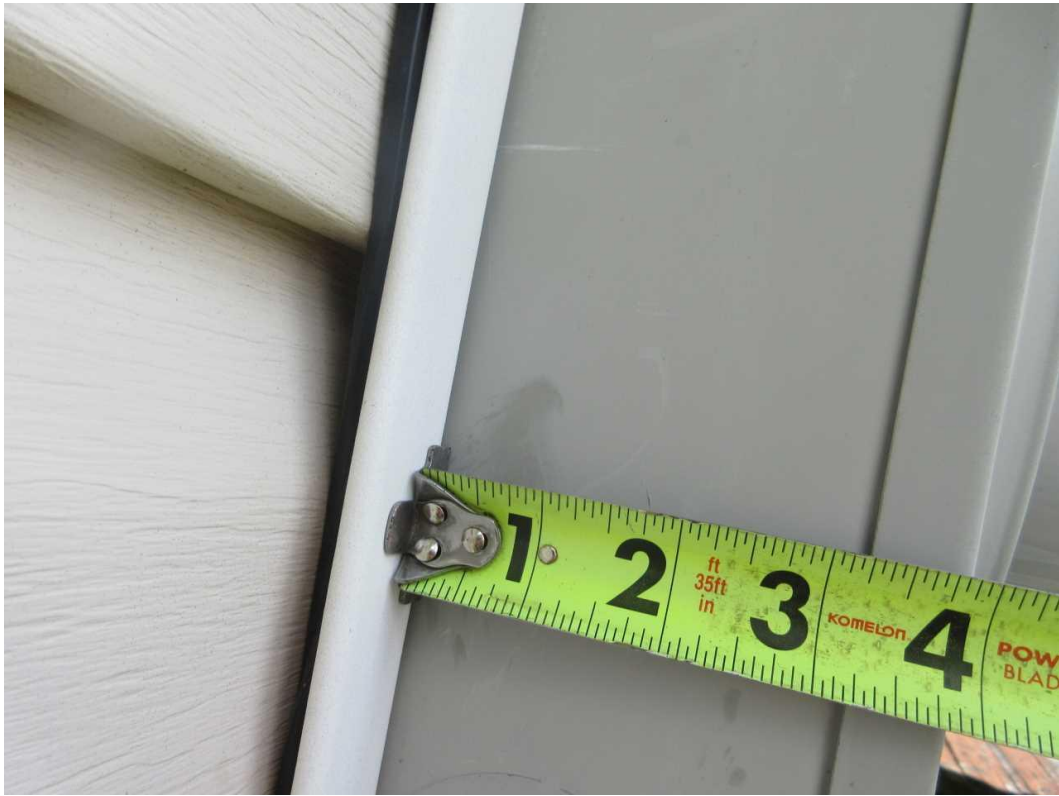
**120-S Rear Elevation**  
Date Taken: 6/27/2025  
Taken By: Michael Wallen  
Hail spatter.

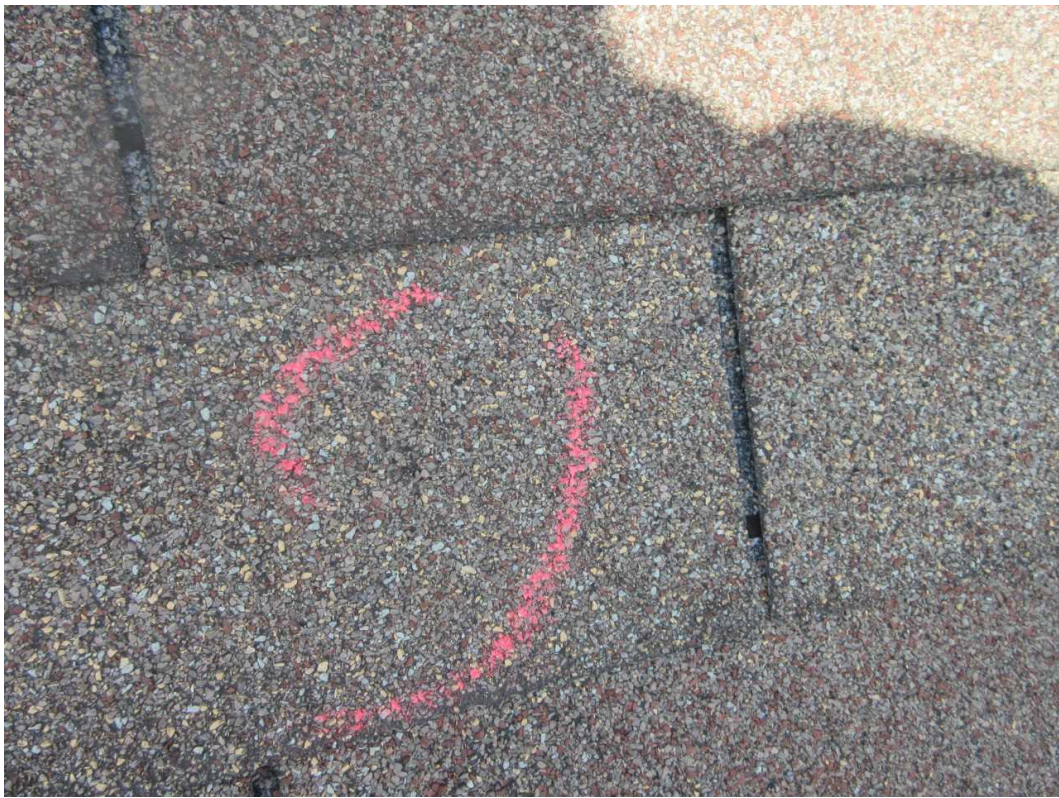
**146-E Left Slope**  
Date Taken: 6/27/2025  
Taken By: Michael Wallen  
Close up of hail damage inside the test square.

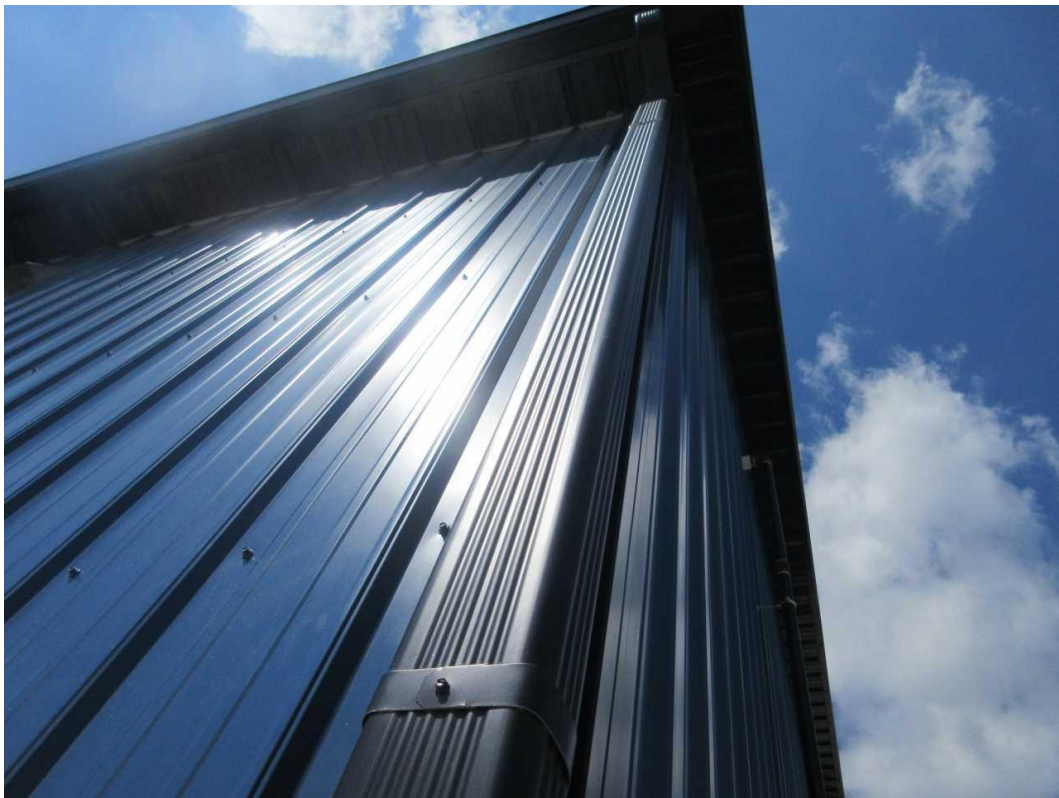
**171-E Rear Elevation**  
Date Taken: 6/27/2025  
Taken By: Michael Wallen  
No storm damage to downspout from the  
claimed date of loss.

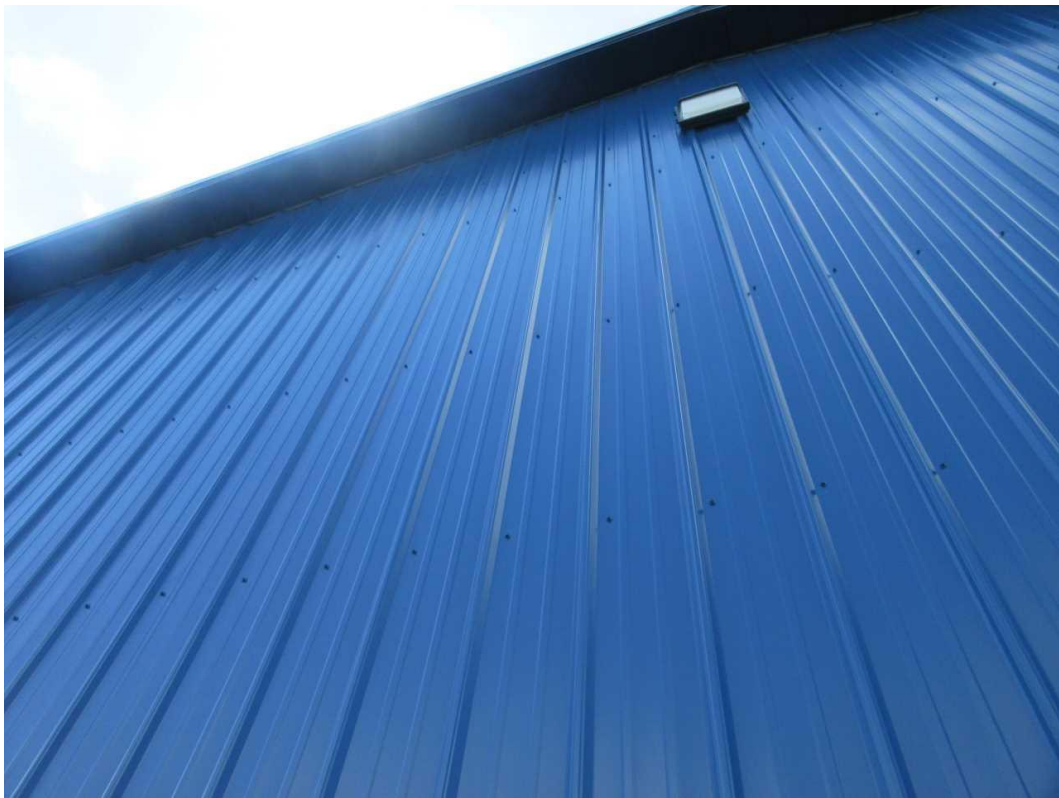
**173-N Left Elevation**  
Date Taken: 6/27/2025  
Taken By: Michael Wallen  
No storm damage to siding from the  
claimed date of loss.

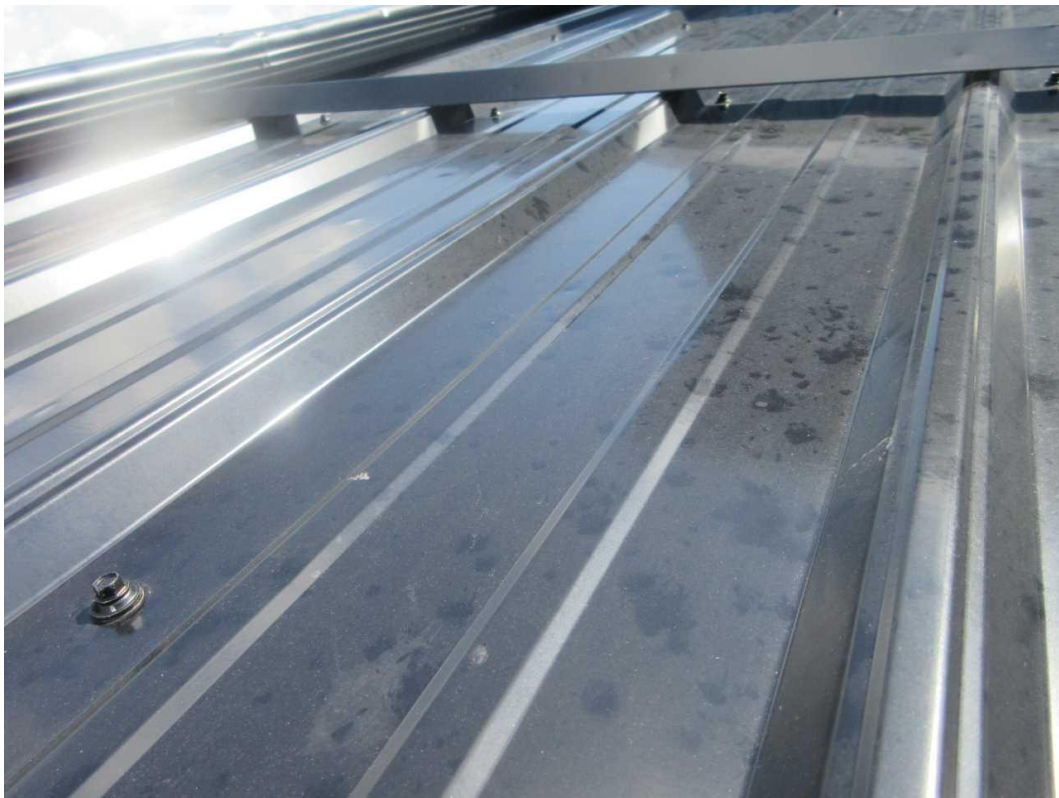
**185-Roof**  
Date Taken: 6/27/2025  
Taken By: Michael Wallen  
Hail damage to ribbed metal roofing.

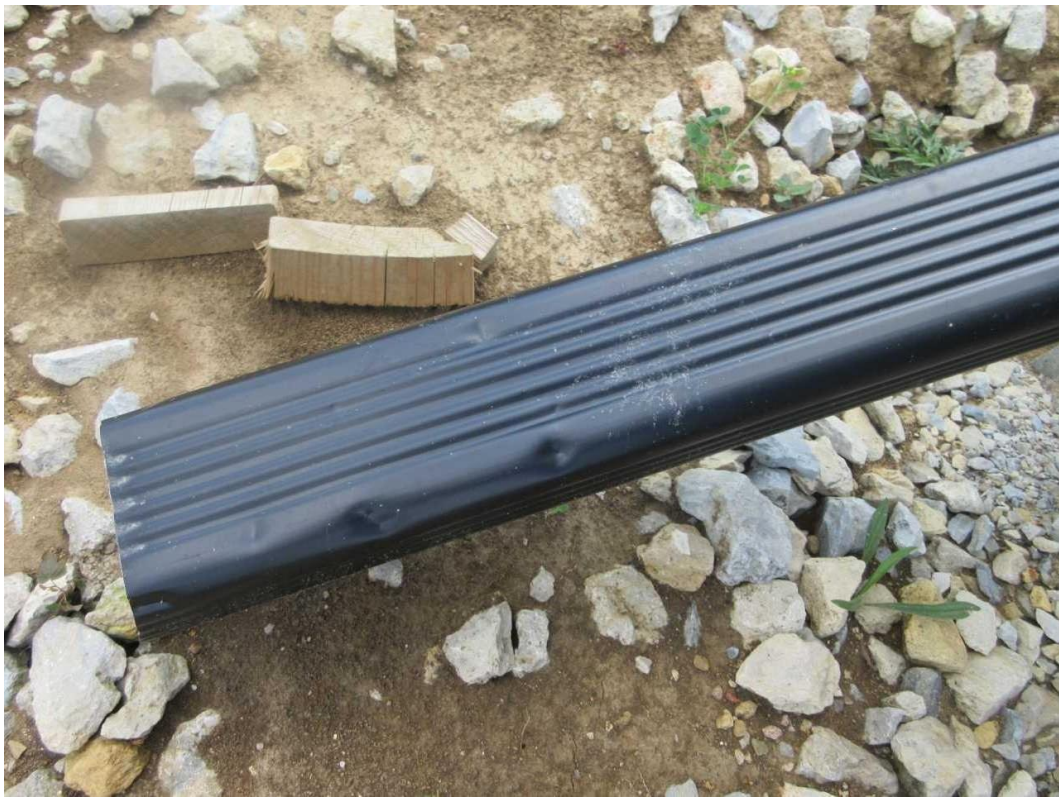
**200-N Left Elevation**  
Date Taken: 6/27/2025  
Taken By: Michael Wallen  
Mechanical damage to downspout on the  
NE corner.
