File # R191337
Claim # 300- -2025
Insured , Crystal

LOSS REPORT

Type of Loss: WATER

Water Backup of
Sewers or Drains

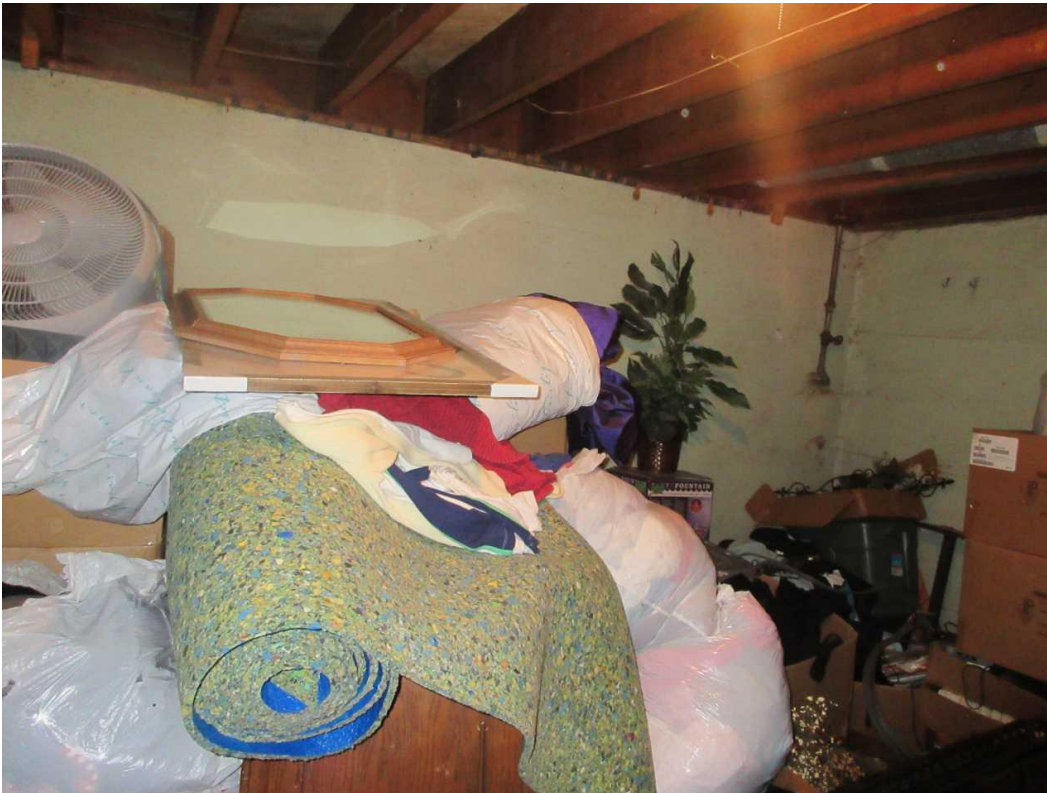
3-Storage

Room overview, large number of contents stored here.

STORAGE: water extraction from the concrete floor, floor cleaning, and replacement of 1 interior door unit.

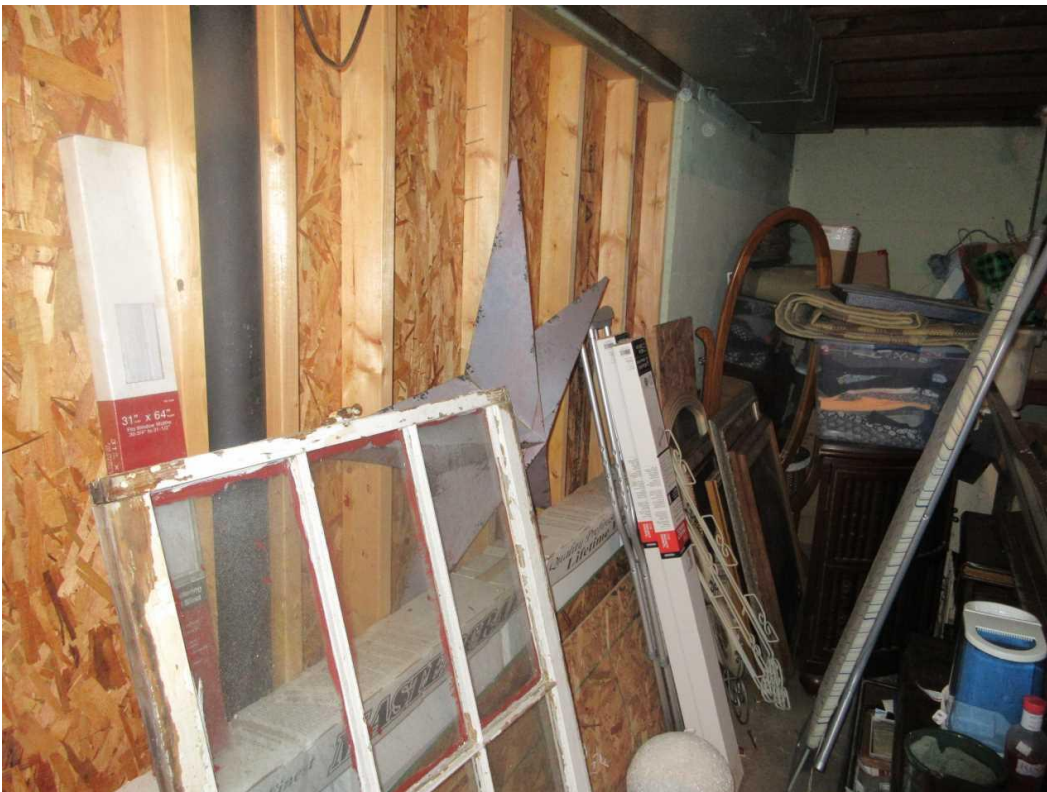
4-Storage

Water damage to interior door unit.

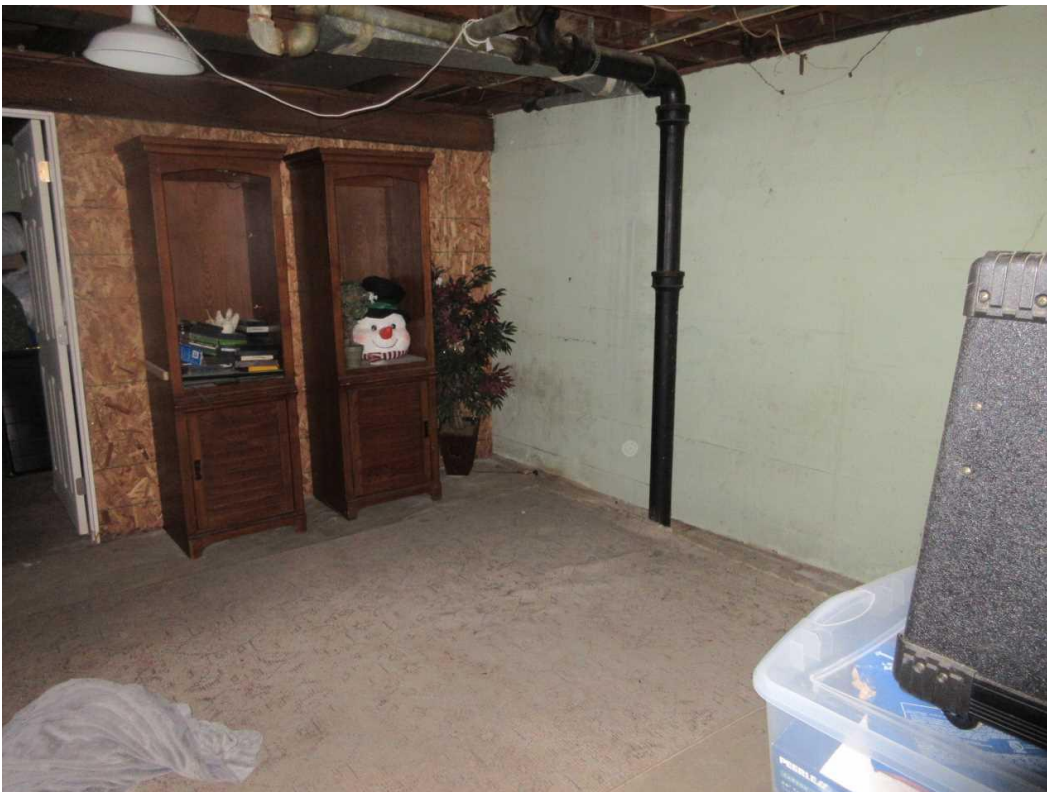
6-Main Room

There is a floor drain in the middle of the Basement level Main Room. It is likely that water backed up through this floor drain in addition to what appears to be ground water entering below the sliding door. Because I am not able to determine the significance to which ground water may or may not have been a factor in this loss, I have completed an estimate for the following repairs, pending a review of coverage and a payment decision by Auto-Owners Insurance:

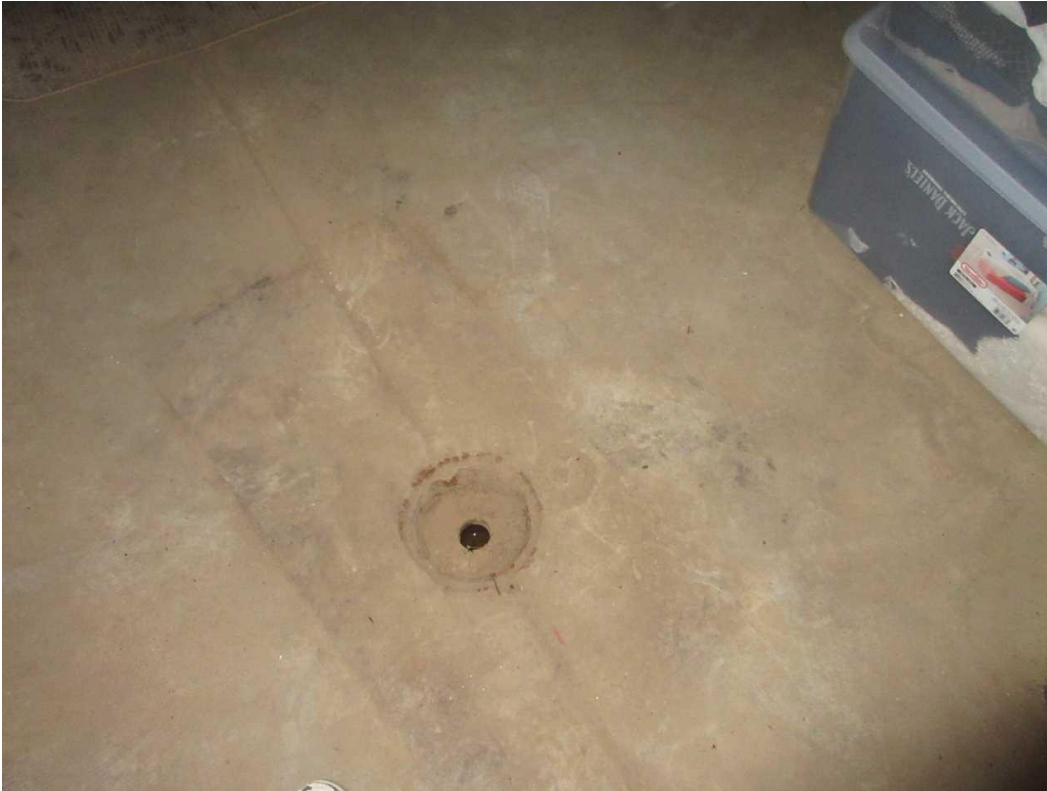
7-Main Room

Possible water backup through floor drain

MAIN ROOM: water extraction from the concrete floor and floor cleaning.

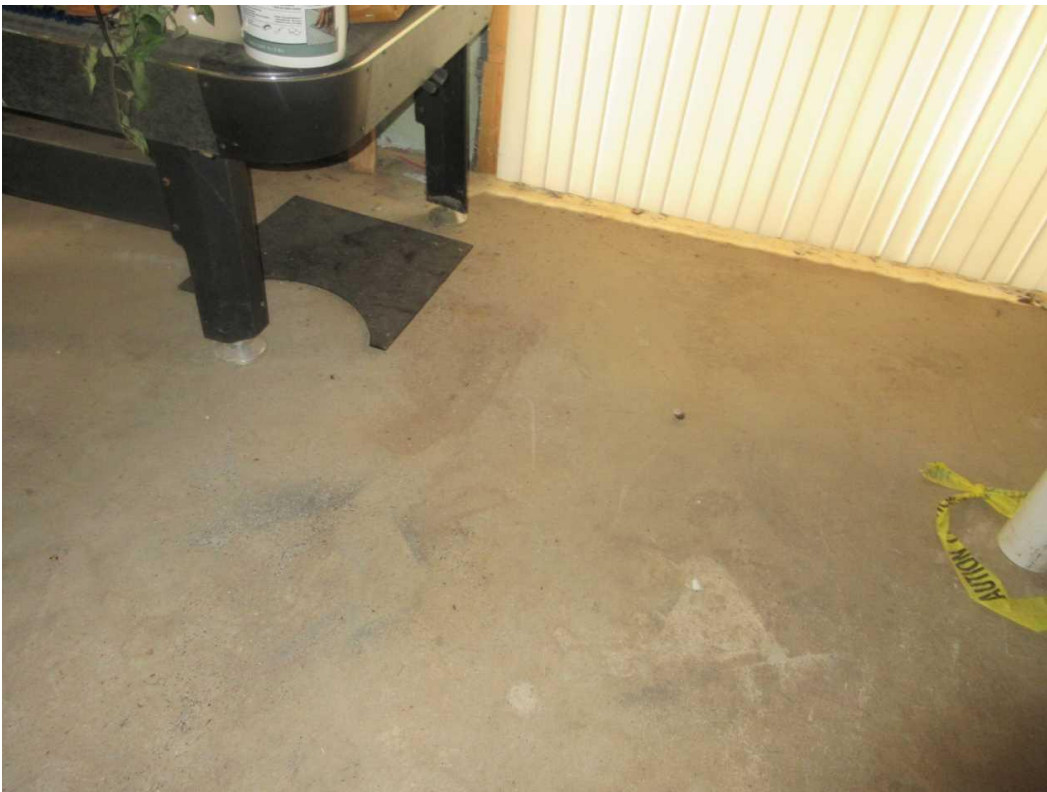
8-Main Room

Dirt and debris around sliding door, possible ground water entry.

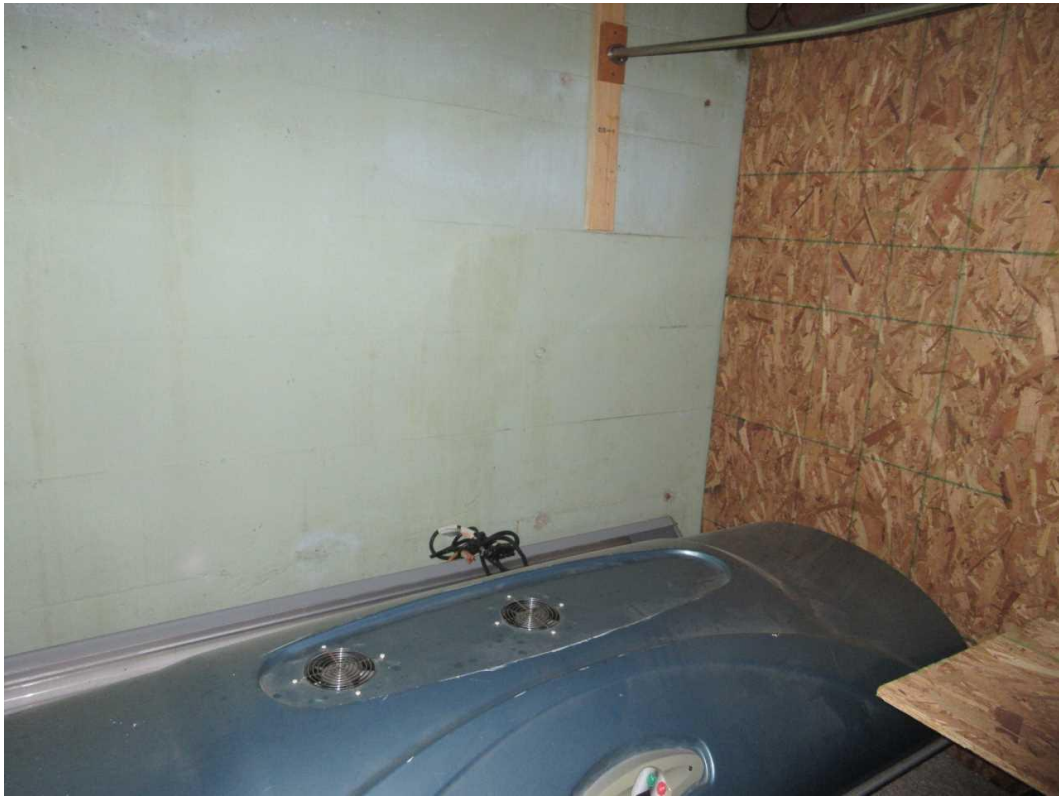
9-Tanning Room
Date Taken: 5/22/2025
Taken By: Michael Wallen
Room overview

TANNING ROOM: water extraction from carpet, carpet cleaning, and replacement of 1 interior door unit.

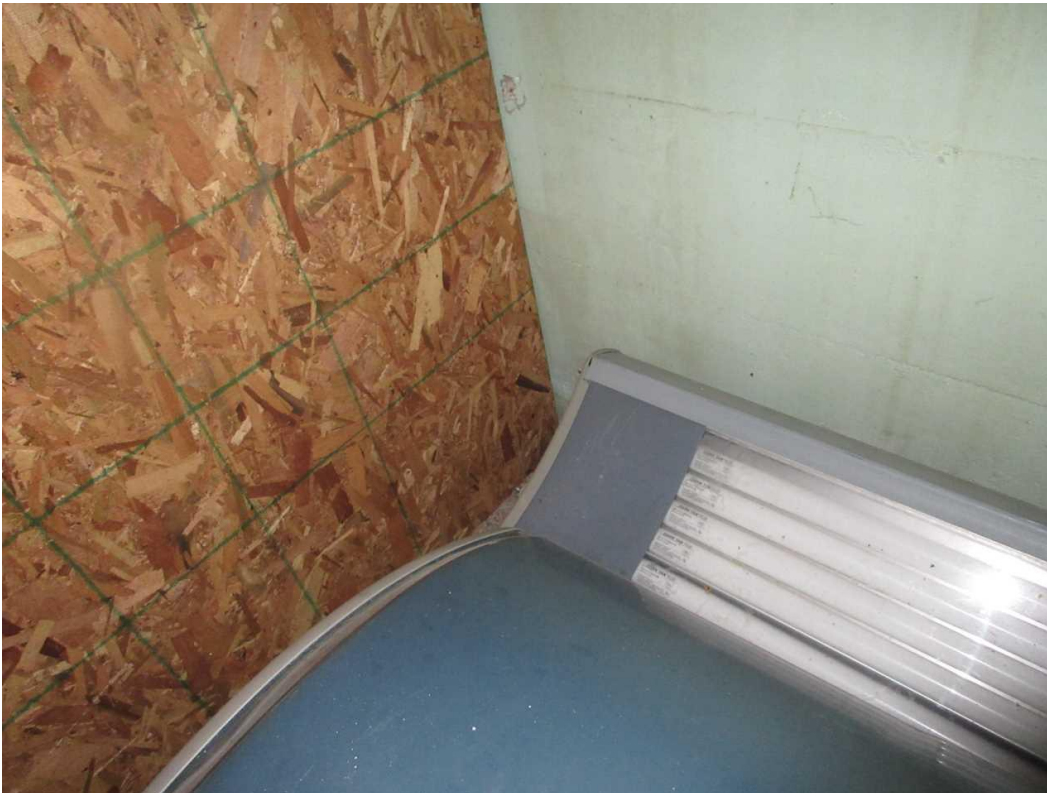
11-Tanning Room

No damage to plywood.

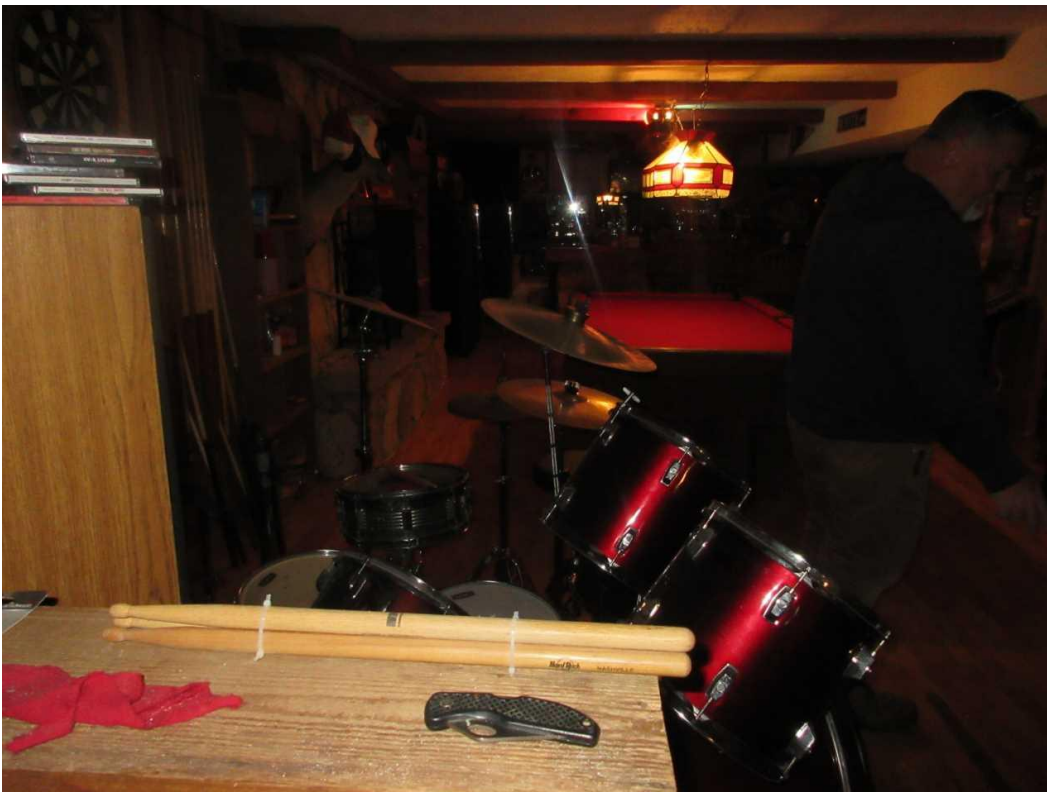
12-Man Cave

Water damage to laminate floor.

MAN CAVE: water extraction from laminate flooring, replacement of the wall paneling, baseboard, laminate flooring, and base cabinets.

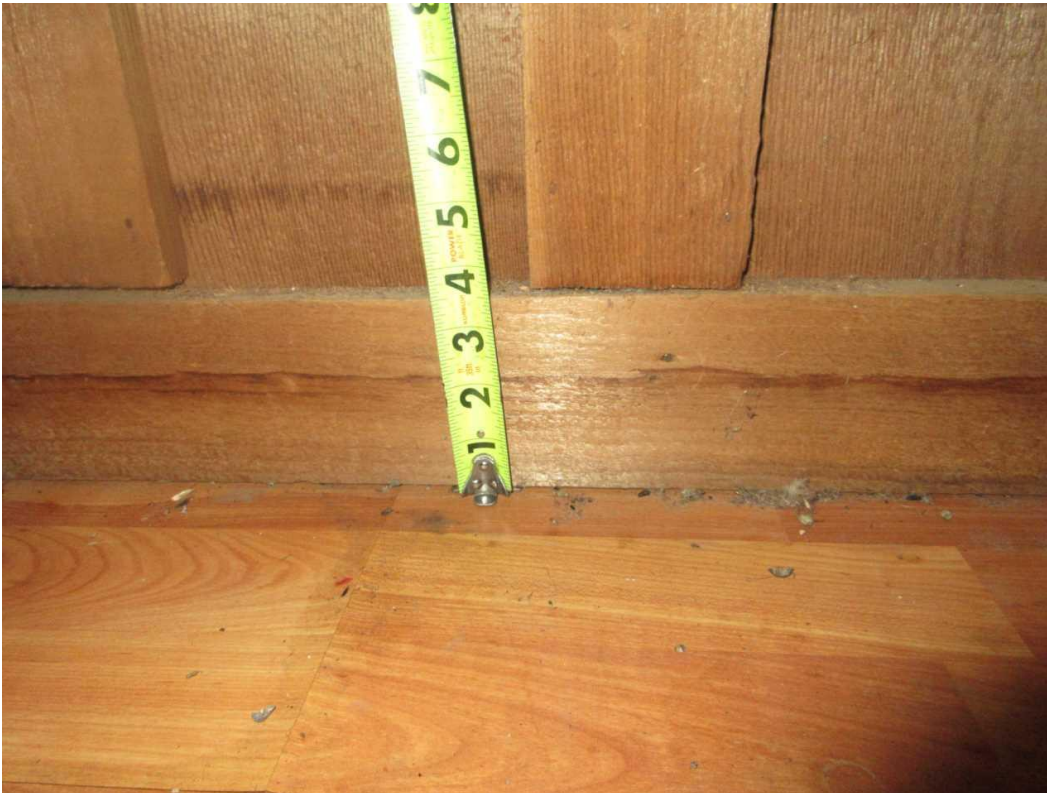
17-Man Cave

3 1/2" baseboard.

18. R&R Baseboard - 3 1/4" stain grade	85.00 LF	4.77	13.09	418.54	(29.75)	388.79
19. Stain & finish baseboard	85.00 LF	1.98	1.61	169.91	(135.93)	33.98
20. R&R Cabinetry - lower (base) units	19.00 LF	258.31	279.77	5,187.66	(1,203.49)	3,984.17

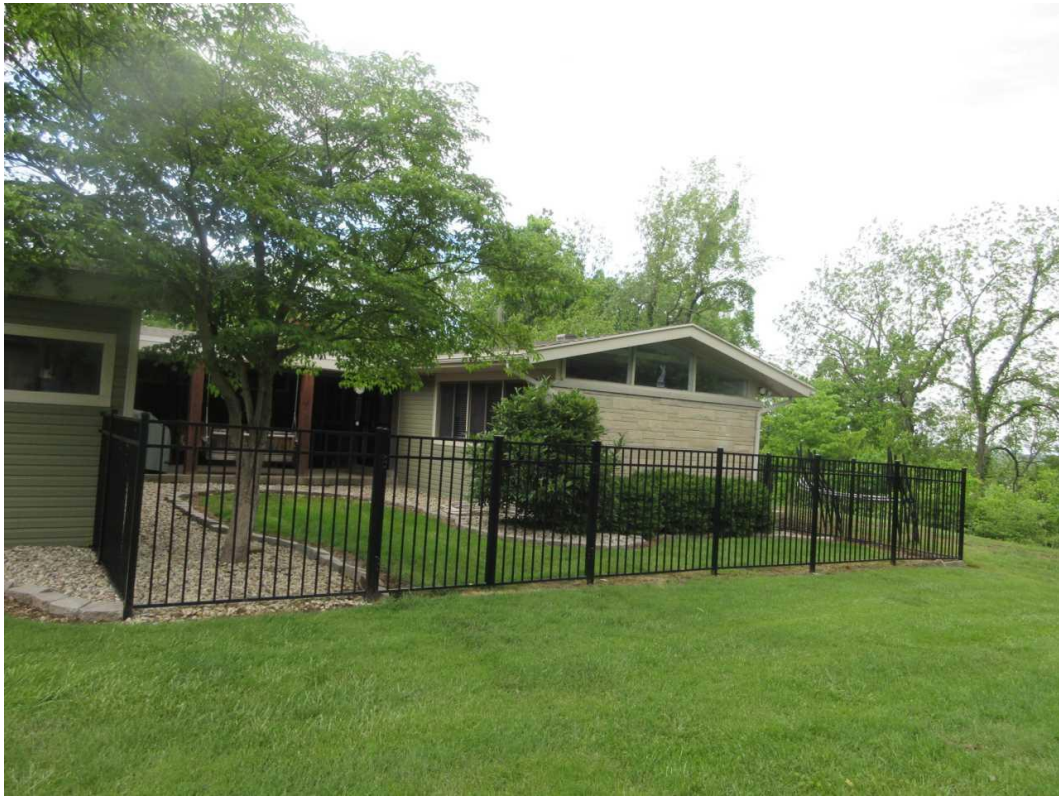
19-S Right Elevation
Date Taken: 5/22/2025
Taken By: Michael Wallen
Elevation overview

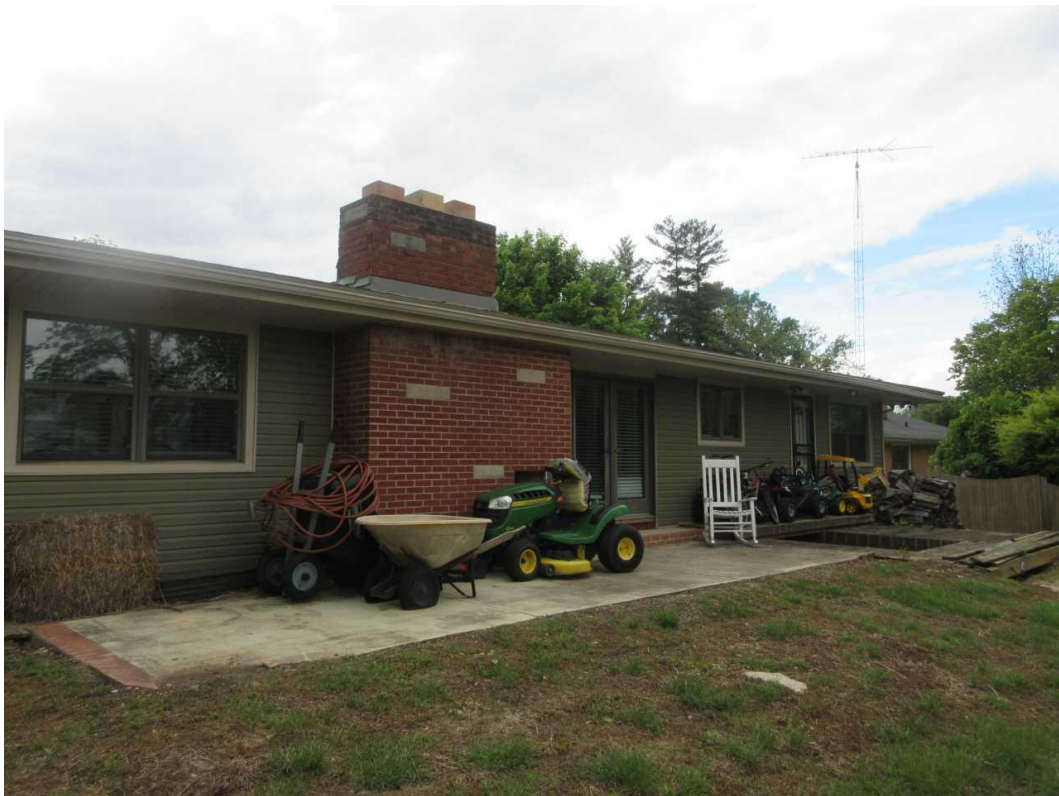
20-E Rear Elevation
Date Taken: 5/22/2025
Taken By: Michael Wallen
Elevation overview

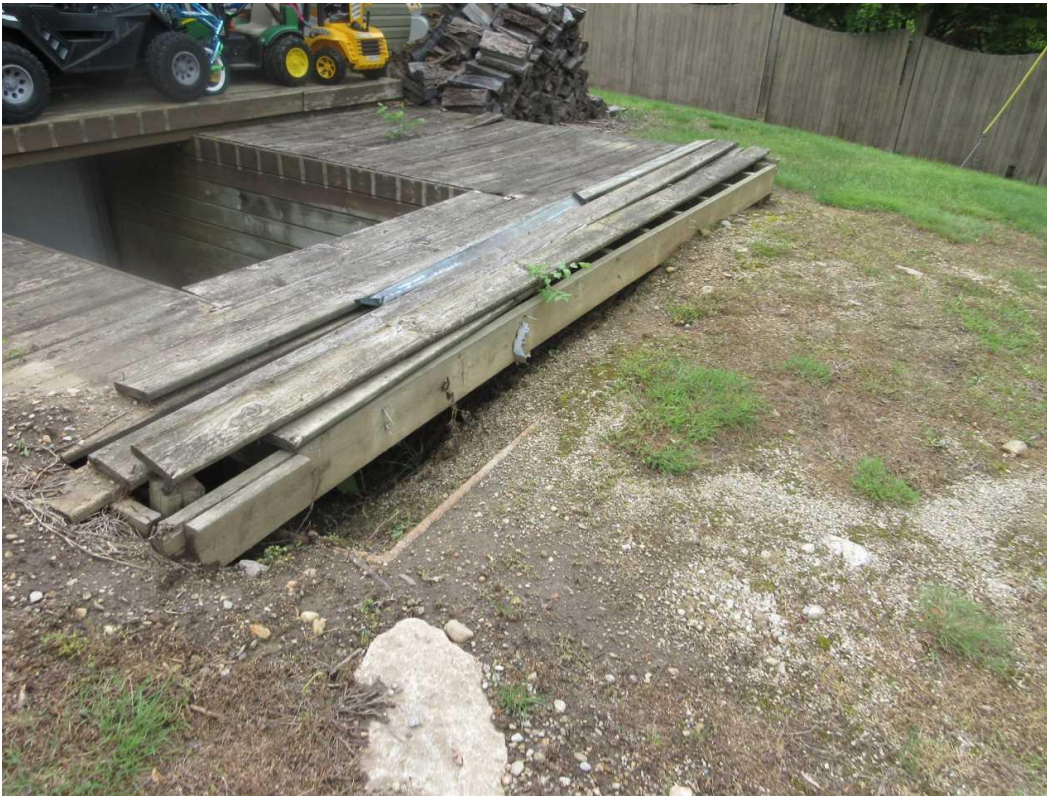
21-E Rear Elevation

Possible location of ground water entry below the deck planking and into the Basement level interior through the sliding door.

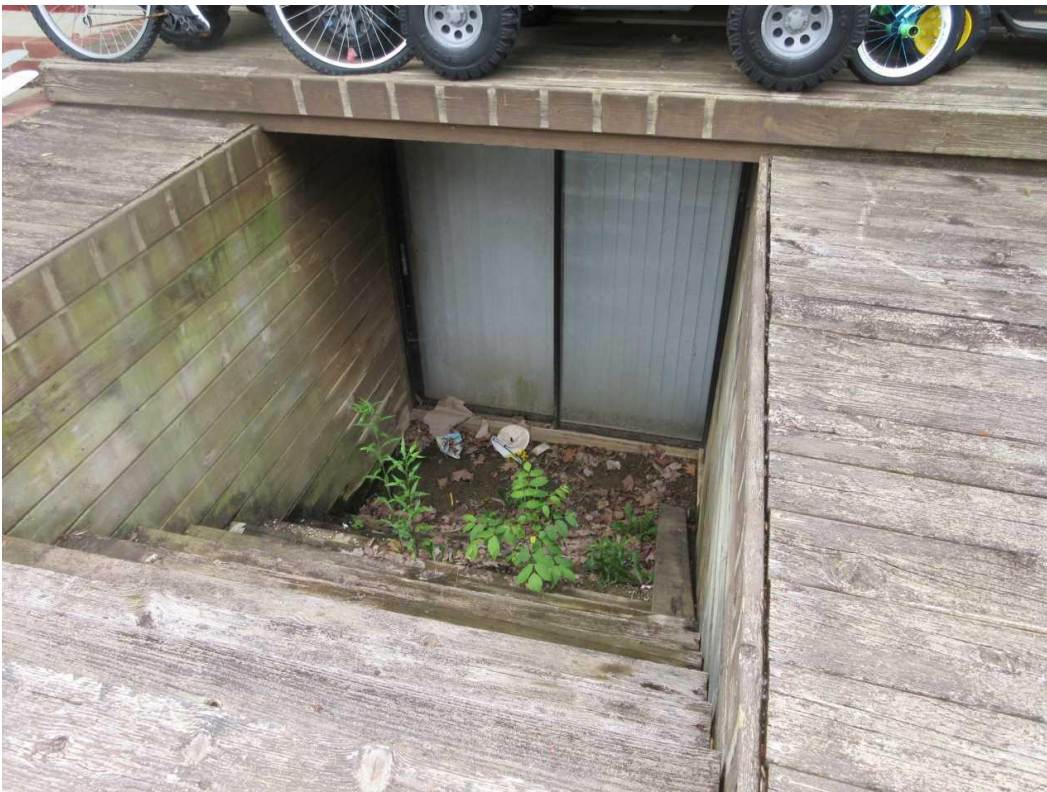
22-E Rear Elevation

Possible location of ground water entry below the deck planking and into the Basement level interior through the sliding door.

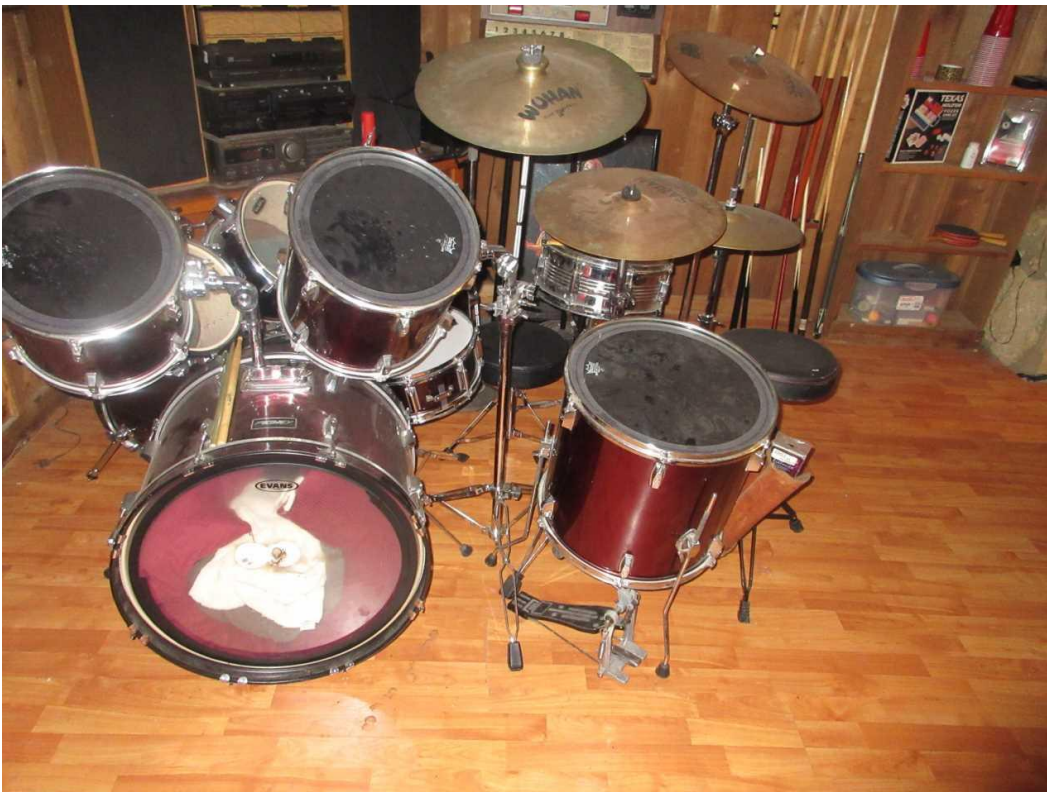
24-Personal Property

Possible water damage to drumset.
