## **Activity Log**

LOSS REPORT

Date of Loss: 5/16/2025 Type of Loss: WIND File Number: R191105

Cause of Loss: Tornado

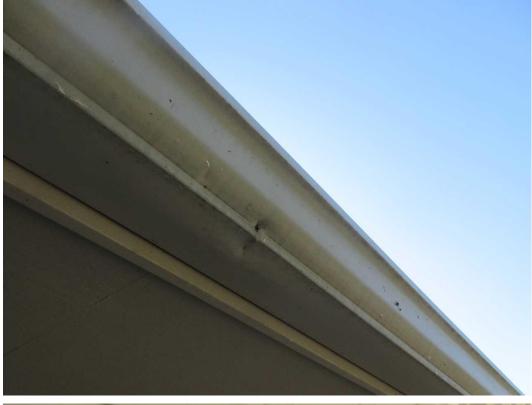
### 3-SW Front Elevation

Debris damage to gutters, no damage to gutter screens; however, screens need

detached and reset.

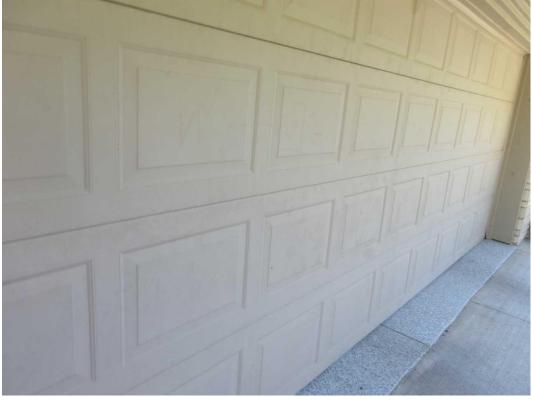
### 4-SW Front Elevation

No storm damage to overhead door from

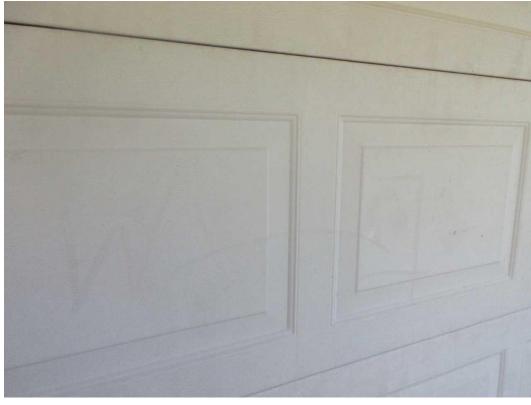
### 5-SW Front Elevation

No storm damage to overhead door from

the claimed date of loss.

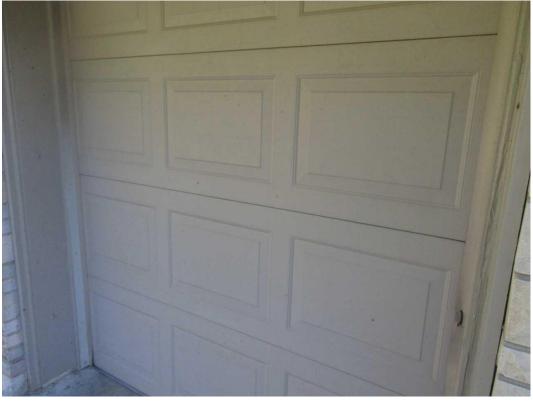
### 6-SW Front Elevation

No storm damage to overhead door from

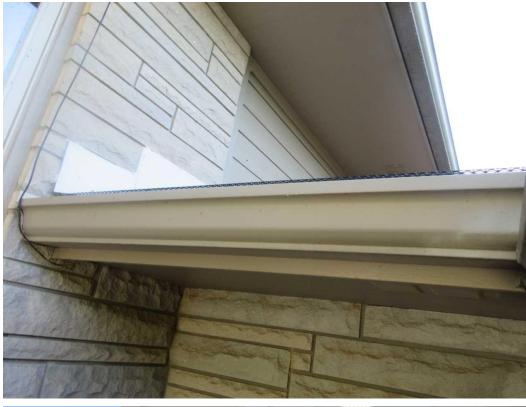
### 7-SW Front Elevation

No storm damage to gutters or gutter screens from the claimed date of loss.

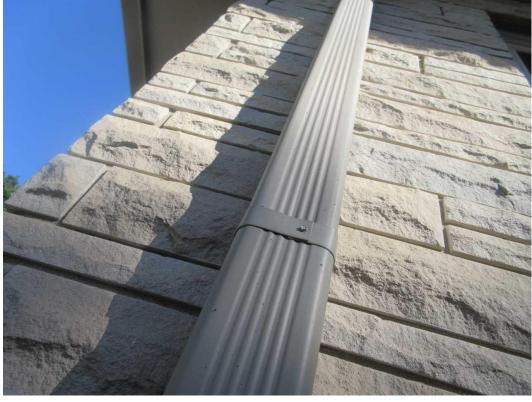
### 8-SW Front Elevation

No storm damage to downspout from the

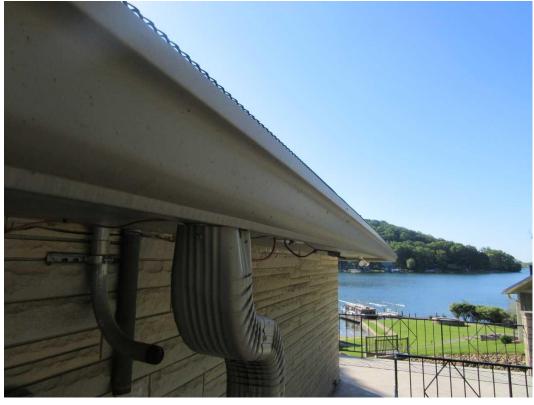
### 9-SW Front Elevation

No storm damage to gutters or gutter screens from the claimed date of loss.

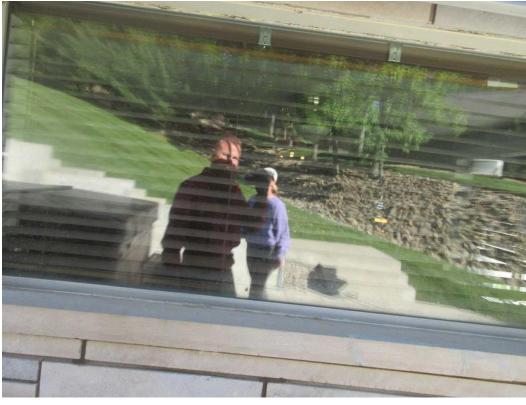
### 11-SW Front Elevation

No storm damage to windows from the

claimed date of loss.

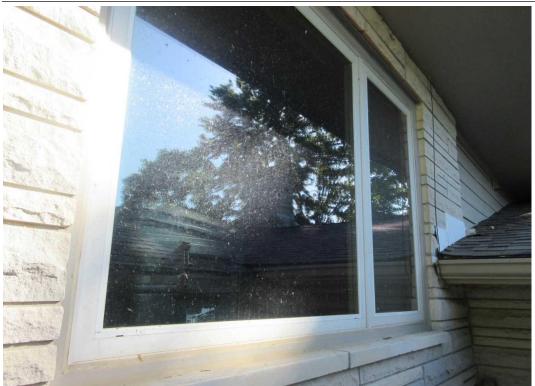
## 13-SE Right Elevation

No storm damage to windows from the

claimed date of loss.

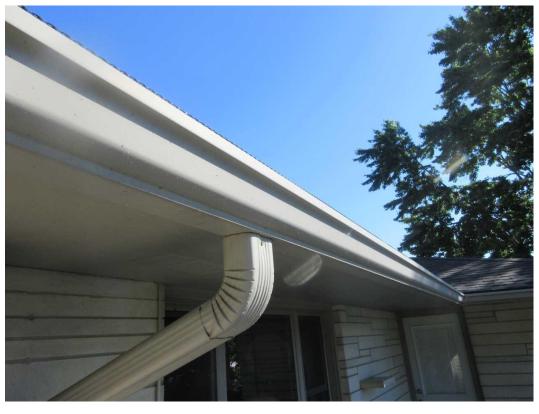
## 14-SE Right Elevation

No storm damage to gutters or gutter screens from the claimed date of loss.

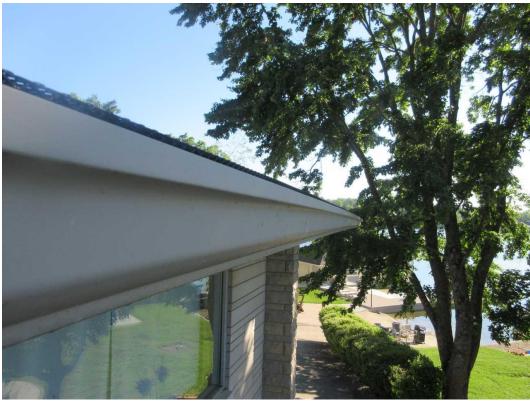
## 15-SE Right Elevation

No storm damage to gutters or gutter screens from the claimed date of loss.

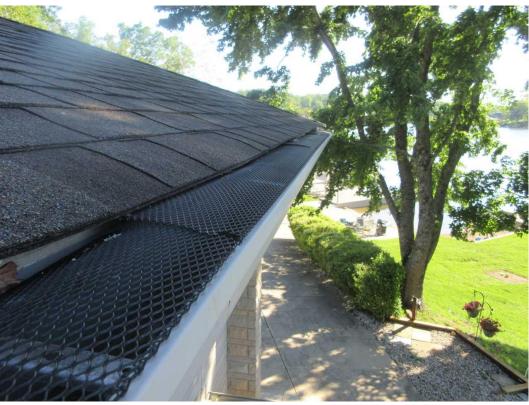
### 16-SE Right Elevation

No storm damage to gutters or gutter screens from the claimed date of loss.

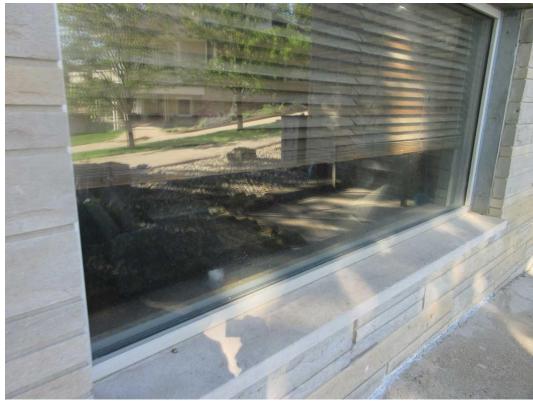
### 23-NE Rear Elevation

No storm damage to windows from the

claimed date of loss.

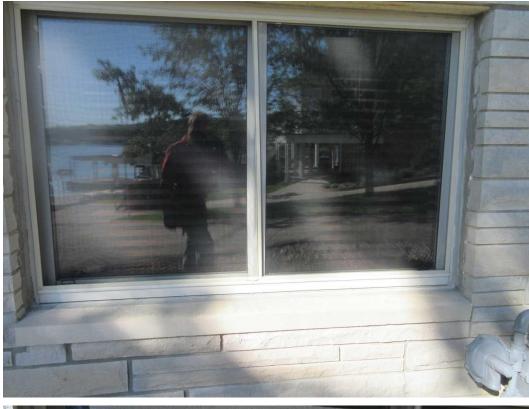
### 25-NE Rear Elevation

No storm damage to windows from the

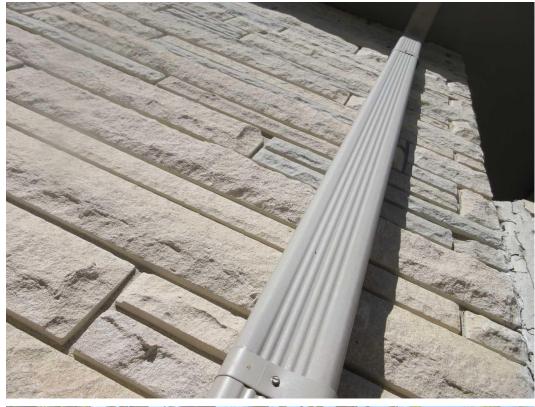
### 29-NE Rear Elevation

No storm damage to downspout from the

claimed date of loss.

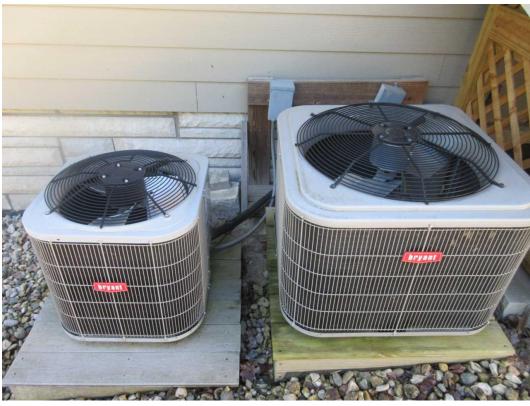
### 31-SW Left Elevation

No storm damage to A/C units from the

claimed date of loss.

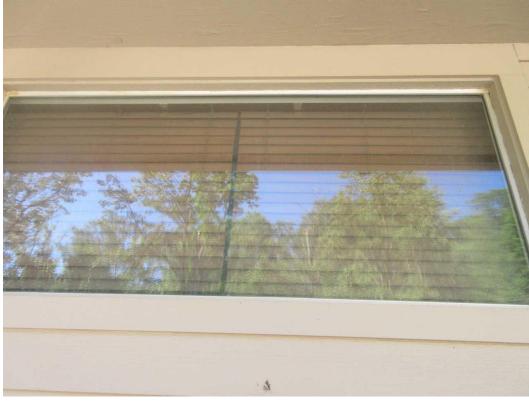
### 33-SW Left Elevation

No storm damage to windows from the

claimed date of loss.

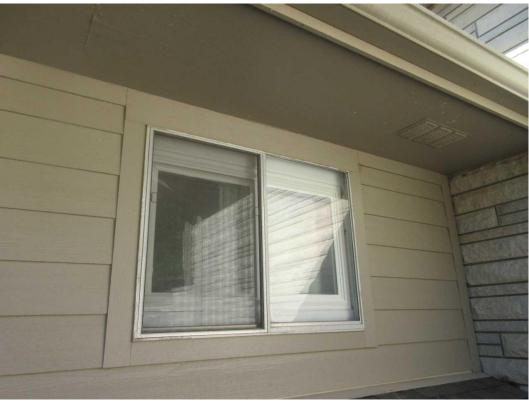
### 34-SW Left Elevation

No storm damage to windows from the

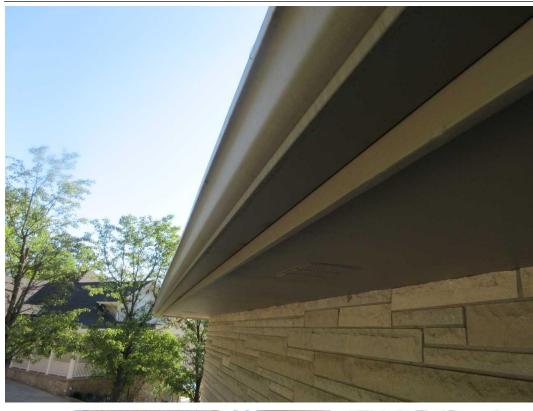
### 35-SW Left Elevation

No storm damage to gutters or gutter screens from the claimed date of loss.

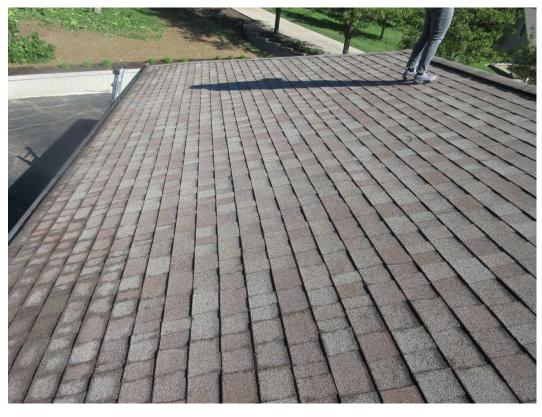
## 44-SW Front Slope

Slope overview, no storm damage to shingles from the claimed date of loss.

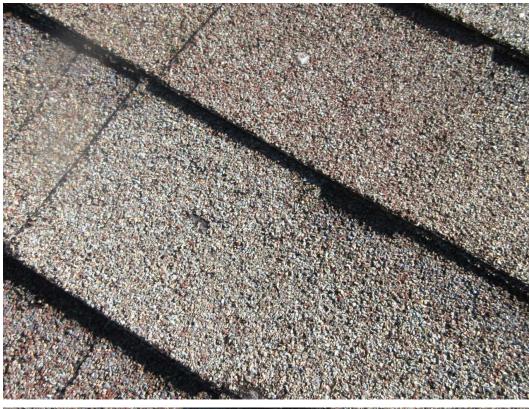
## 45-SW Front Slope

Granule loss is not storm related.

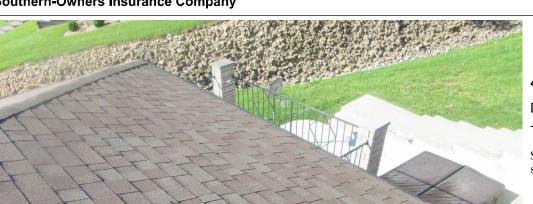
### 49-SW Front Slope

Slope overview, no storm damage to shingles from the claimed date of loss.

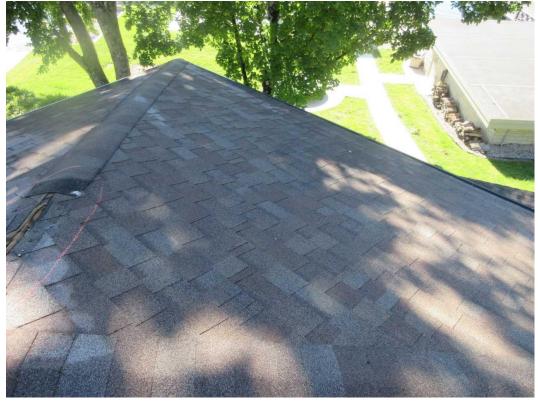
## 51-SE Right Slope

Slope overview, no storm damage to shingles from the claimed date of loss.

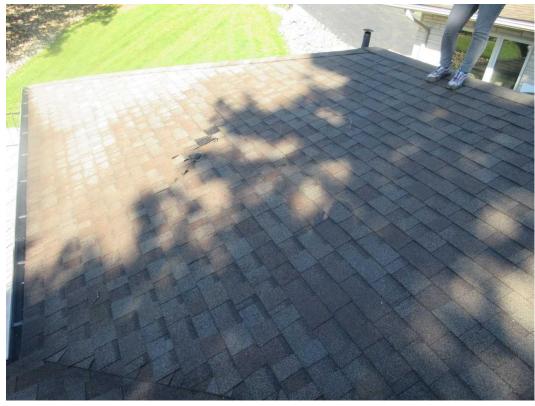
## 53-SE Right Slope

Wind damage to ridge shingles only, no

damage to field shingles.

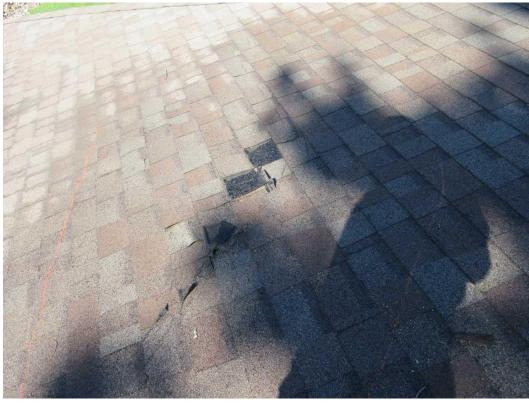
### 54-SE Right Slope

Slope overview

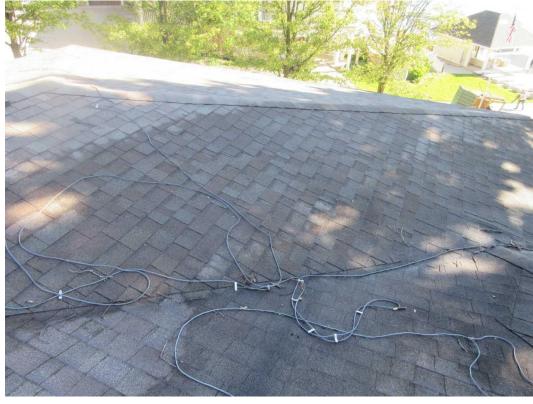
## 56-SE Right Slope

Slope overview, no storm damage to shingles from the claimed date of loss.

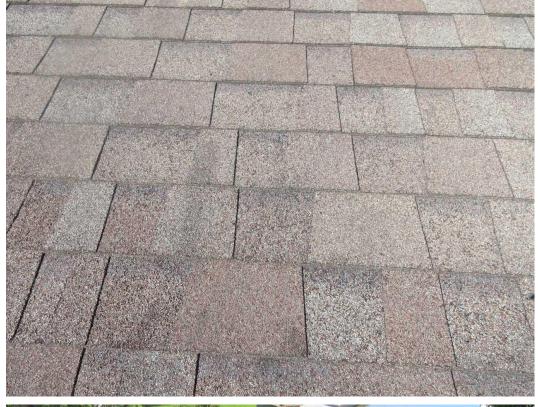
## 59-NE Rear Slope

Slope overview, no storm damage to shingles from the claimed date of loss.

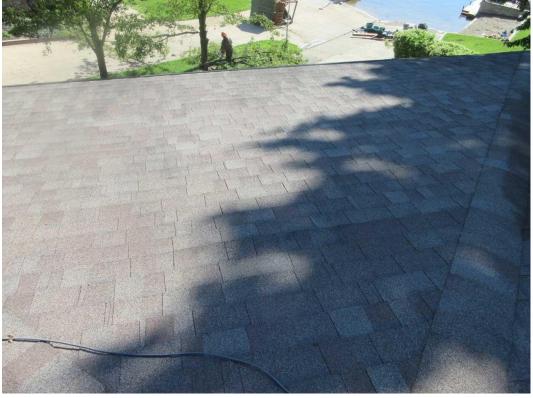
## 60-NE Rear Slope

Granule loss is not storm related.

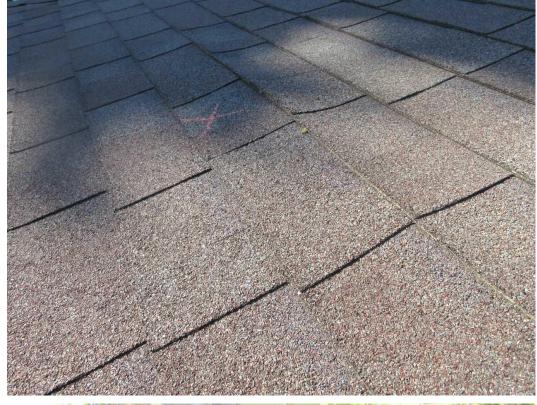
## 61-NE Rear Slope

Slope overview, no storm damage to shingles from the claimed date of loss.

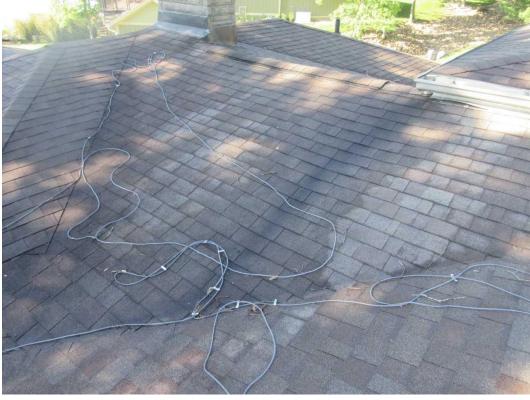
### 62-NE Rear Slope

Uneven decking, no storm damage from the claimed date of loss.

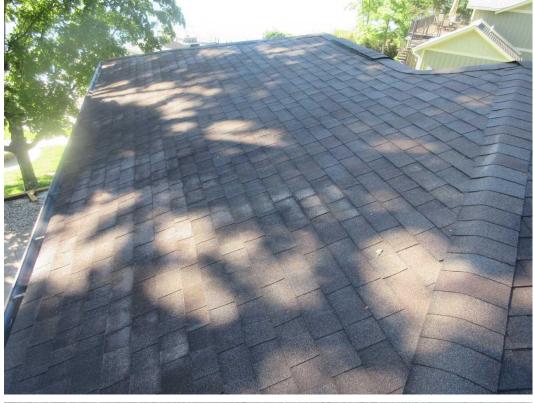
### 63-NE Rear Slope

Slope overview, no storm damage to shingles from the claimed date of loss.

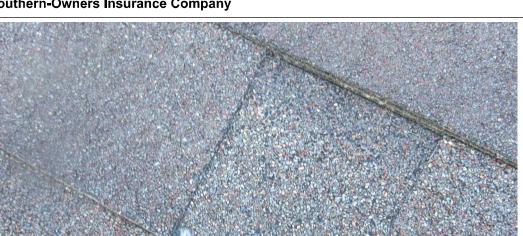
## 65-NE Rear Slope

Mechanical damage to shingle, granule loss is not storm-related and is

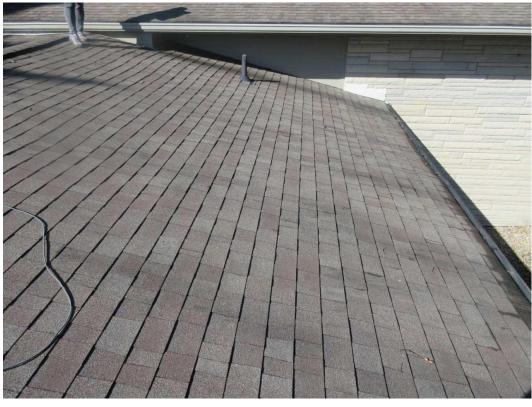
#### 68-NW Left Slope

Slope overview, no storm damage to shingles from the claimed date of loss.

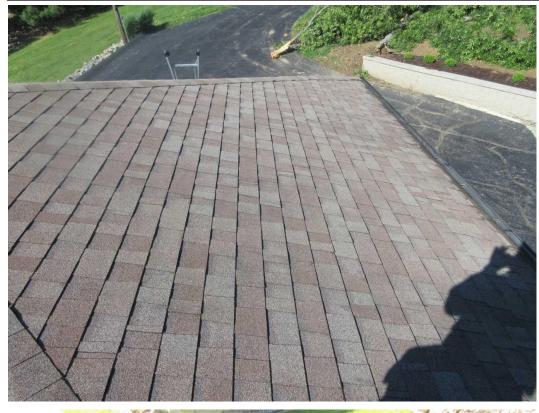
## 69-NW Left Slope

Slope overview, no storm damage to shingles from the claimed date of loss.

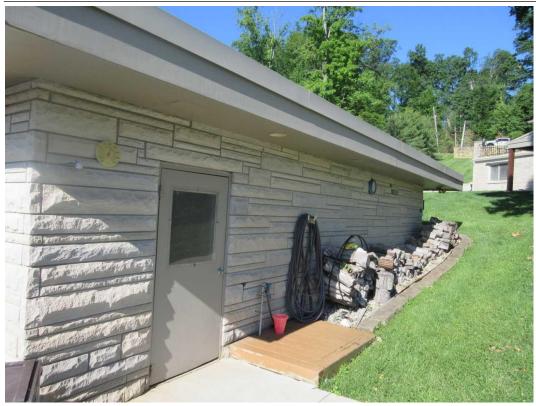
#### 81-NW Left Elevation

No storm damage to gutters from the

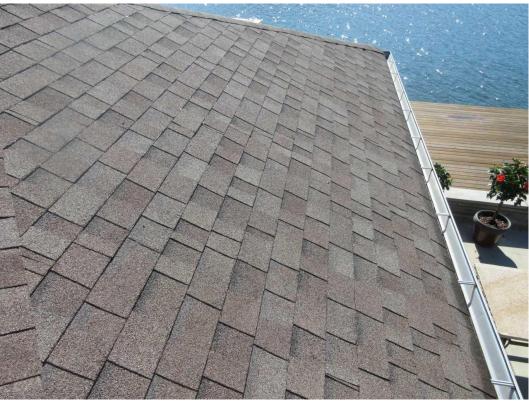
#### 94-SE Right Slope

Roof overview, no storm damage from

the claimed date of loss.

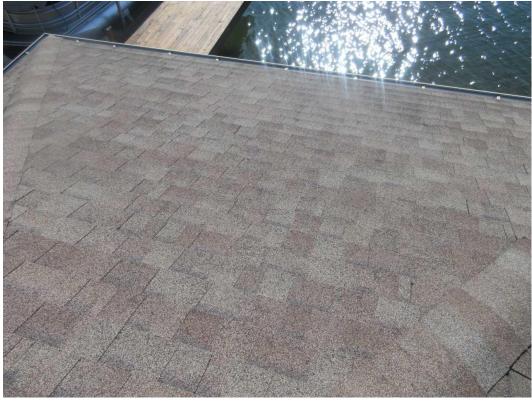
## 95-NE Back Slope

Roof overview, no storm damage from

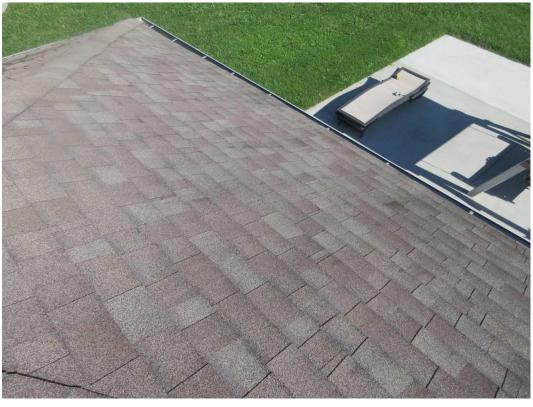
## 96-NW Left Slope

Roof overview, no storm damage from

the claimed date of loss.

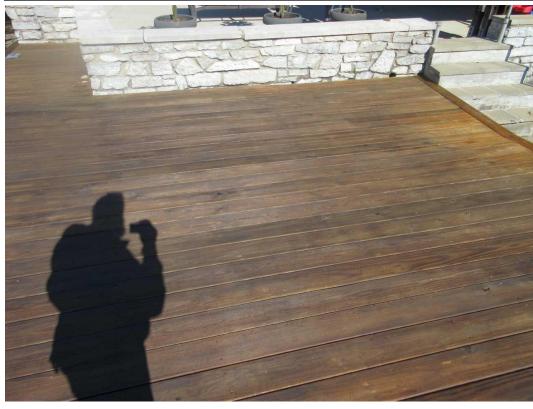
#### 97-Boat Dock

No storm damage from the claimed date

of loss.

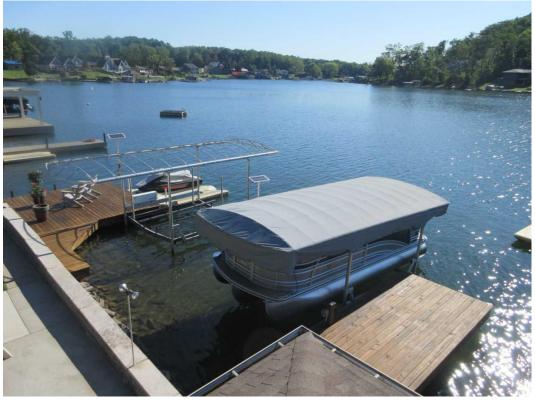
#### 98-Boat Lifts

No storm damage from the claimed date
