File # R192712  
 Claim # 300- [REDACTED]-2025  
 Insured [REDACTED] Automotive Services

## LOSS REPORT

Cause of Loss: Hail

Damaged items include: Location 1 Building 1 Roof/Elevations, Location 3 Building 1 Roof/Elevations, Location 3 Building 2 Roof, Location 5 Building 1 Roof/Elevations, Location 6 Building 1 Roof/Elevations, Location 6 Building 2 Roof/Elevations

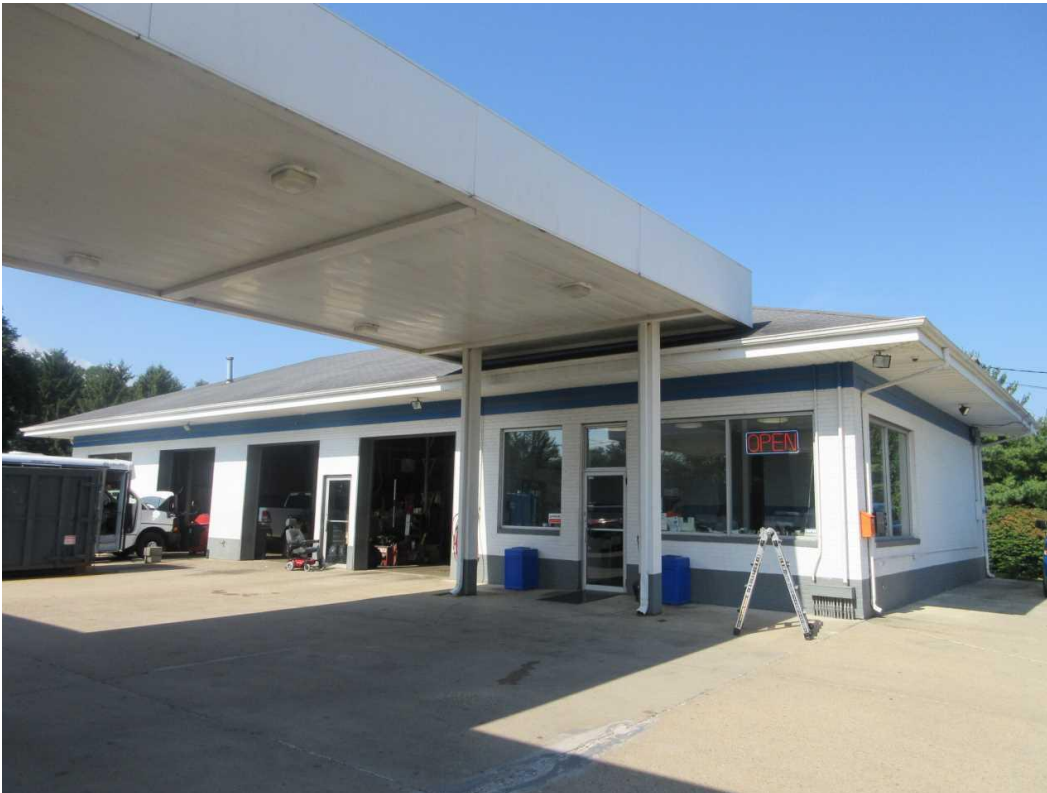
## 1-Risk

Risk/Location 1 Building 1/E Front  
Elevation overview

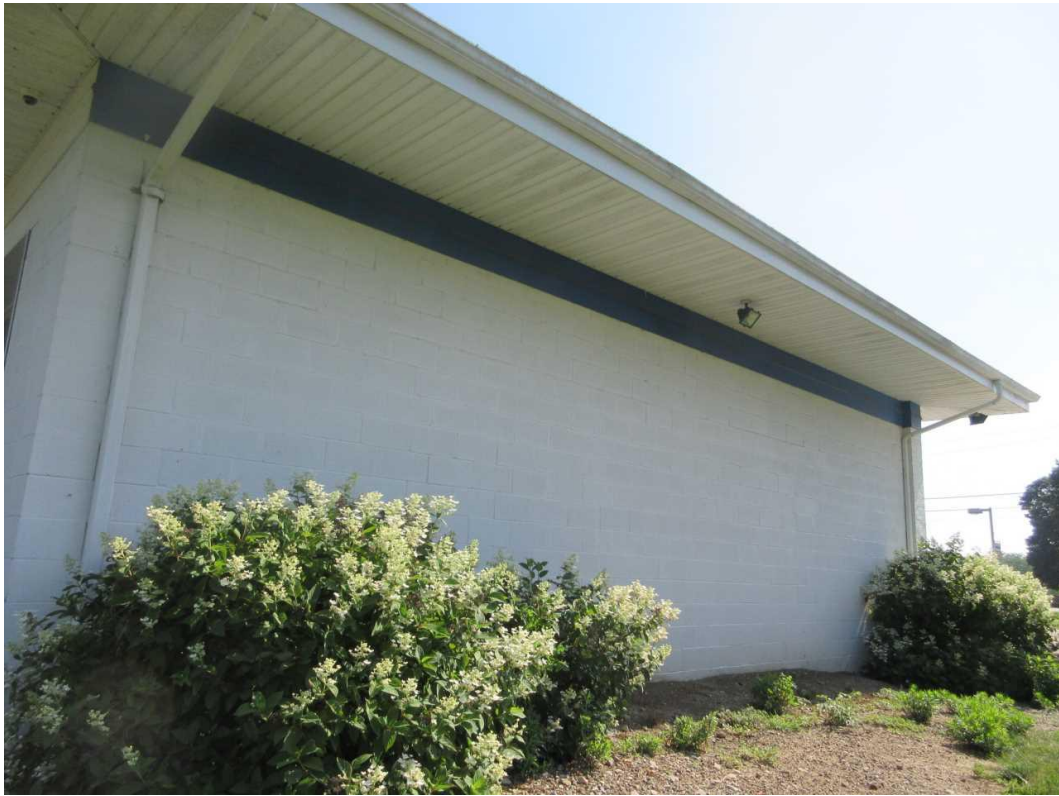
**6-S Left Elevation**  
Date Taken: 6/27/2025  
Taken By: Michael Wallen  
Elevation overview

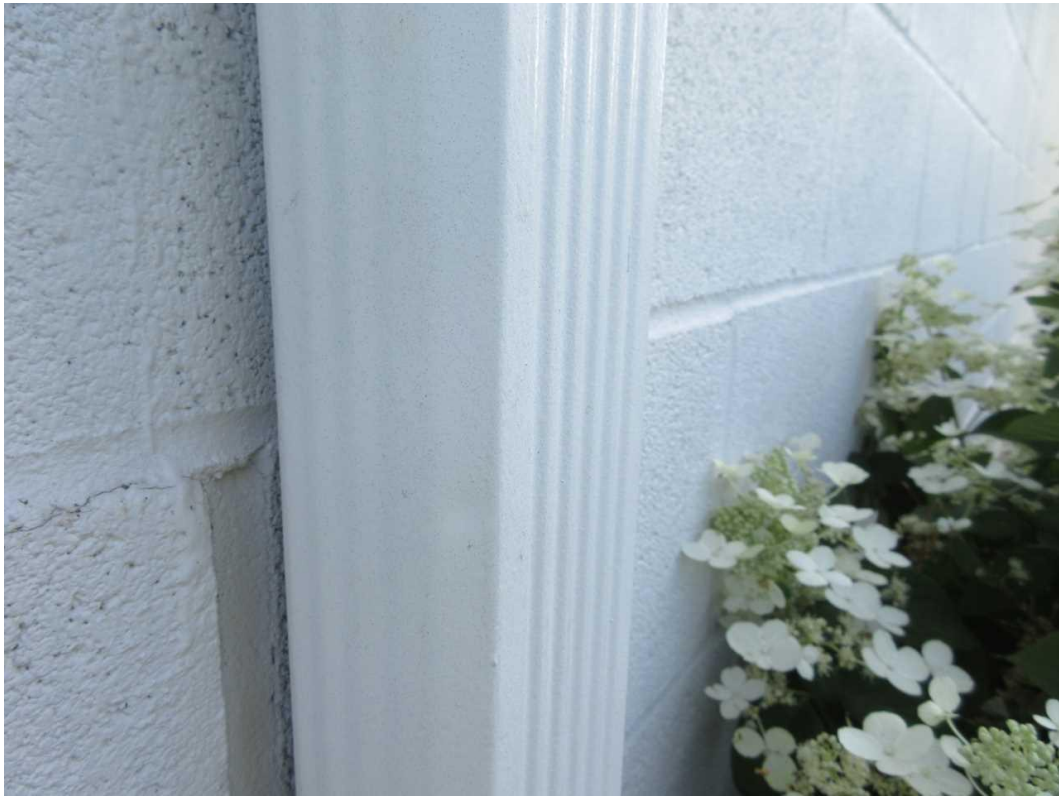
**7-S Left Elevation**

Hail damage to downspout.

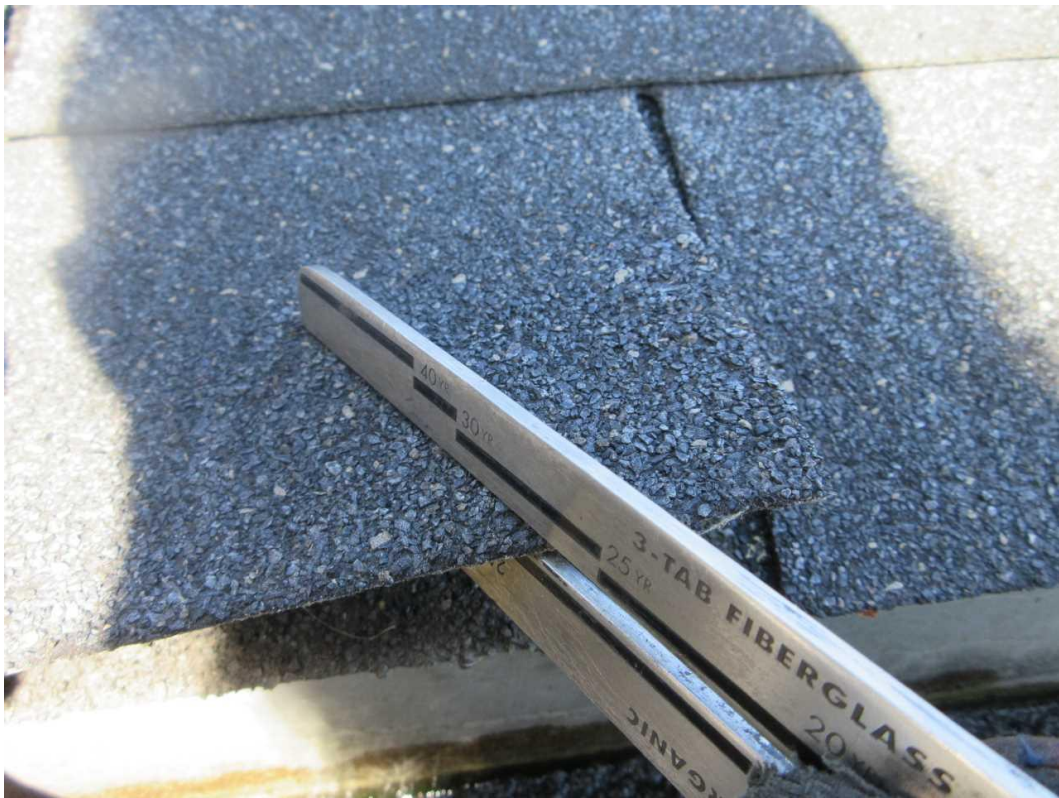
**9-Shingles**  
Date Taken: 6/27/2025  
Taken By: Michael Wallen  
25-year 3-tab

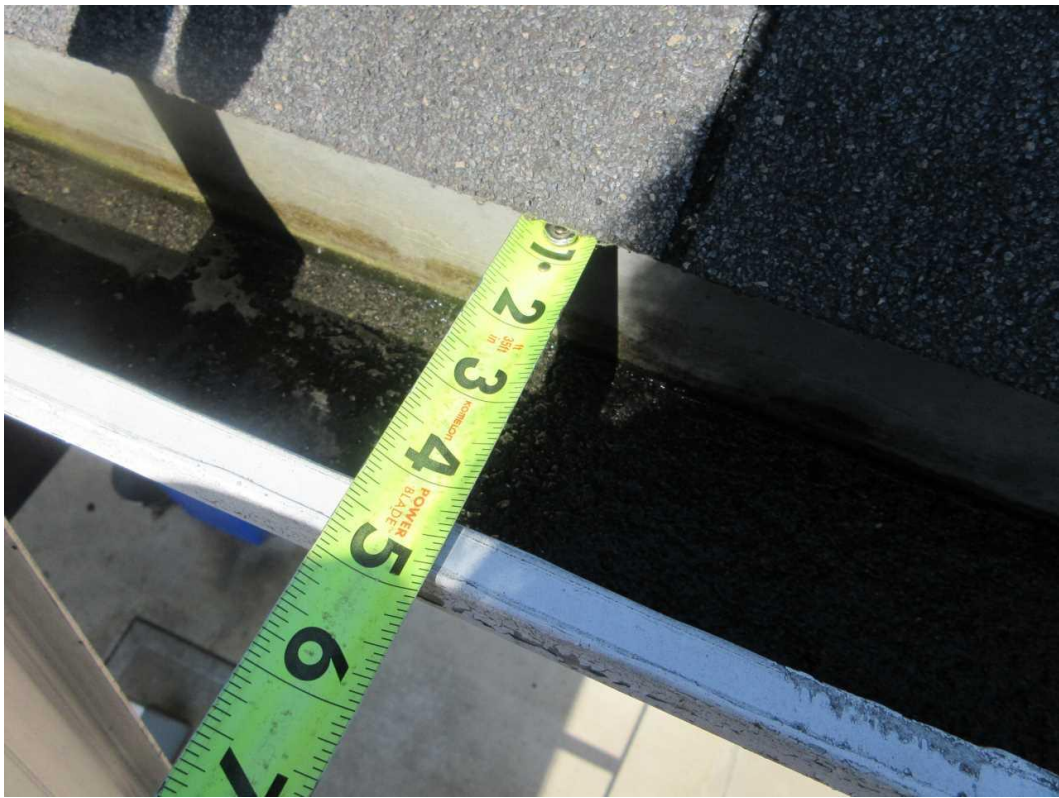
**10-Gutters**  
Date Taken: 6/27/2025  
Taken By: Michael Wallen  
5" Aluminum

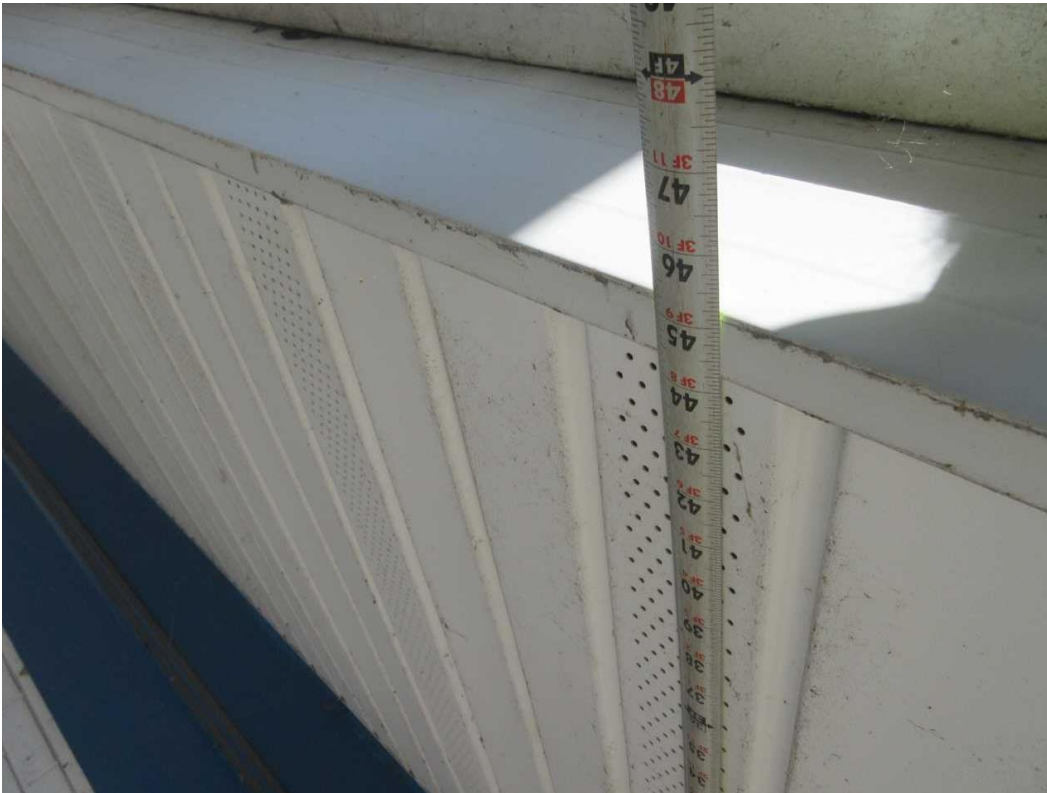
## 11-Soffit

1'9" soffit.

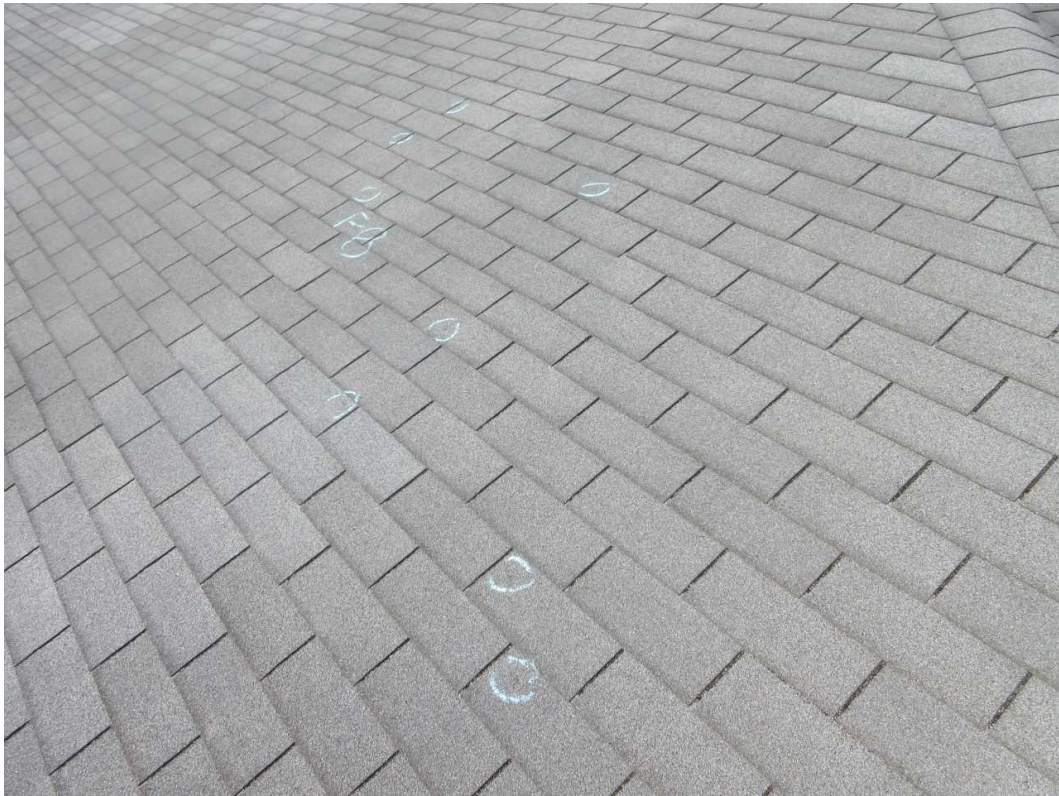
**13-E Front Slope**

Date Taken: 6/27/2025  
Taken By: Michael Wallen  
Overview of the test square.

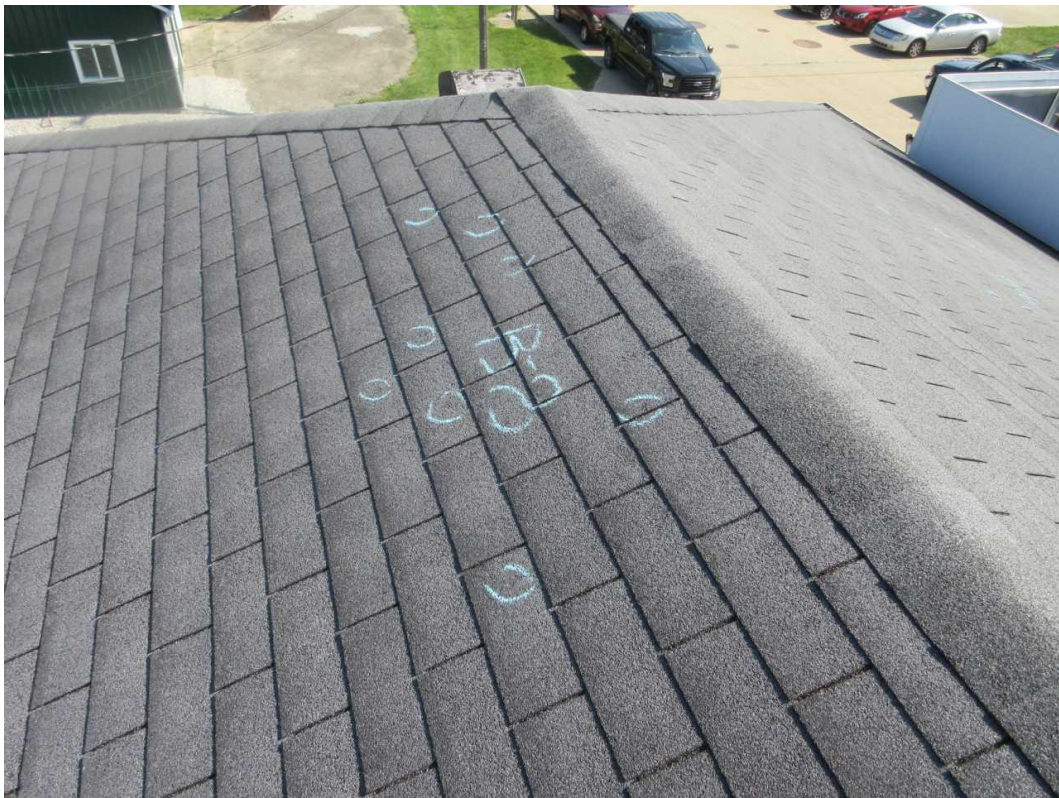
**17-W Back Slope**  
Date Taken: 6/27/2025  
Taken By: Michael Wallen  
Overview of the test square.

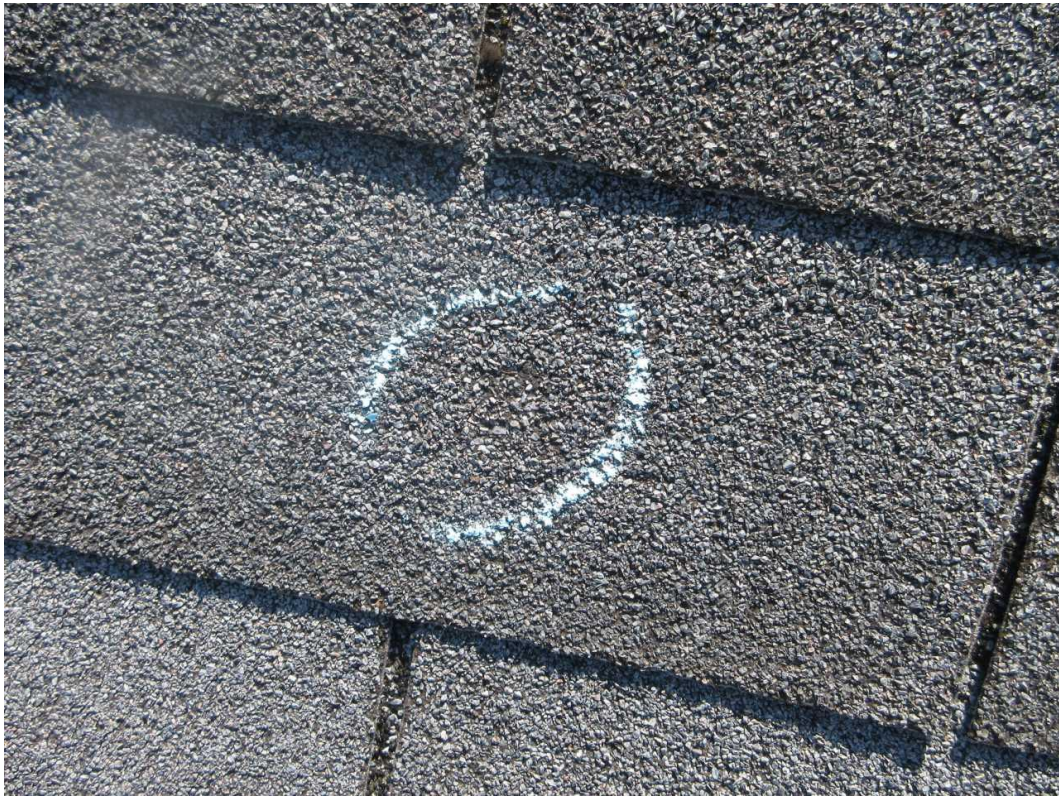
## 19-W Back Slope

Close up of hail damage inside the test square.

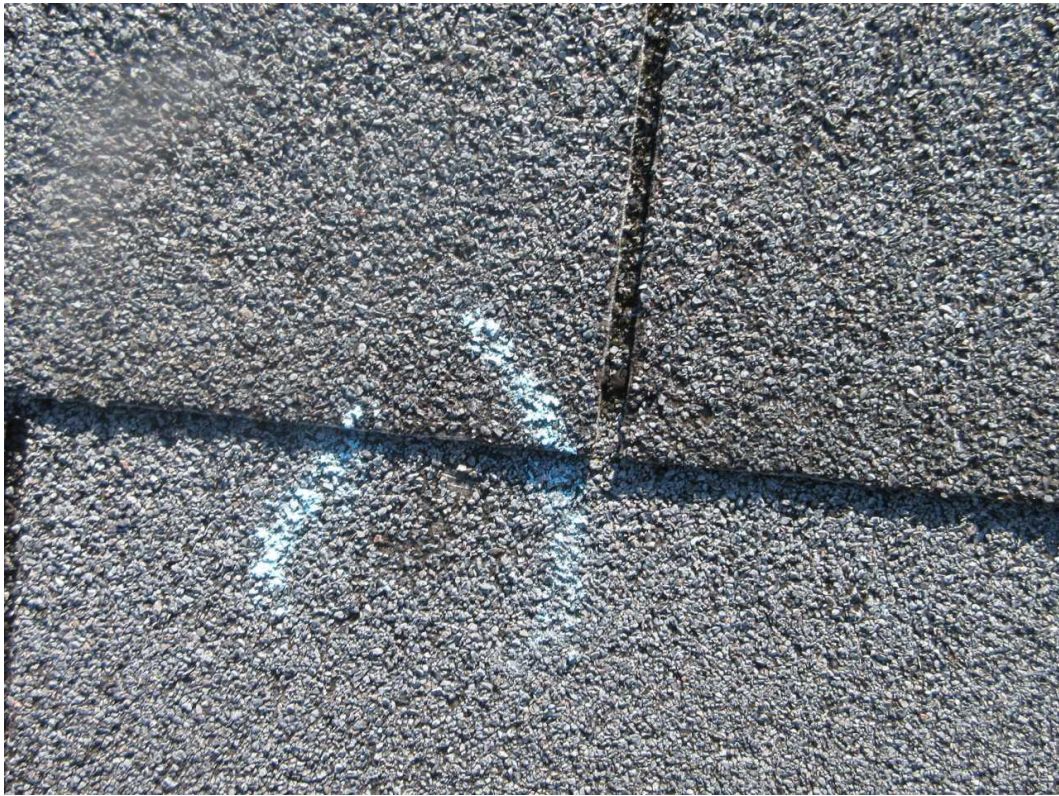
## 20-W Back Slope

Close up of hail damage inside the test square.

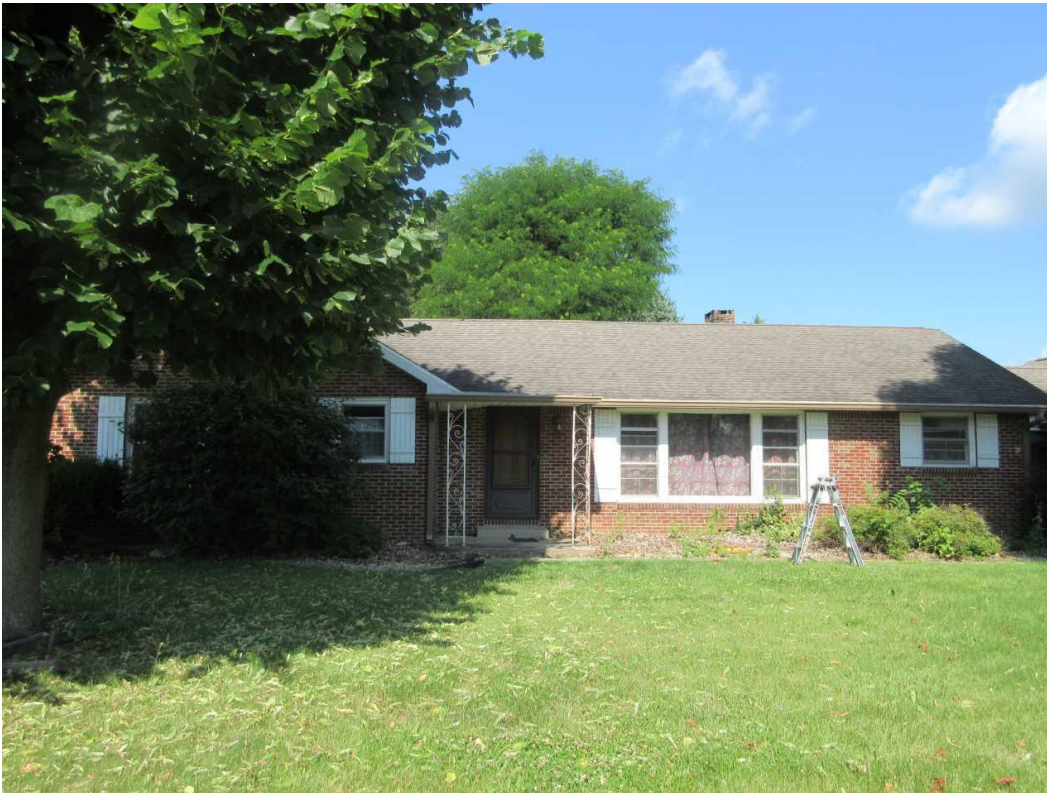
## 25-Risk

Risk/Location 3 Building 1/E Front  
Elevation overview

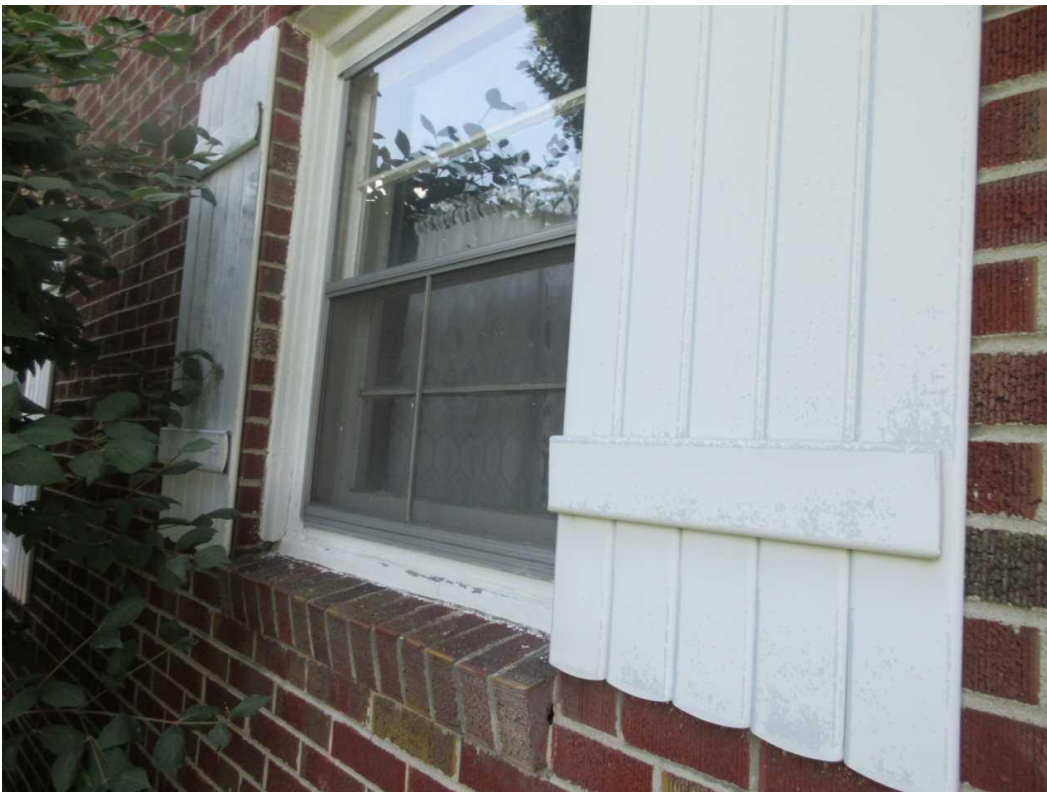
## 26-E Front Elevation

No storm damage to windows from the  
claimed date of loss.

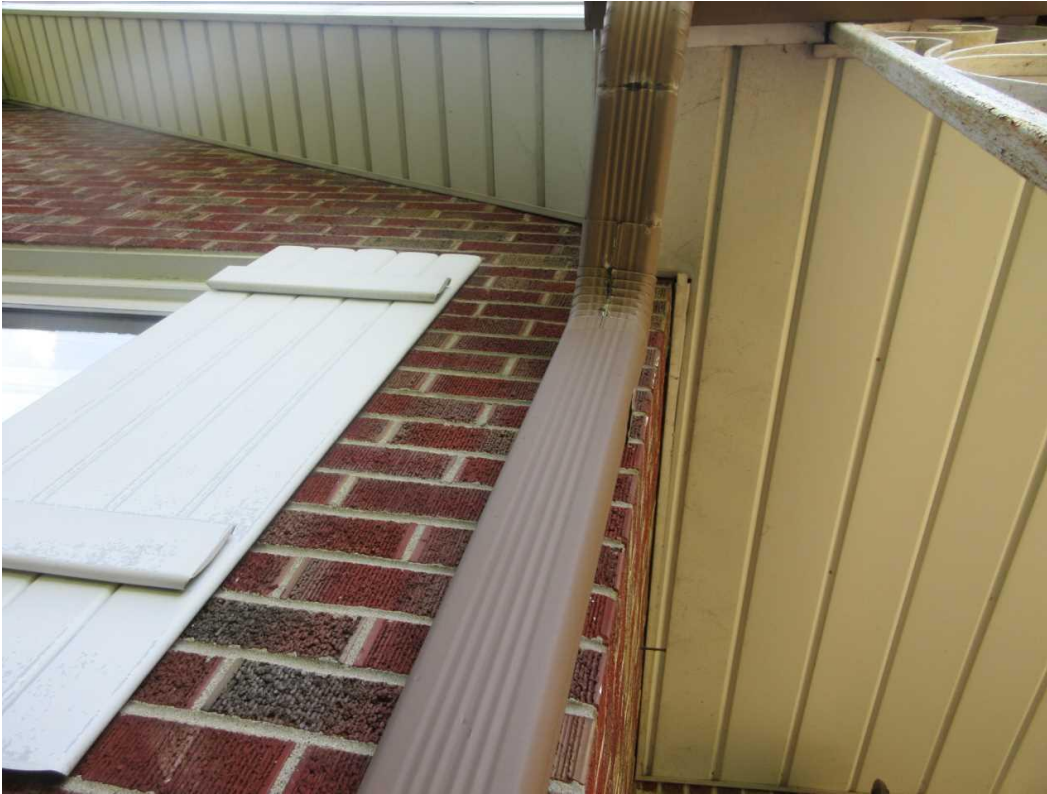
## 27-E Front Elevation

No storm damage to downspout from the claimed date of loss.

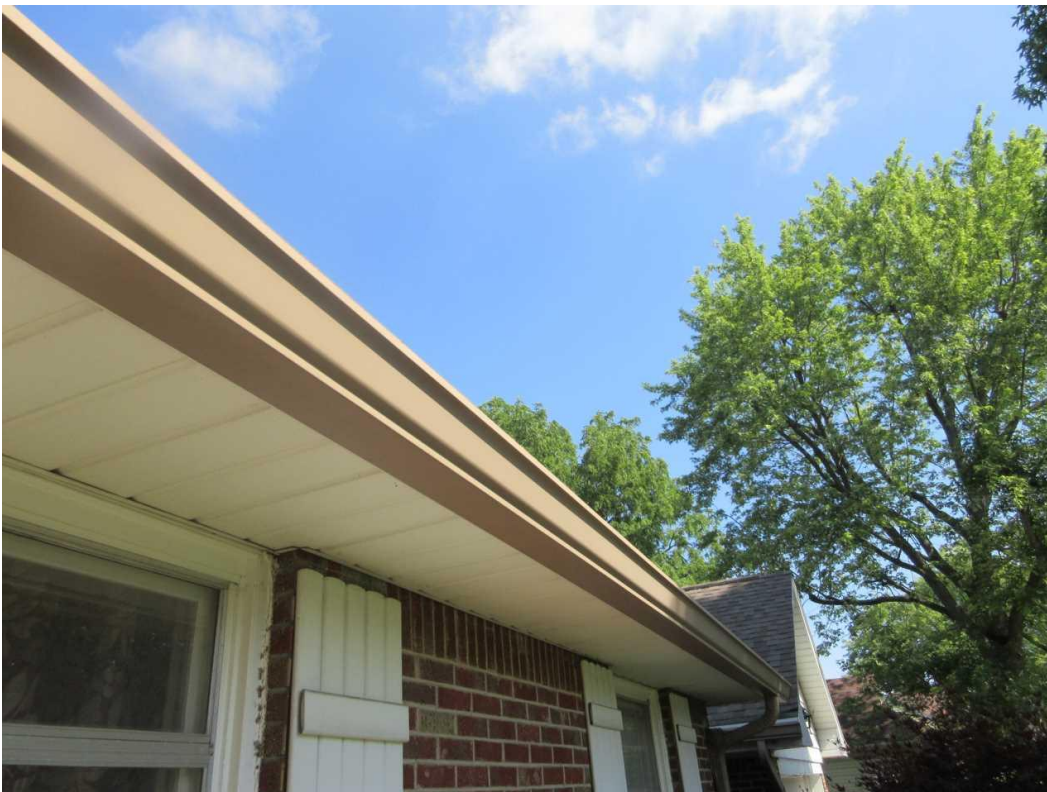
## 28-E Front Elevation

No storm damage to gutters from the claimed date of loss.

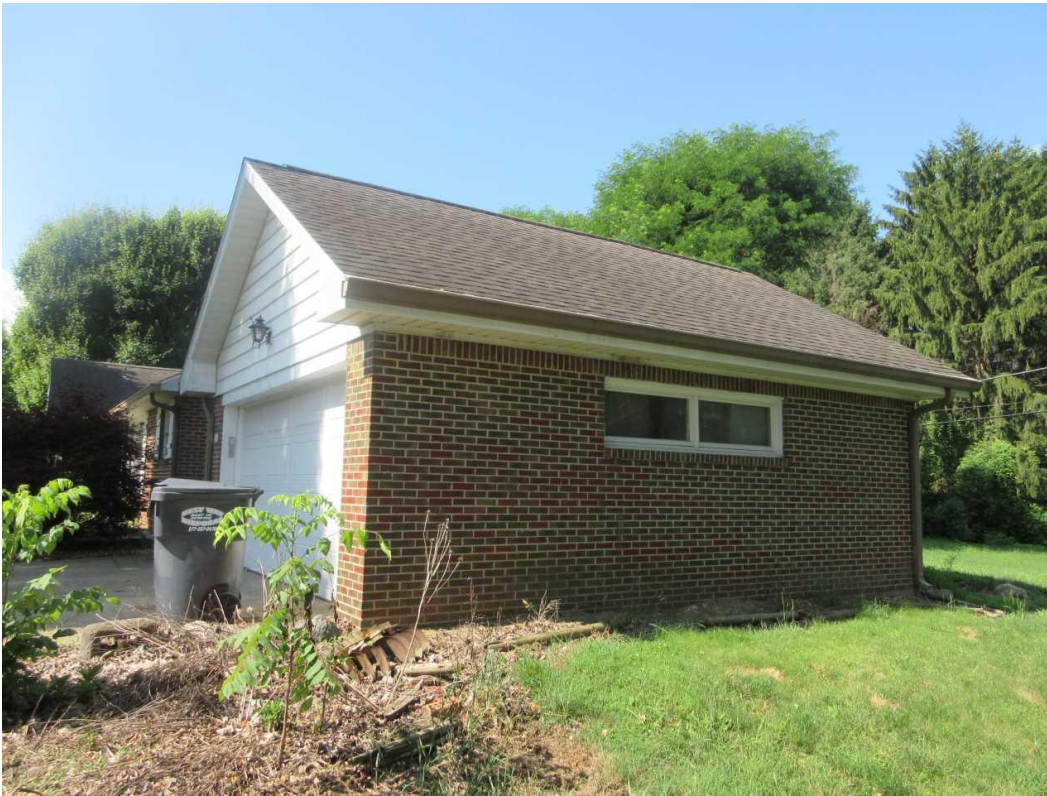
## 31-N Right Elevation

Elevation overview

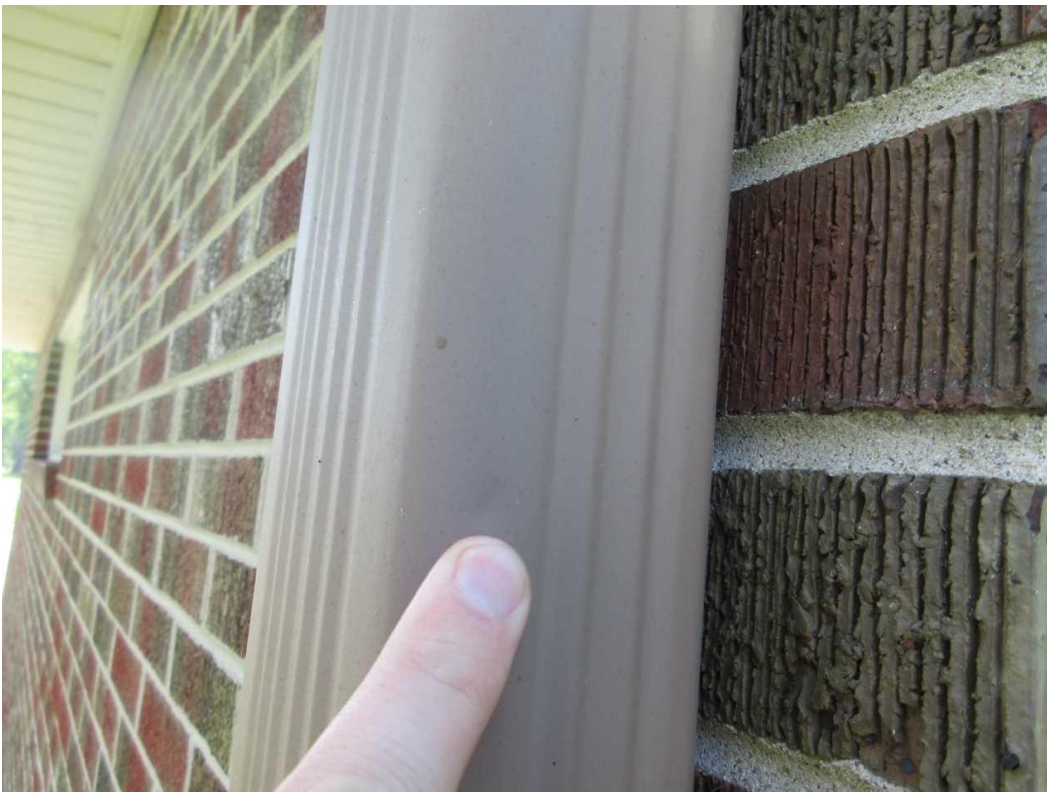
## 32-N Right Elevation

Hail damage to downspout.

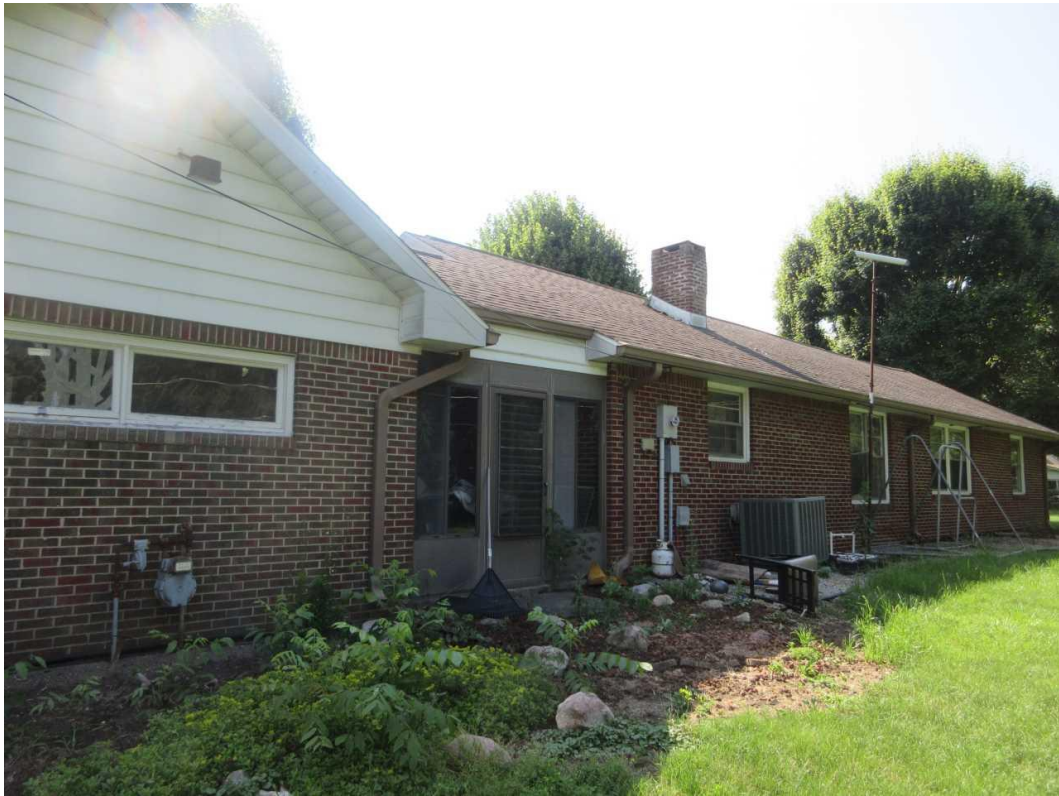
**33-W Rear Elevation**  
Date Taken: 6/27/2025  
Taken By: Michael Wallen  
Elevation overview

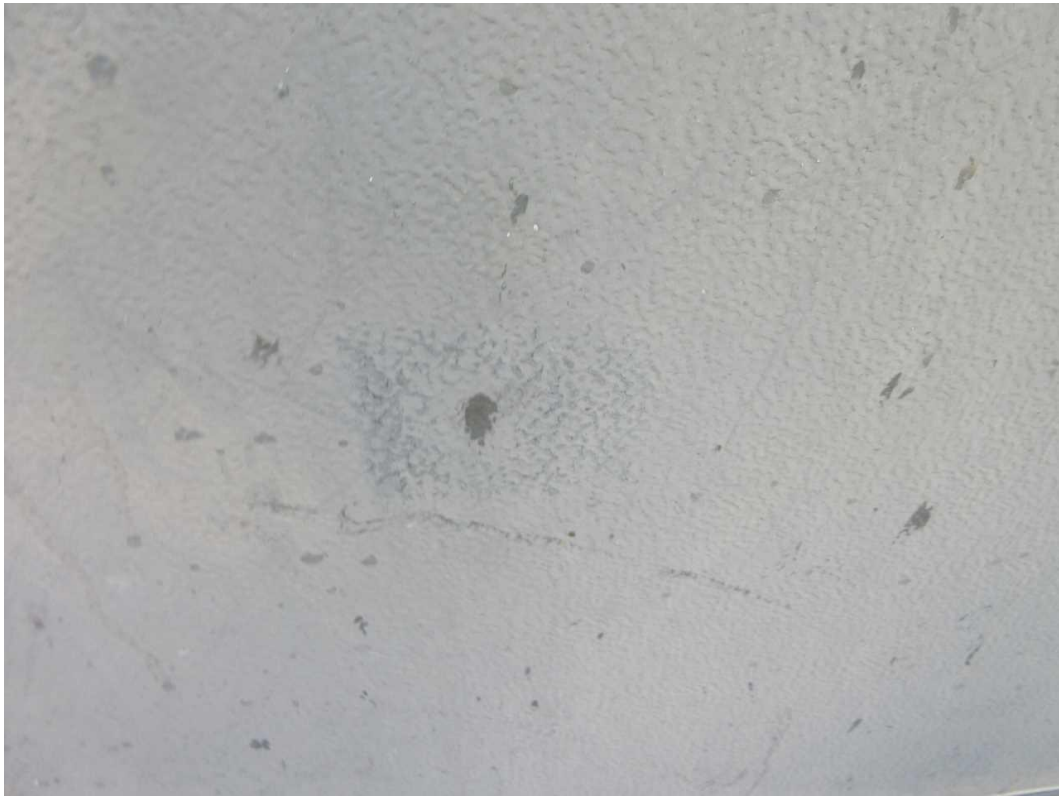
**35-W Rear Elevation**

Hail damage to patio enclosure.

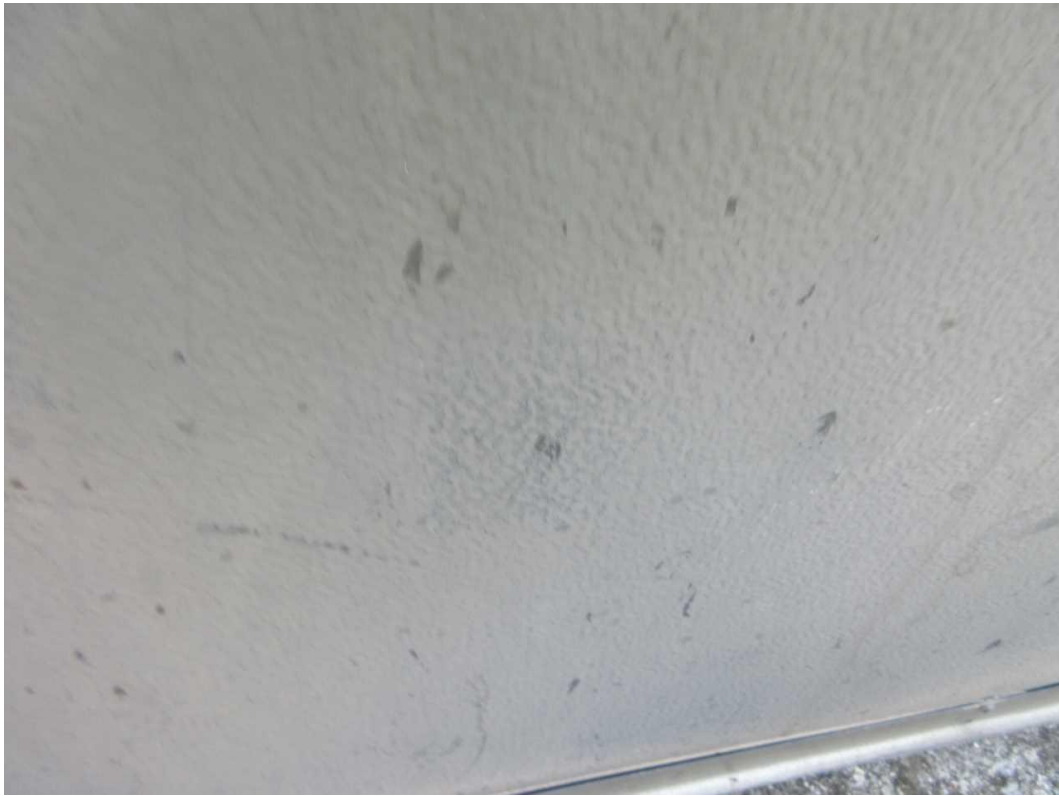
**36-W Rear Elevation**

Hail damage to patio enclosure.

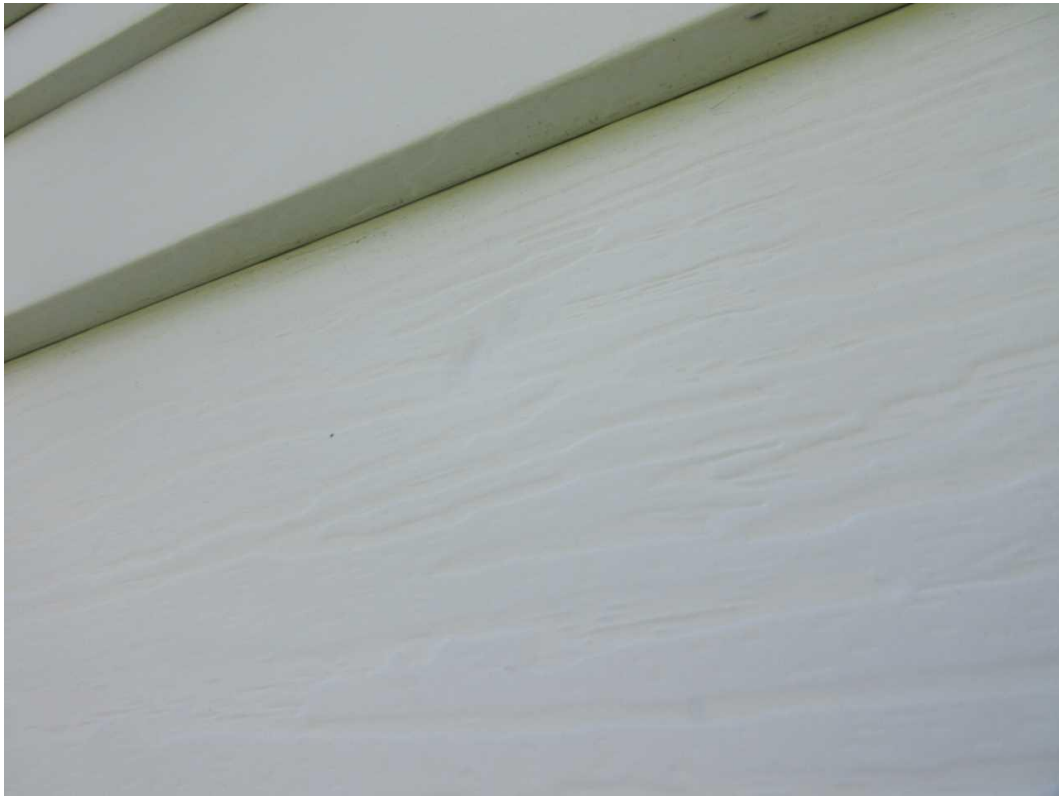
**39-W Rear Elevation**

Hail damage to aluminum siding.

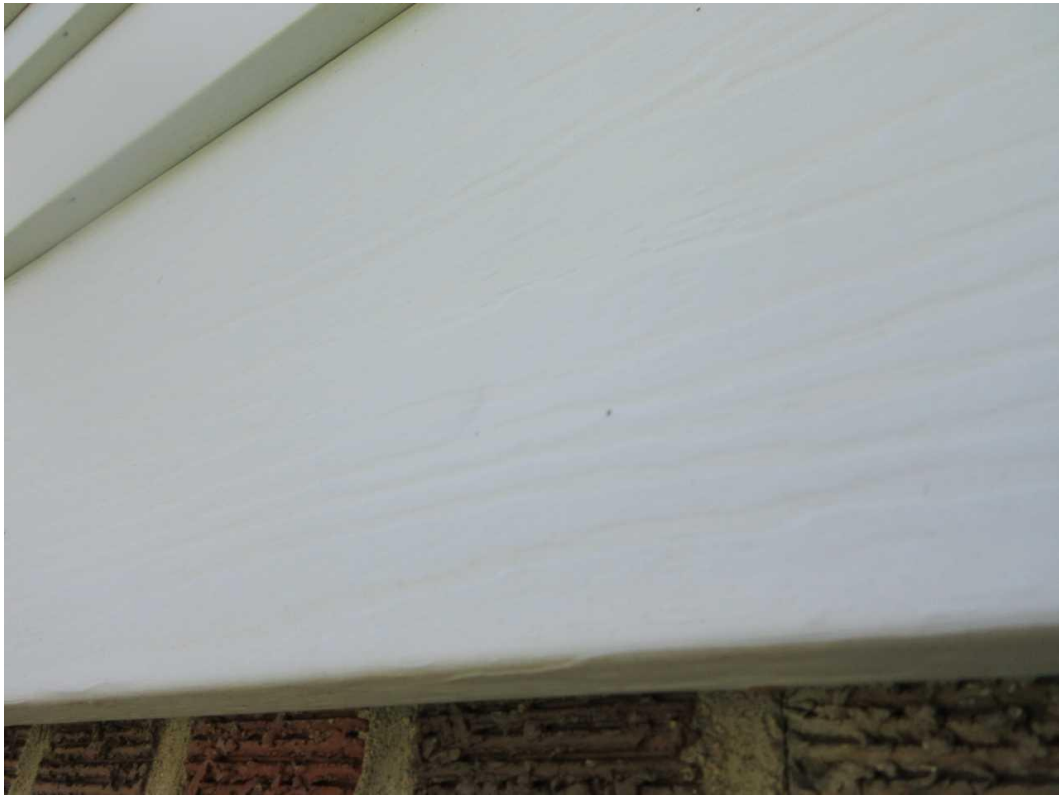
**40-W Rear Elevation**

Hail damage to aluminum siding.

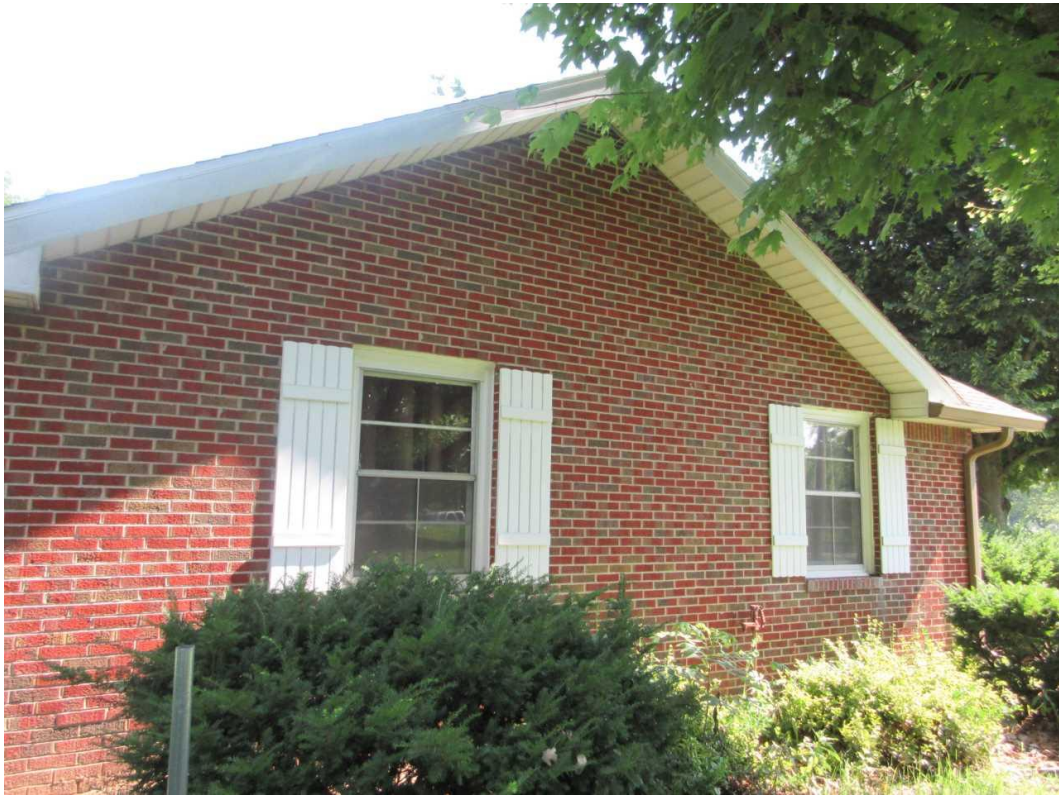
**48-S Left Elevation**  
Date Taken: 6/27/2025  
Taken By: Michael Wallen  
Elevation overview

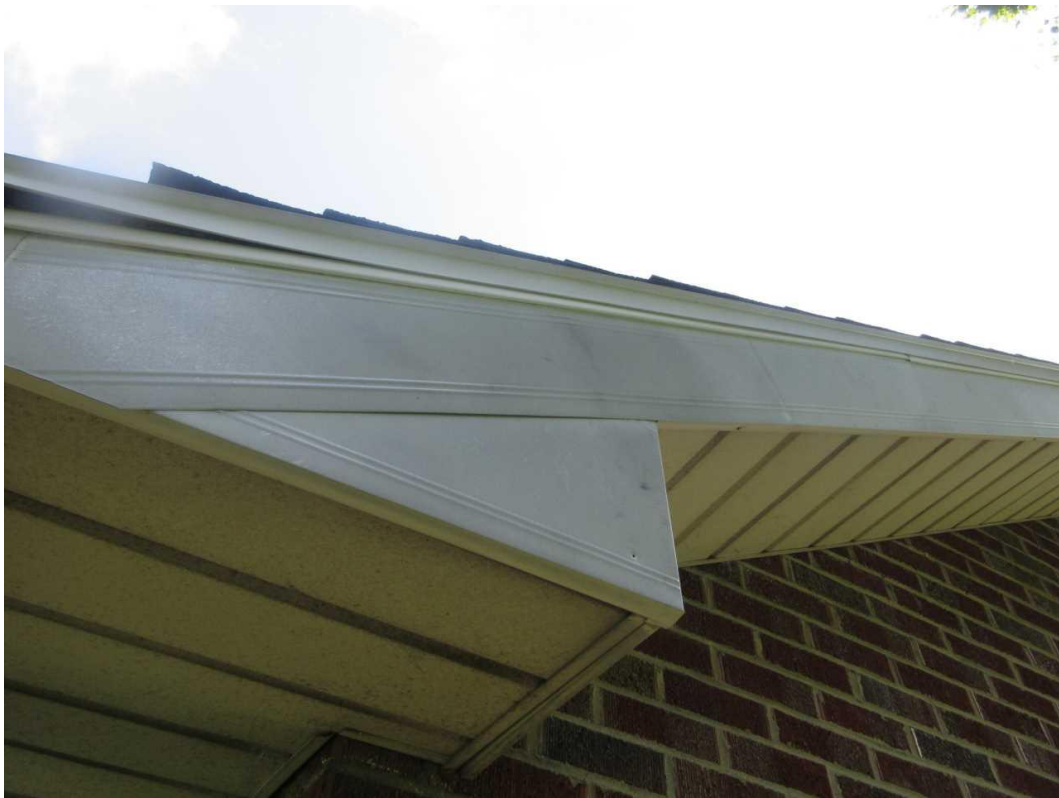
**49-S Left Elevation**

Hail damage to fascia.

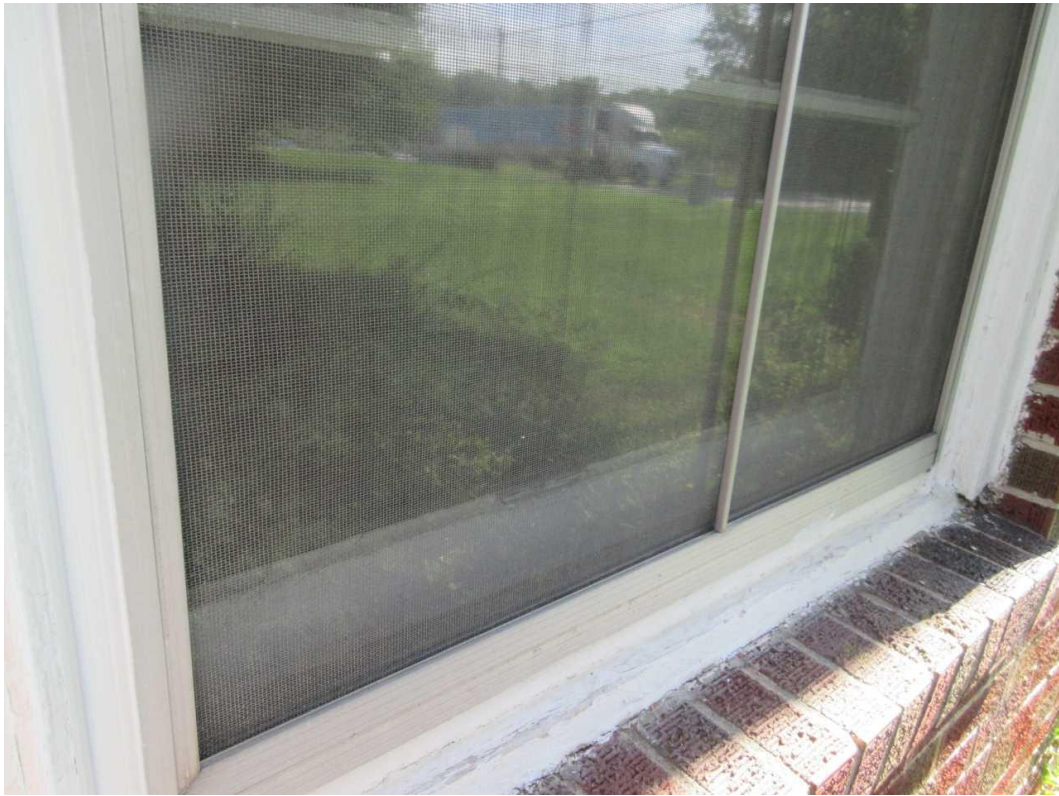
**50-S Left Elevation**

Hail damage to window screen.

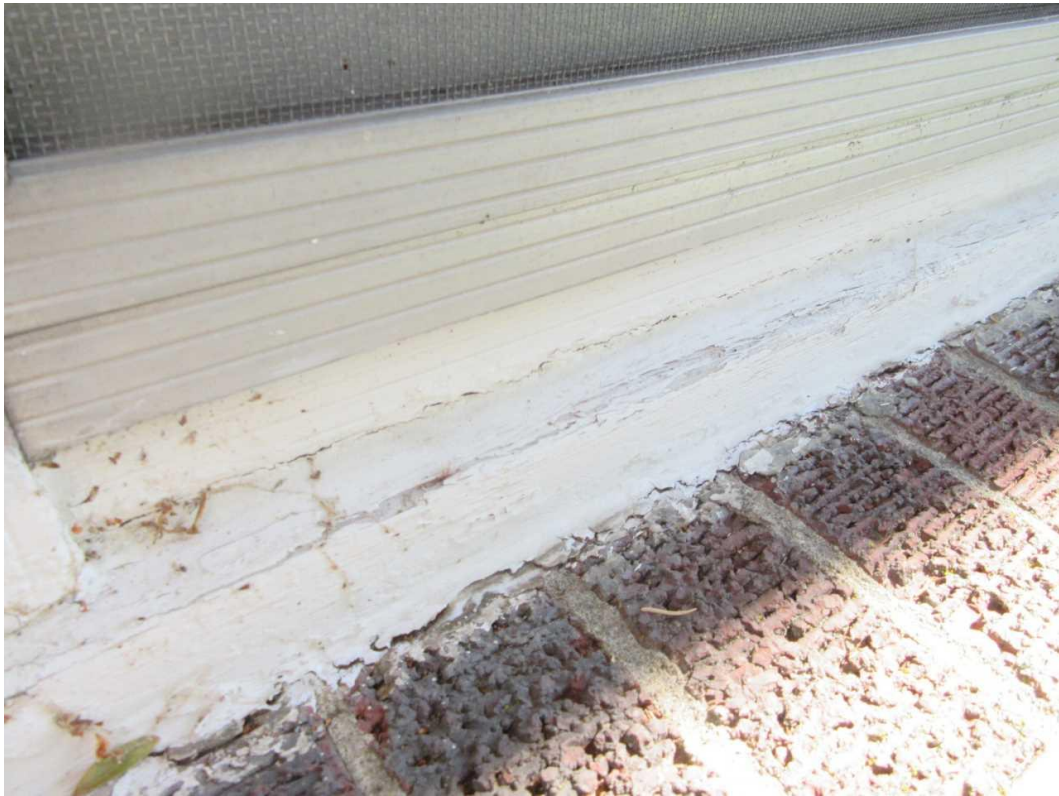
## 51-S Left Elevation

Hail damage to paint on the wood windows.

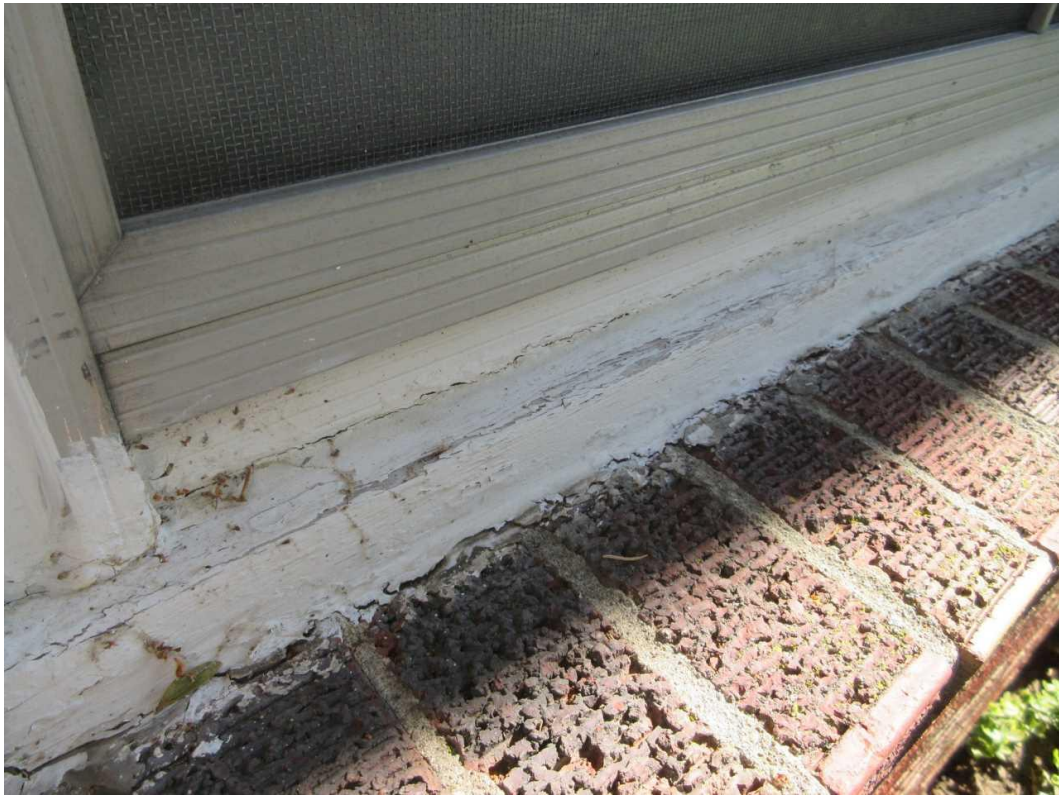
## 52-S Left Elevation

Hail damage to paint on the wood windows.

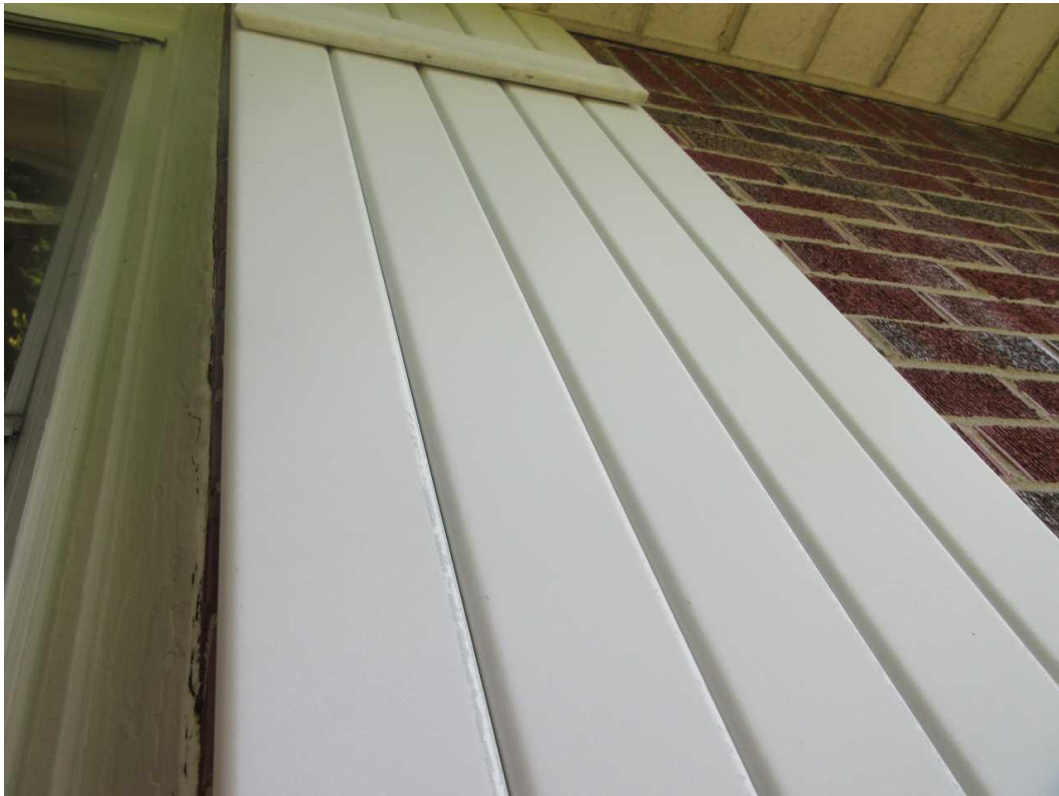
**53-S Left Elevation**

No storm damage to shutters from the claimed date of loss.
