File # R192712  
 Claim # 300- [REDACTED]-2025  
 Insured [REDACTED] Automotive Services

## LOSS REPORT

Cause of Loss: Hail

Damaged items include: Location 1 Building 1 Roof/Elevations, Location 3 Building 1 Roof/Elevations, Location 3 Building 2 Roof, Location 5 Building 1 Roof/Elevations, Location 6 Building 1 Roof/Elevations, Location 6 Building 2 Roof/Elevations

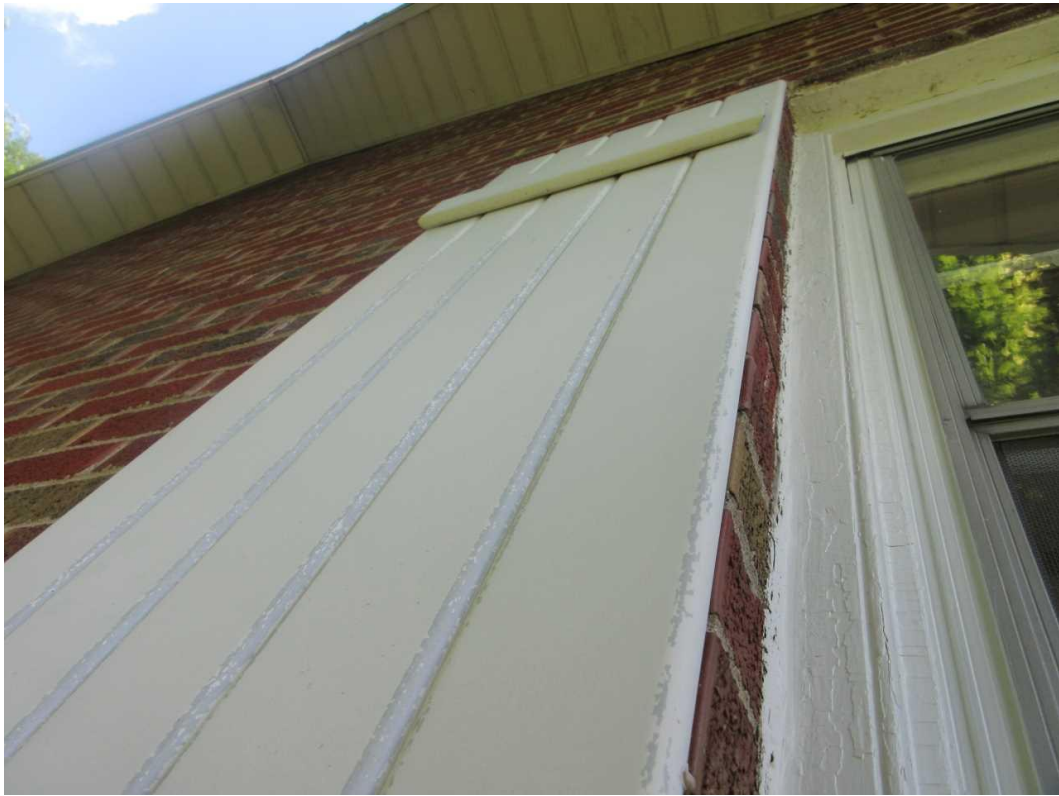
**54-S Left Elevation**

No storm damage to shutters from the claimed date of loss.

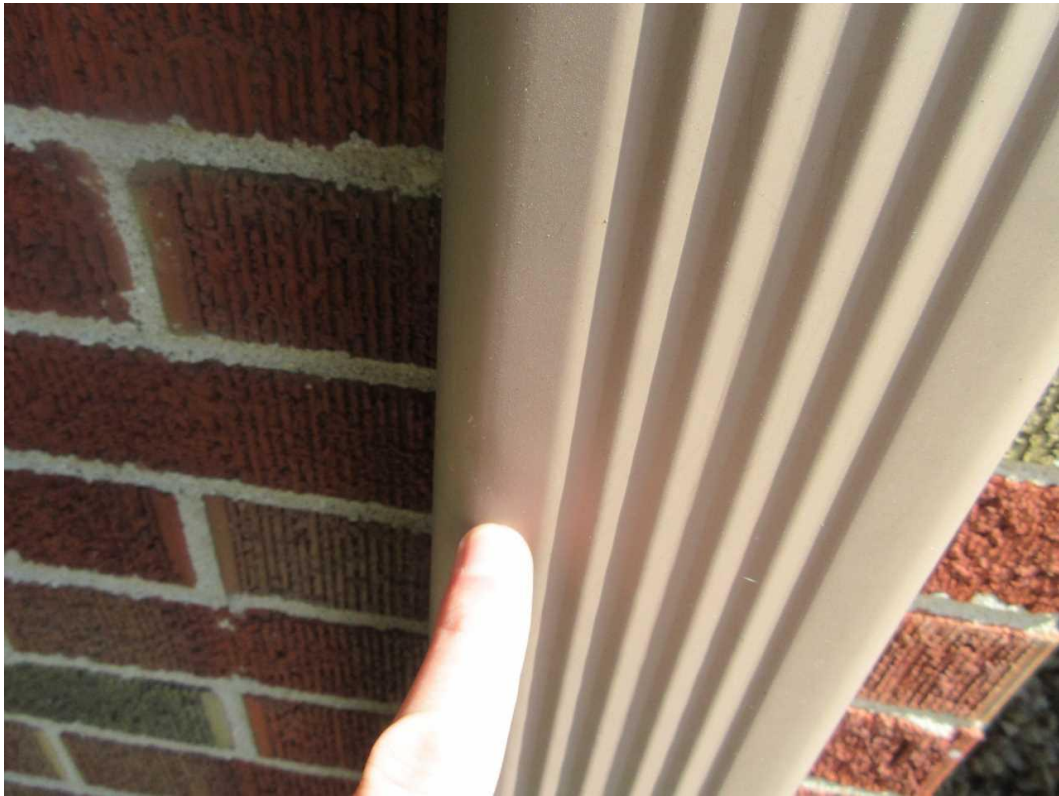
**55-S Left Elevation**

Hail damage to downspout.

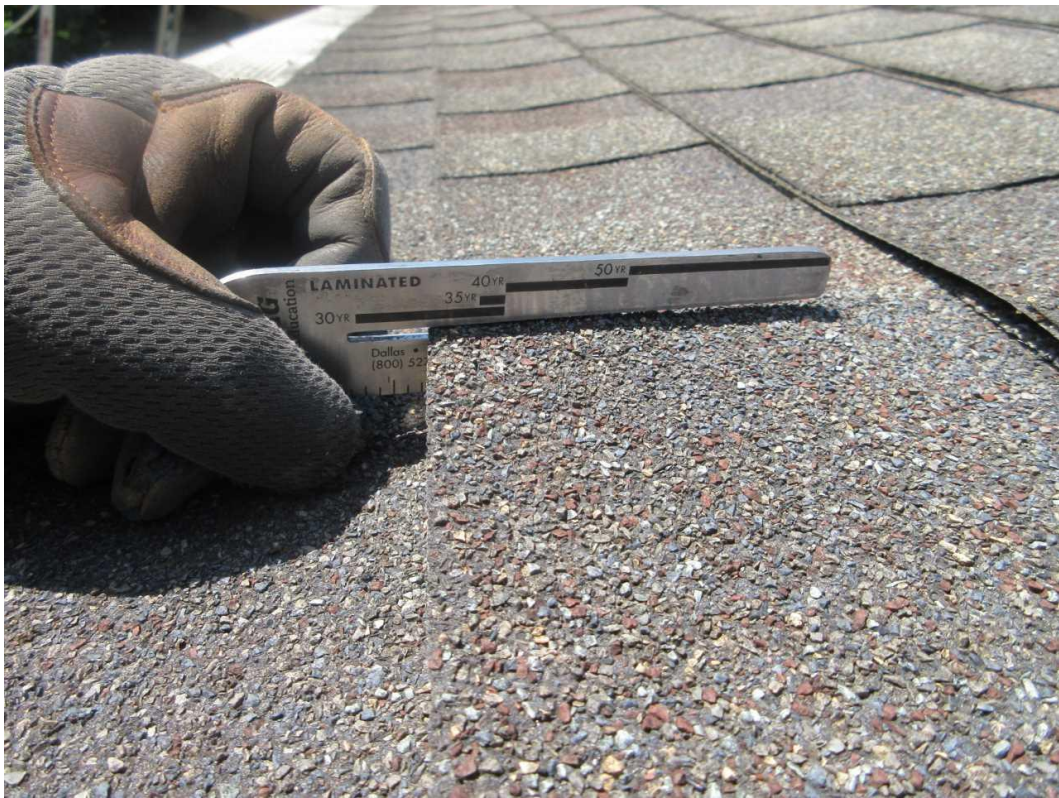
**57-Shingles**  
Date Taken: 6/27/2025  
Taken By: Michael Wallen  
30-year laminate

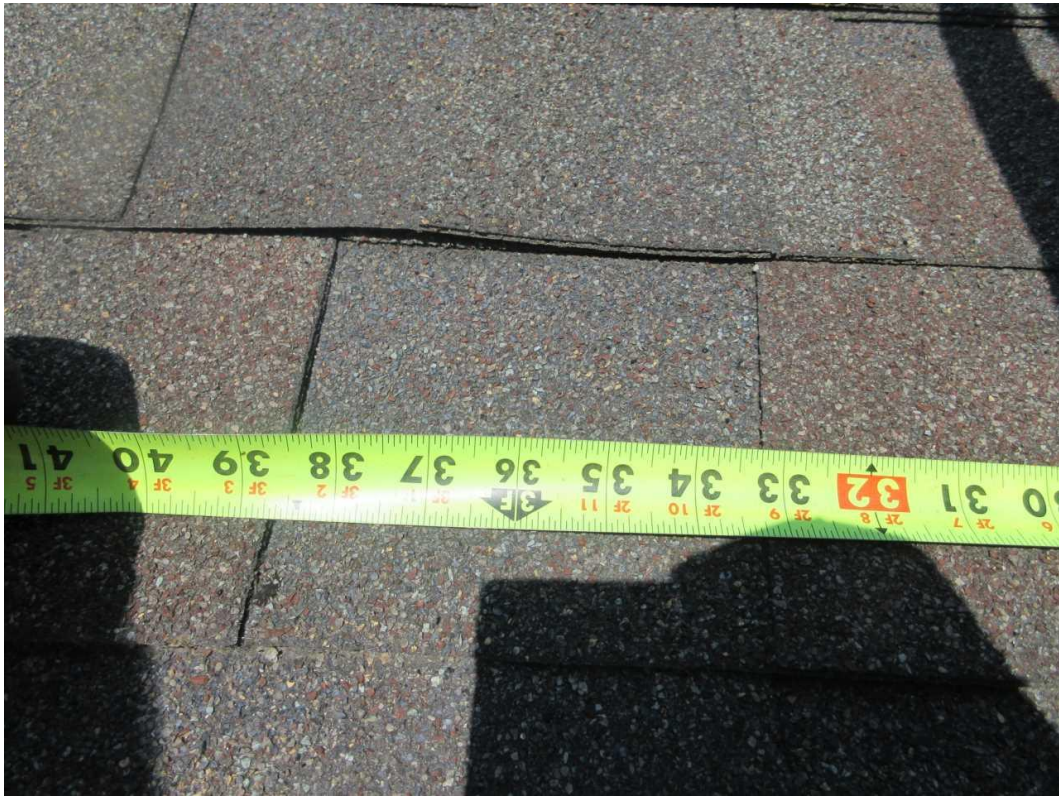
**59-Shingle Width**

Date Taken: 6/27/2025  
Taken By: Michael Wallen  
38.75"

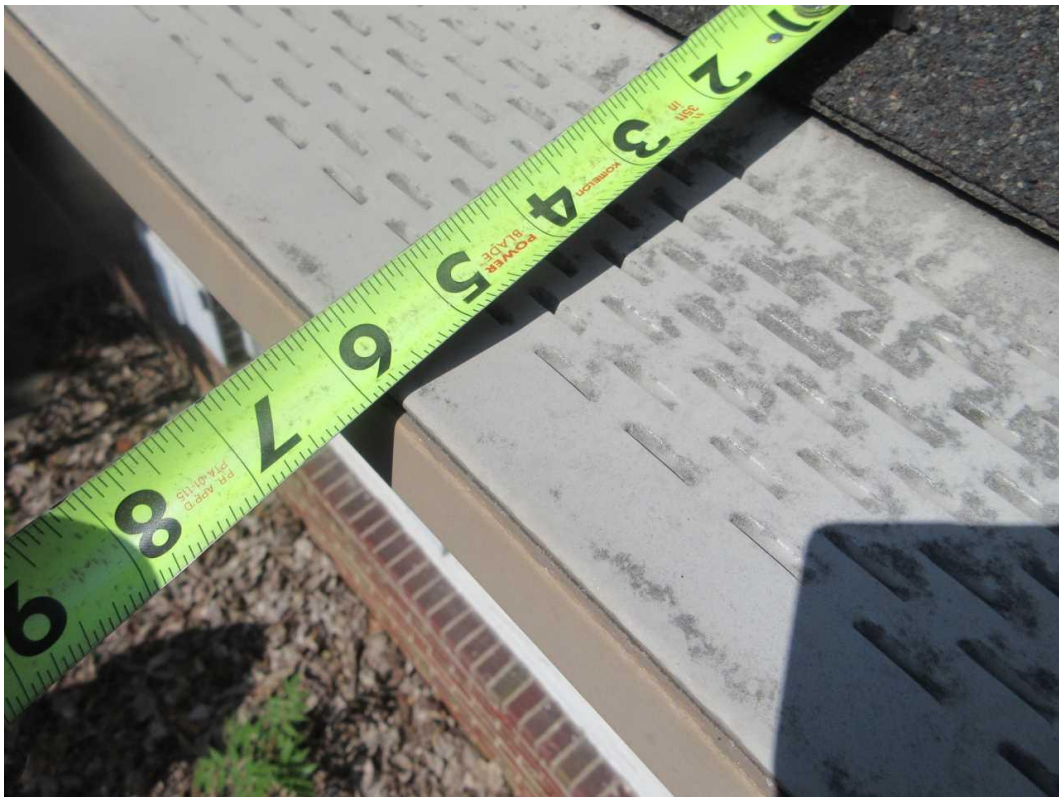
**60-Gutters**

Date Taken: 6/27/2025  
Taken By: Michael Wallen  
6" Aluminum with high grade gutter  
guards.

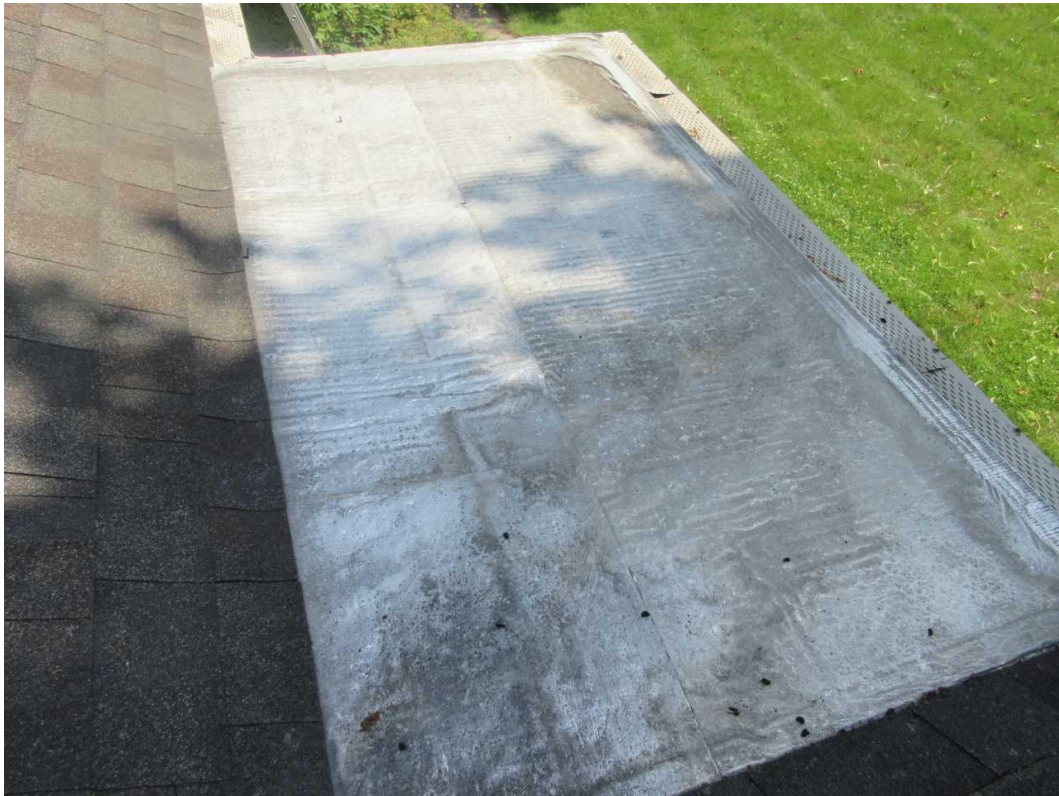
## 63-Built-up Roof

Overview, no damage to built-up roof or coating from the claimed date of loss.

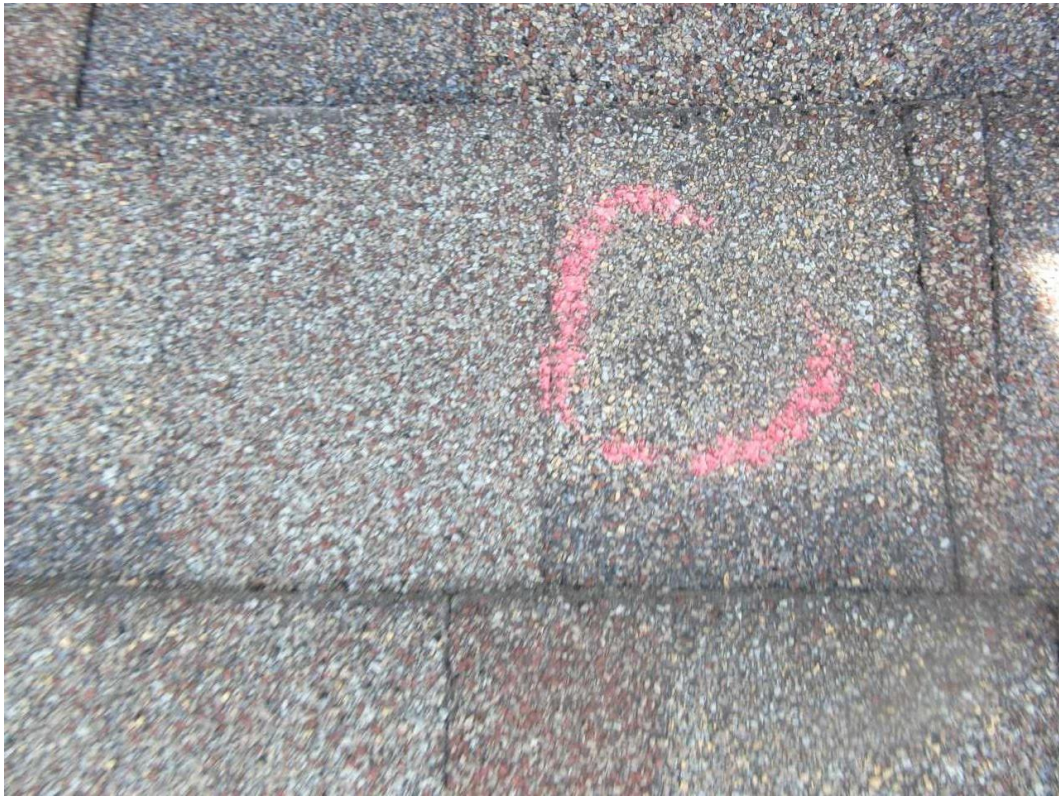
**65-E Front Slope**

Close up of hail damage inside the test square.

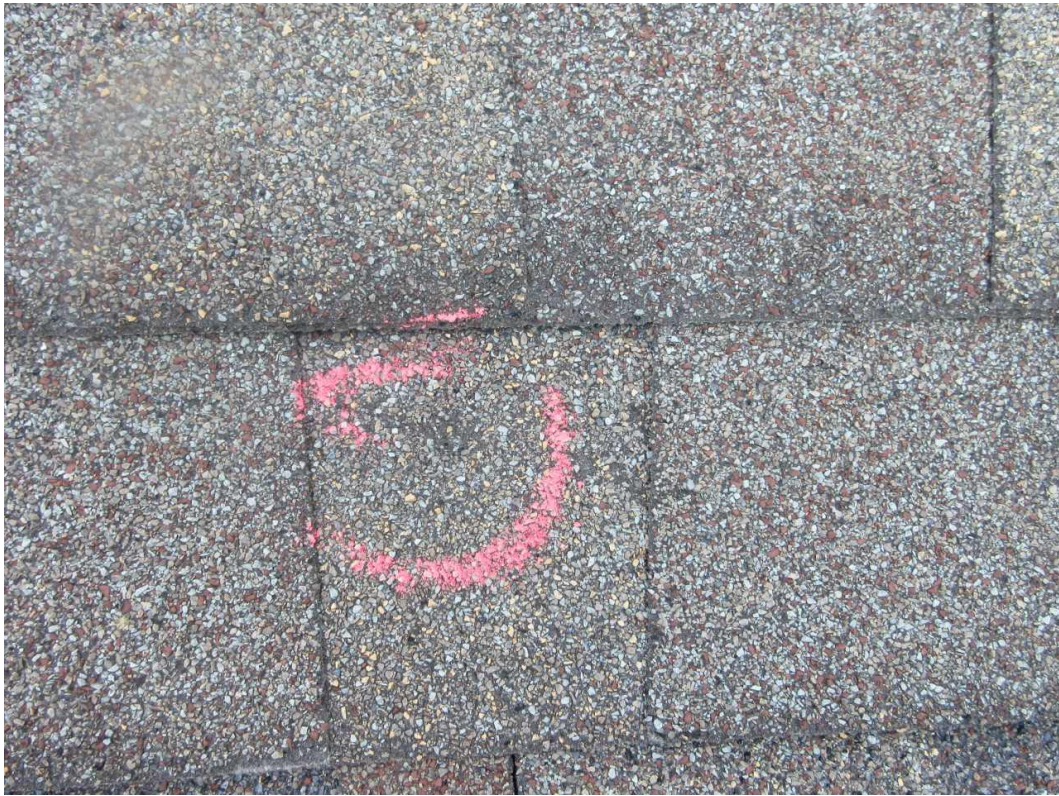
**66-E Front Slope**

Close up of hail damage inside the test square.

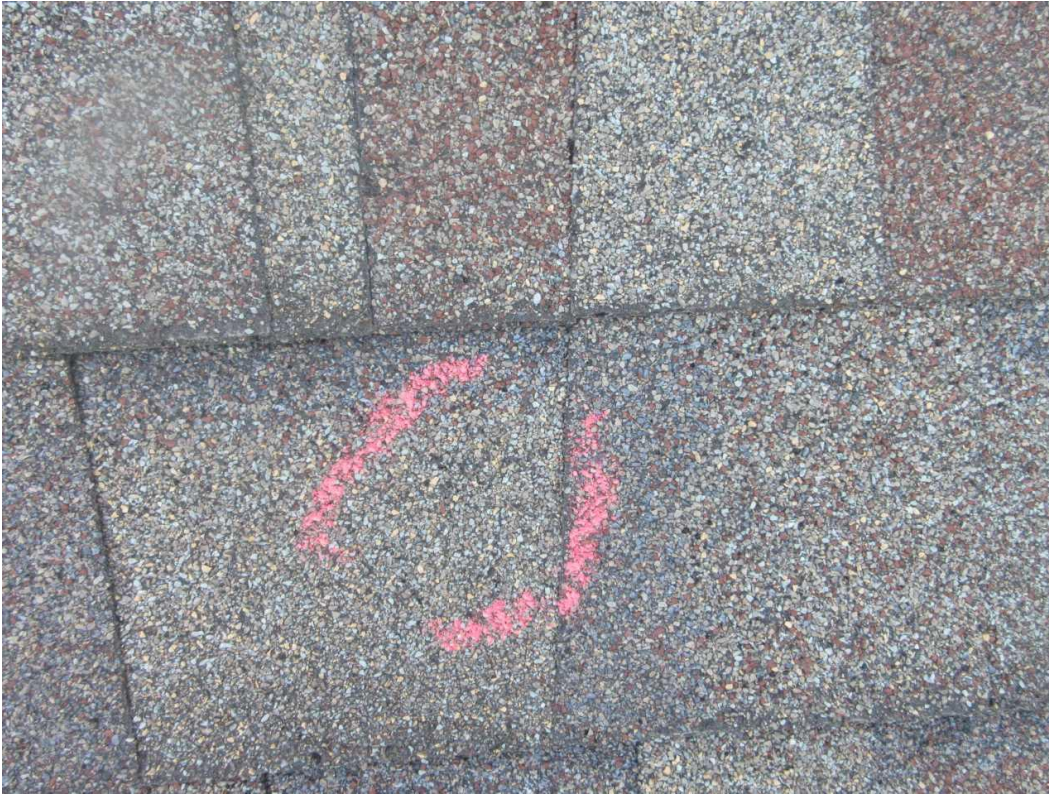
## 67-E Front Slope

Close up of hail damage inside the test square.

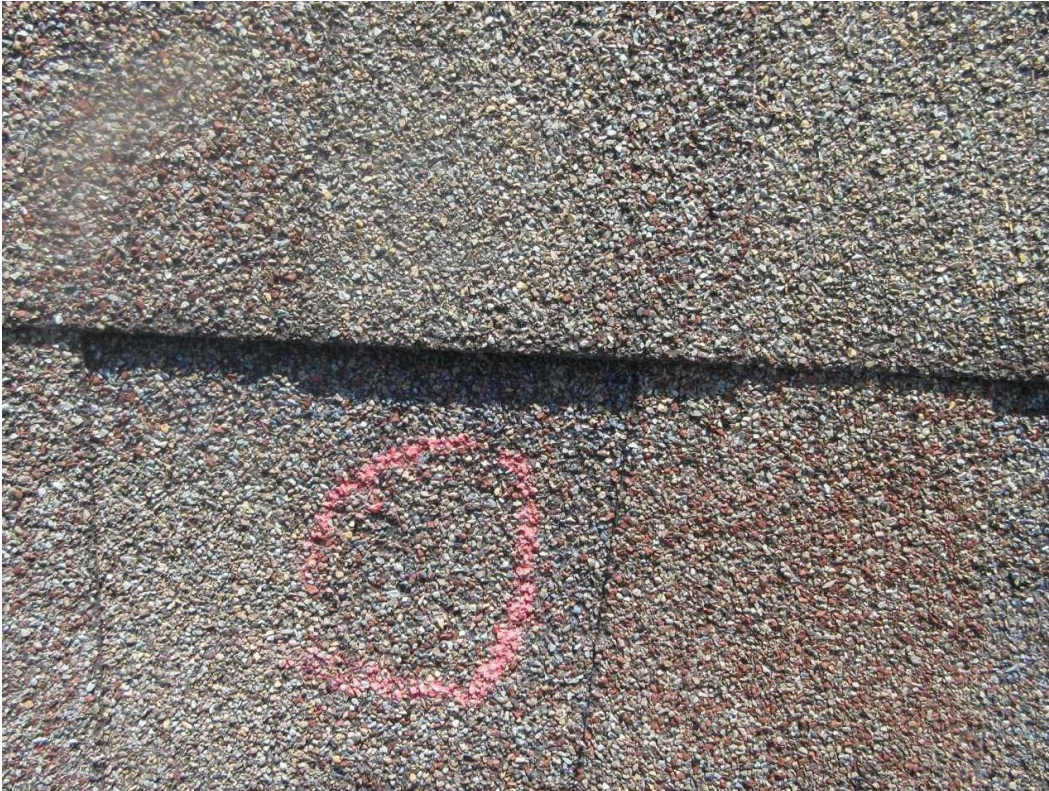
## 69-W Back Slope

Close up of hail damage inside the test square.

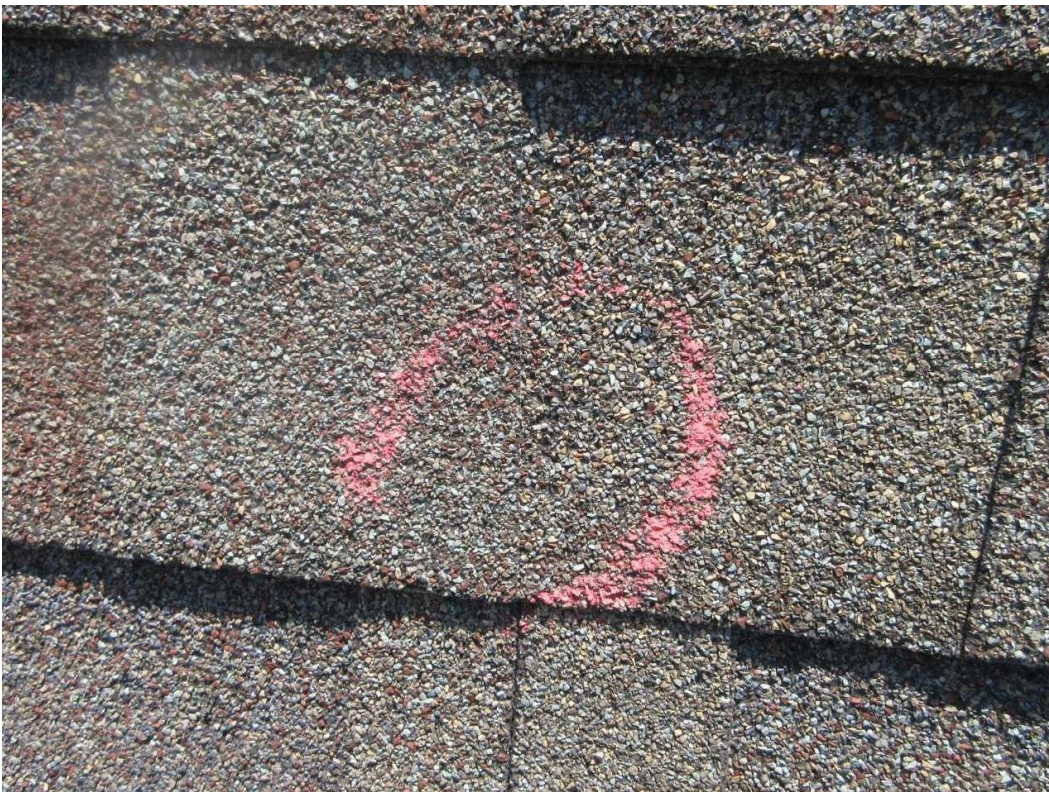
## 70-W Back Slope

Close up of hail damage inside the test square.

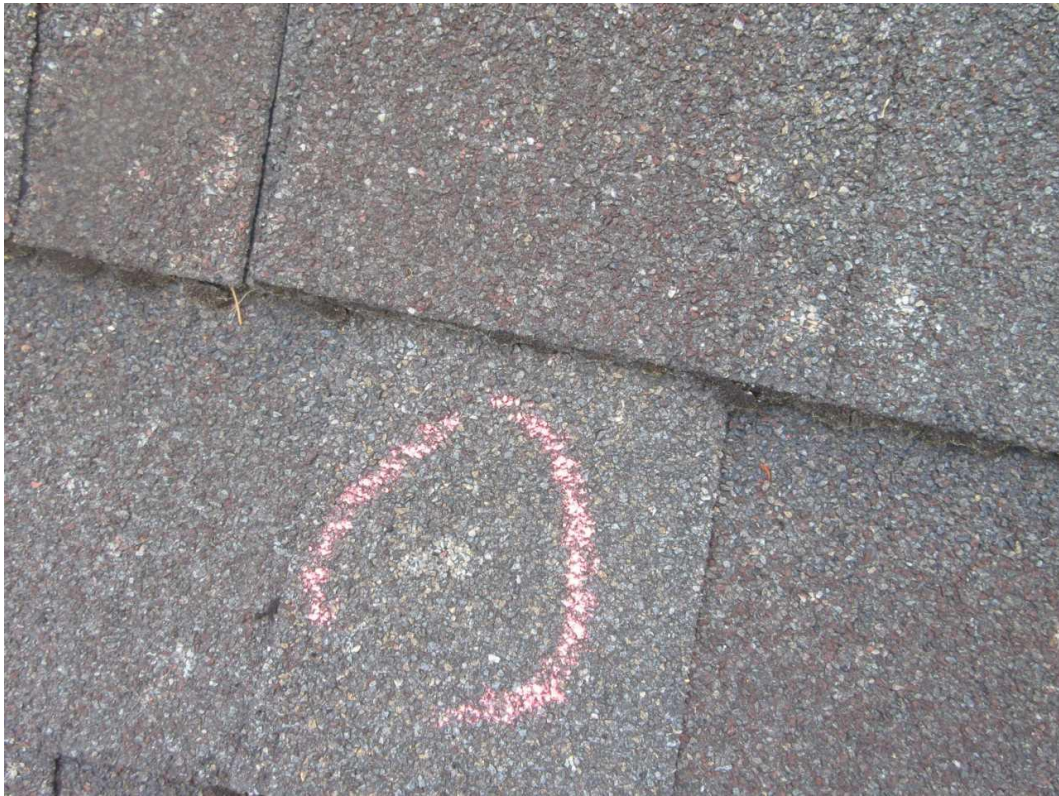
## 73-N Right Slope

Close up of hail damage inside the test square.

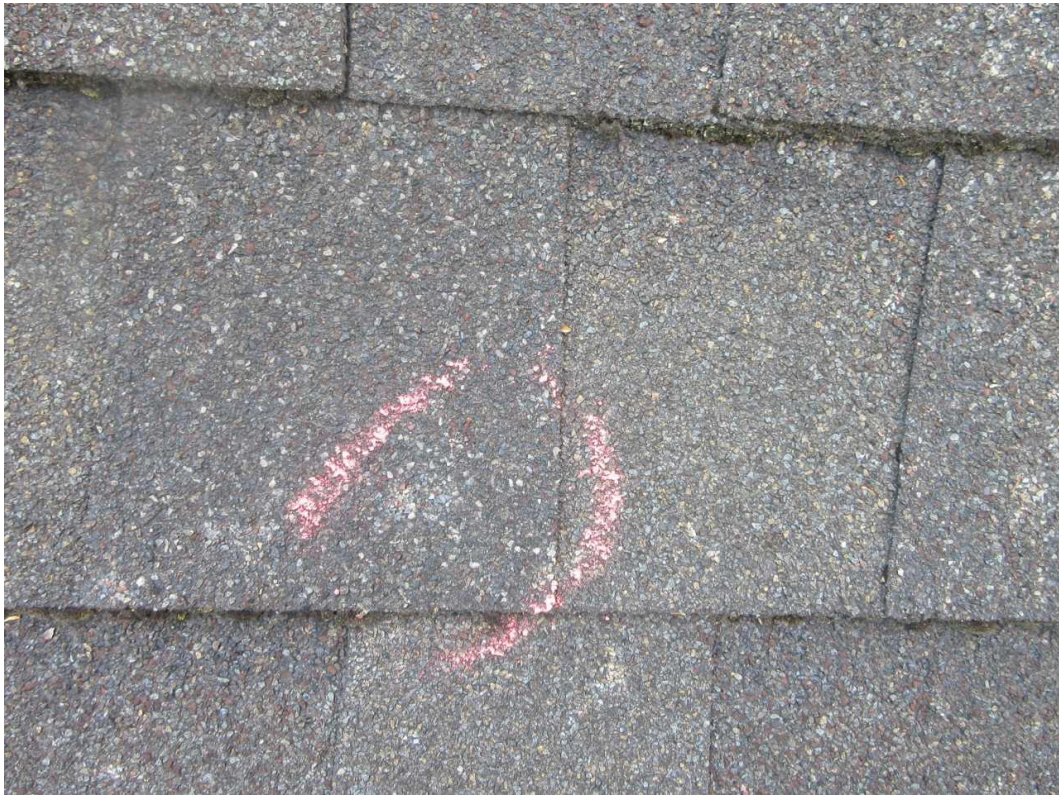
## 74-N Right Slope

Close up of hail damage inside the test square.

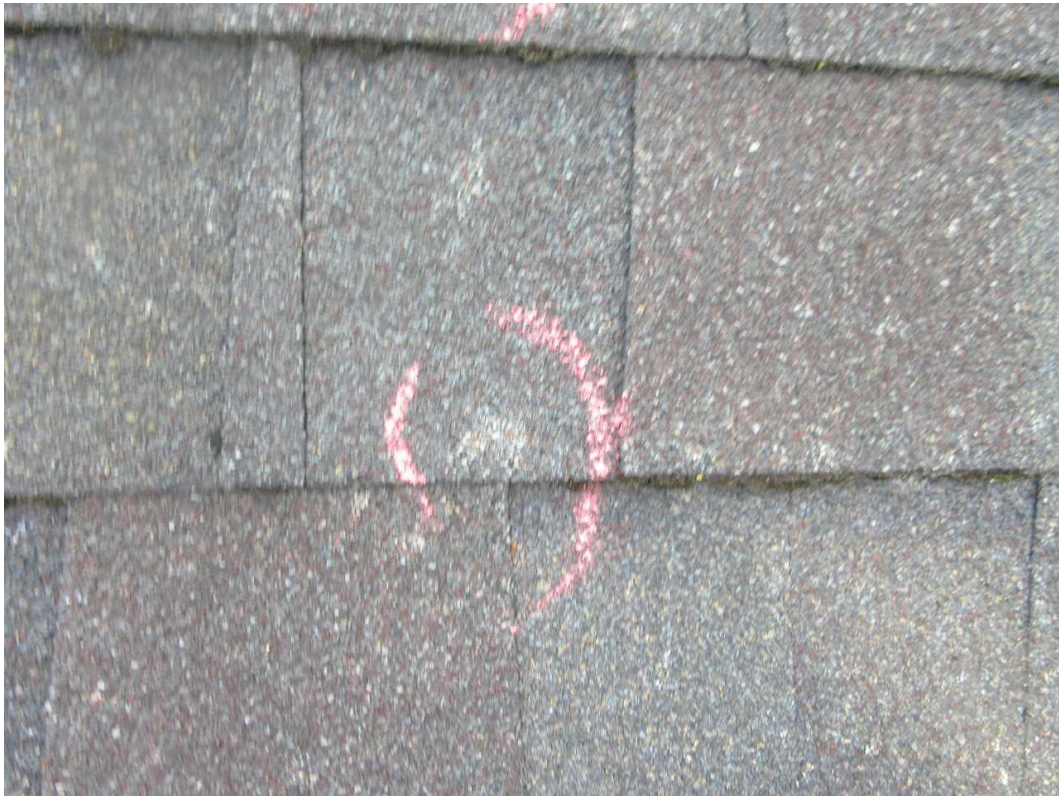
## 75-N Right Slope

Close up of hail damage inside the test square.

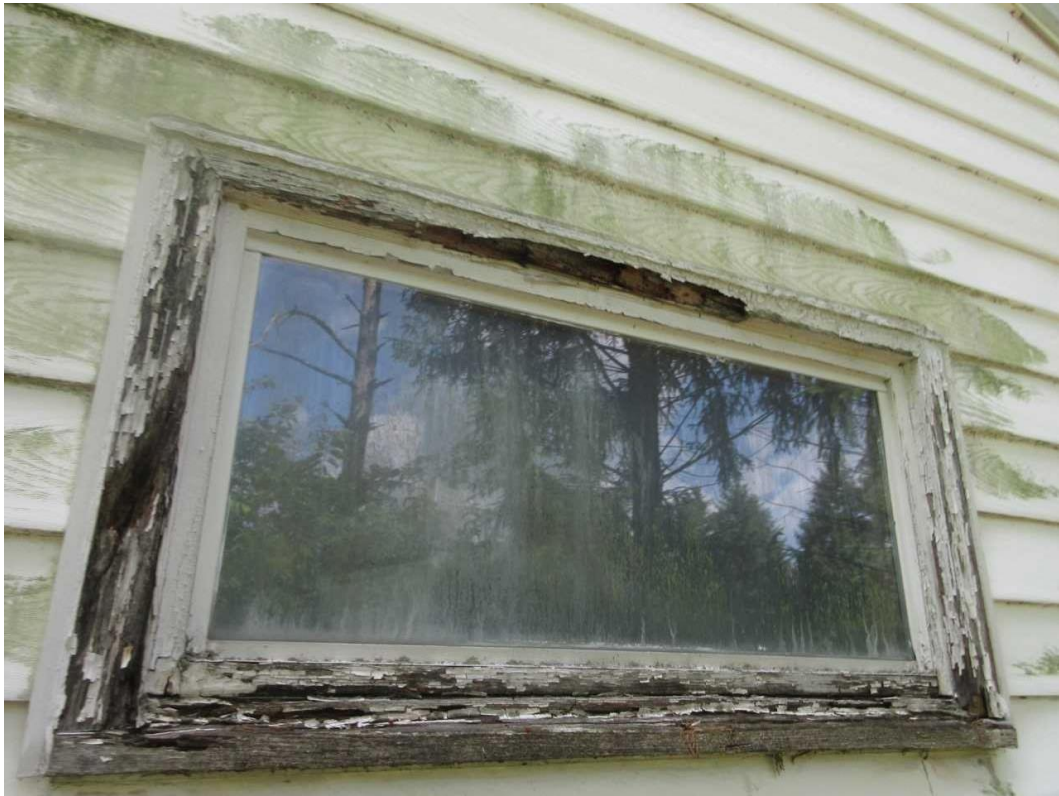
**85-W Rear Elevation**

Pre-existing condition of window, not storm related.

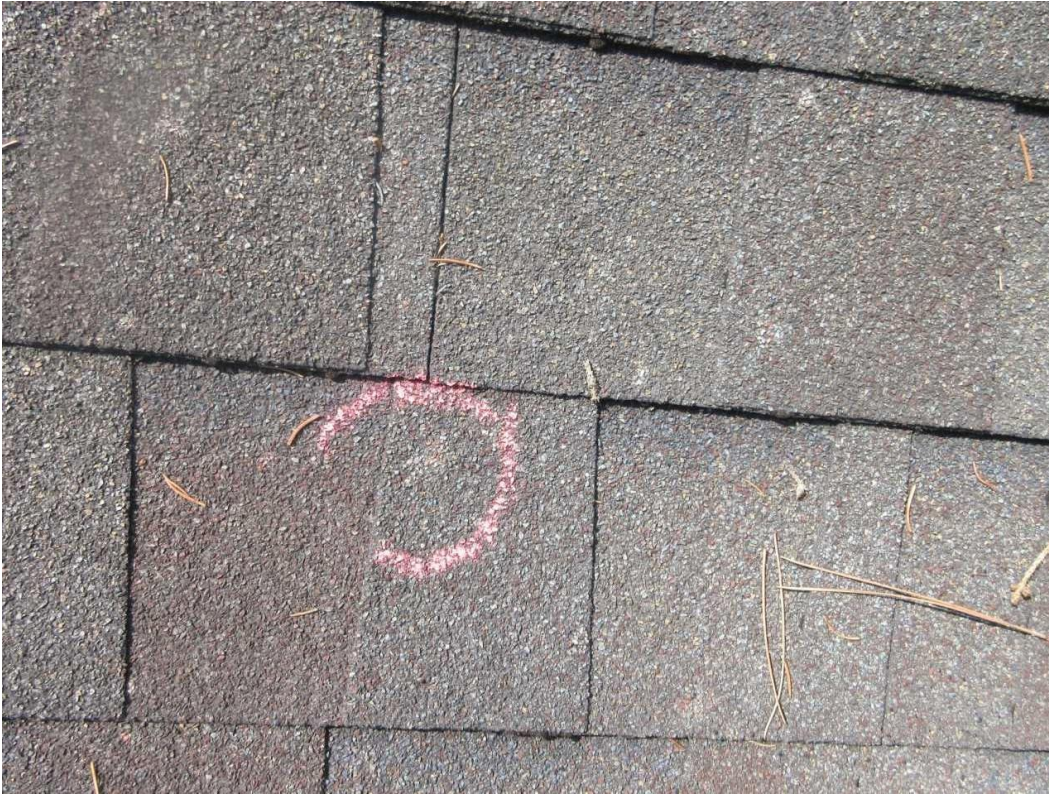
## 91-N Right Slope

Close up of hail damage inside the test square.

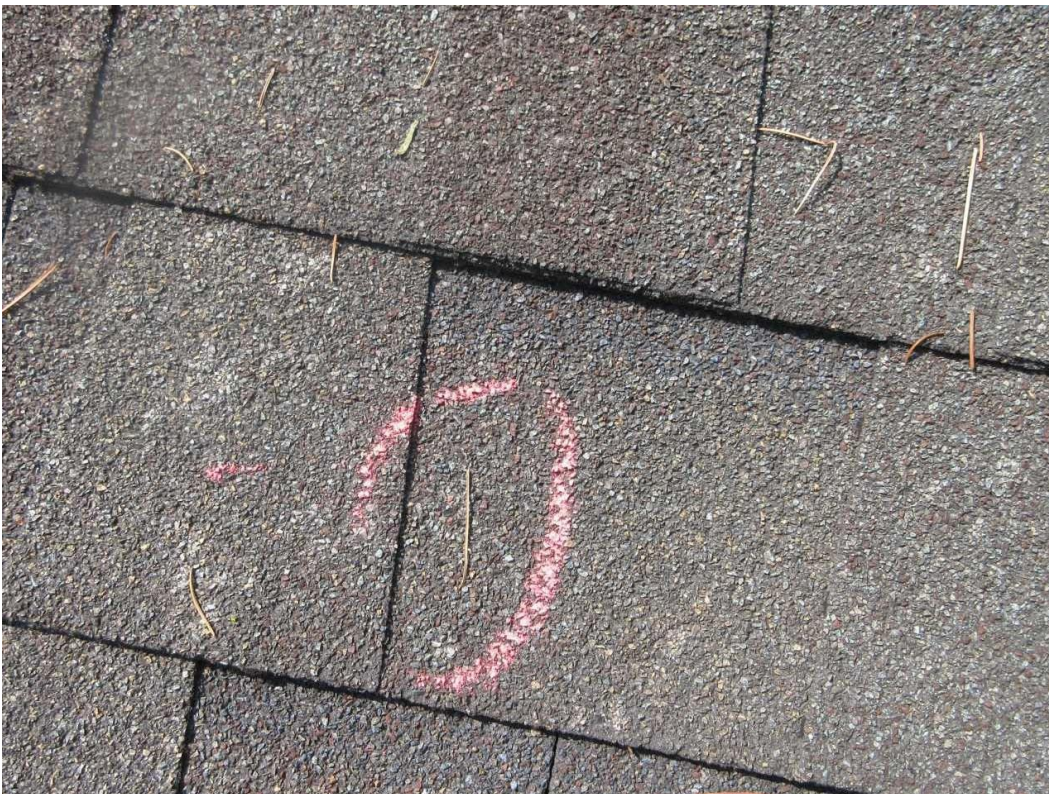
## 92-N Right Slope

Close up of hail damage inside the test square.

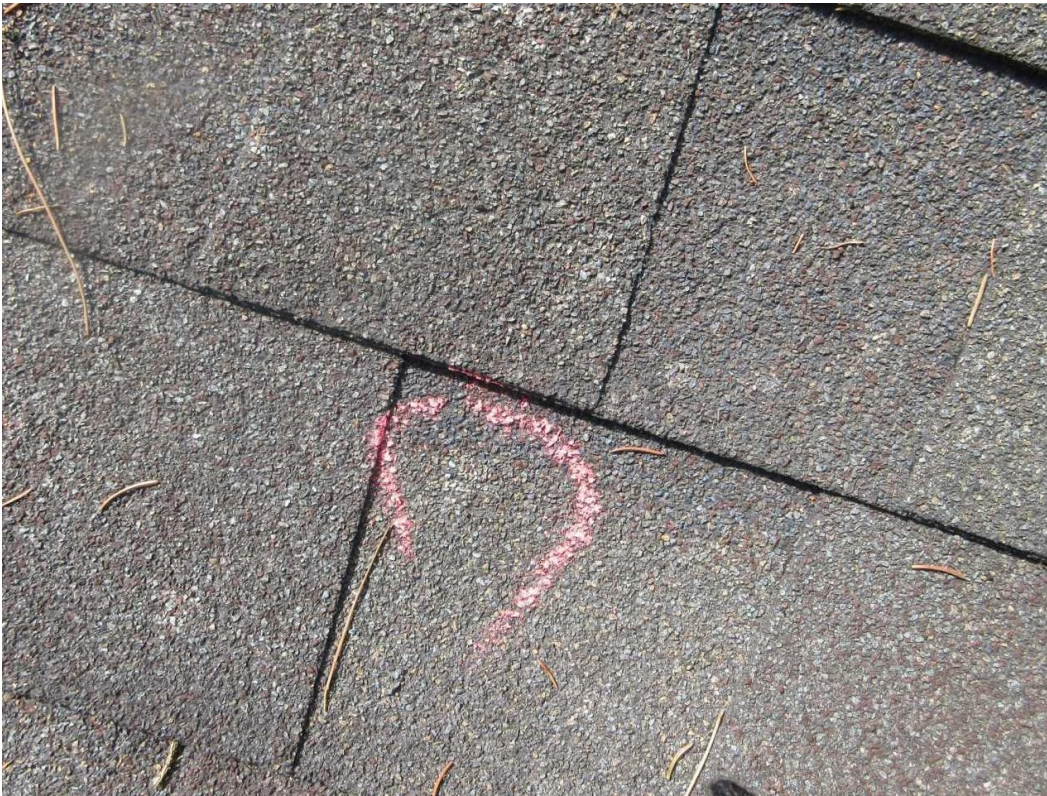
## 93-N Right Slope

Close up of hail damage inside the test square.

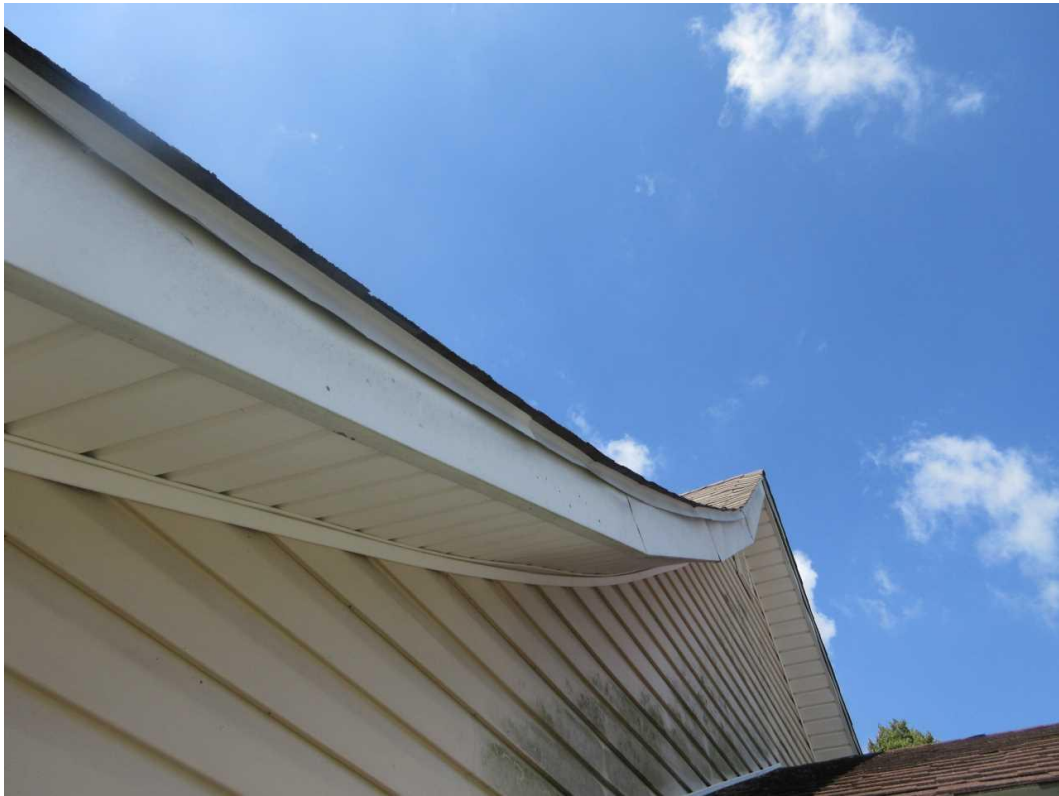
**99-N Front Elevation**

No storm damage to fascia from the claimed date of loss.

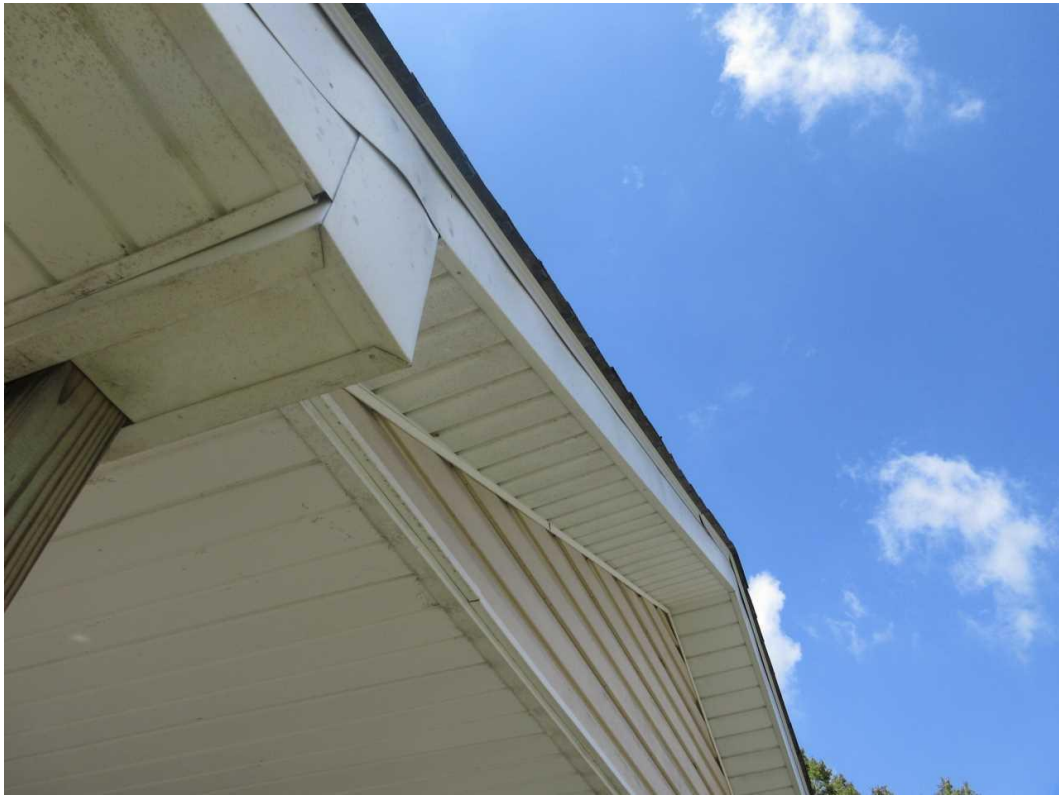
**100-N Front Elevation**

No storm damage to fascia from the claimed date of loss.

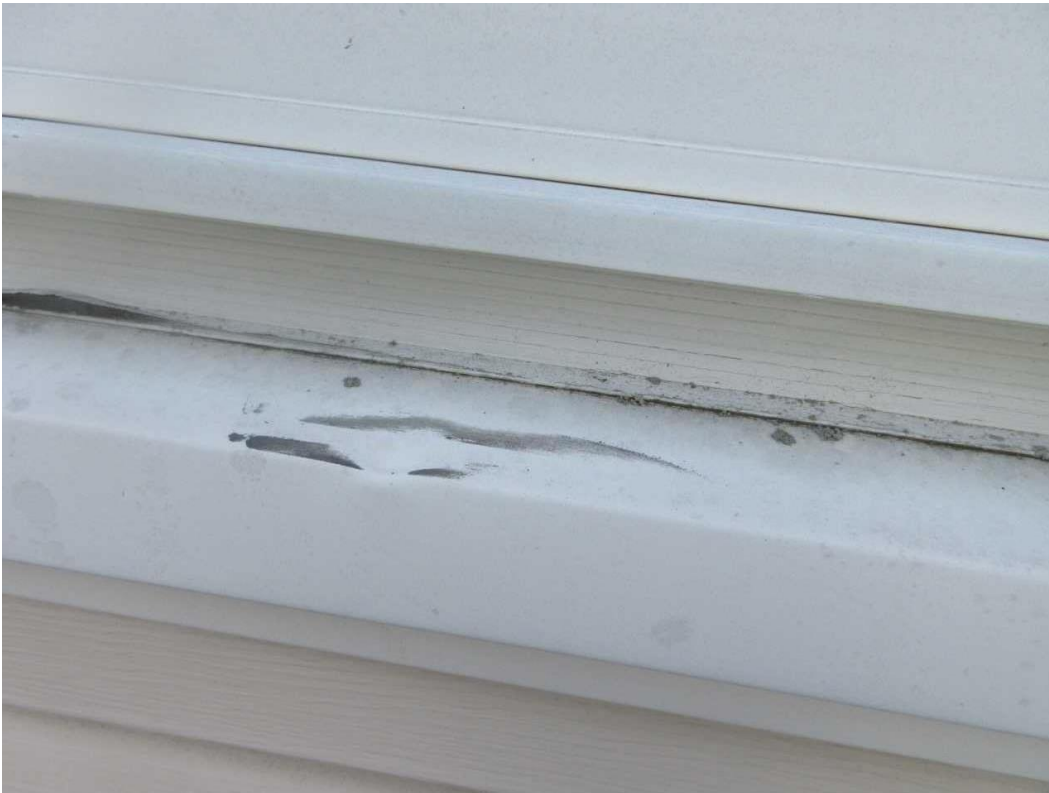
## 105-W Right Elevation

Hail damage to window wrap.

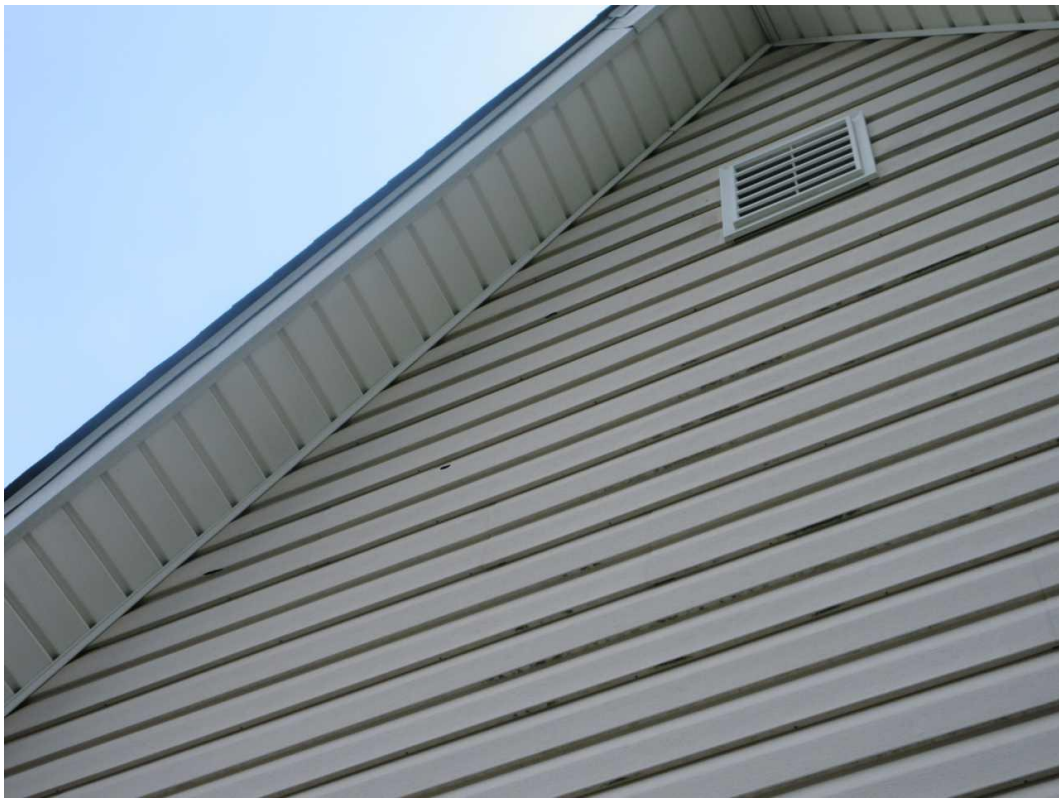
**113-W Right Elevation**

Hail damage to vinyl siding.

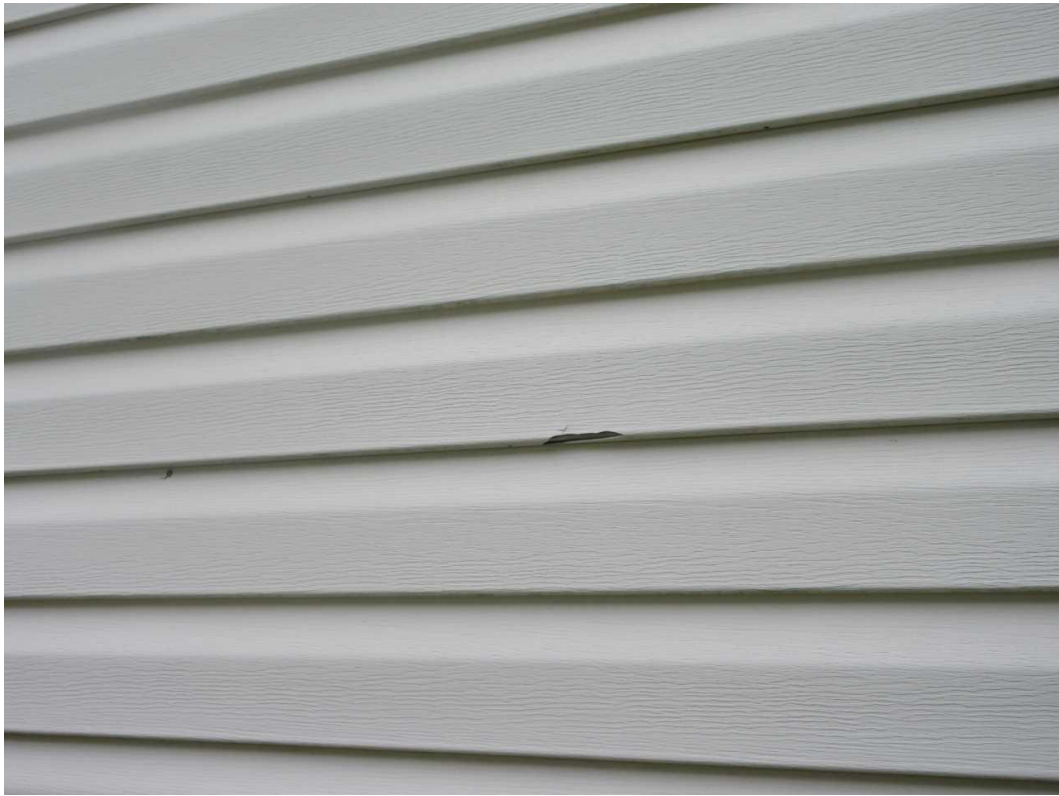
**114-W Right Elevation**

Hail damage to vinyl siding.

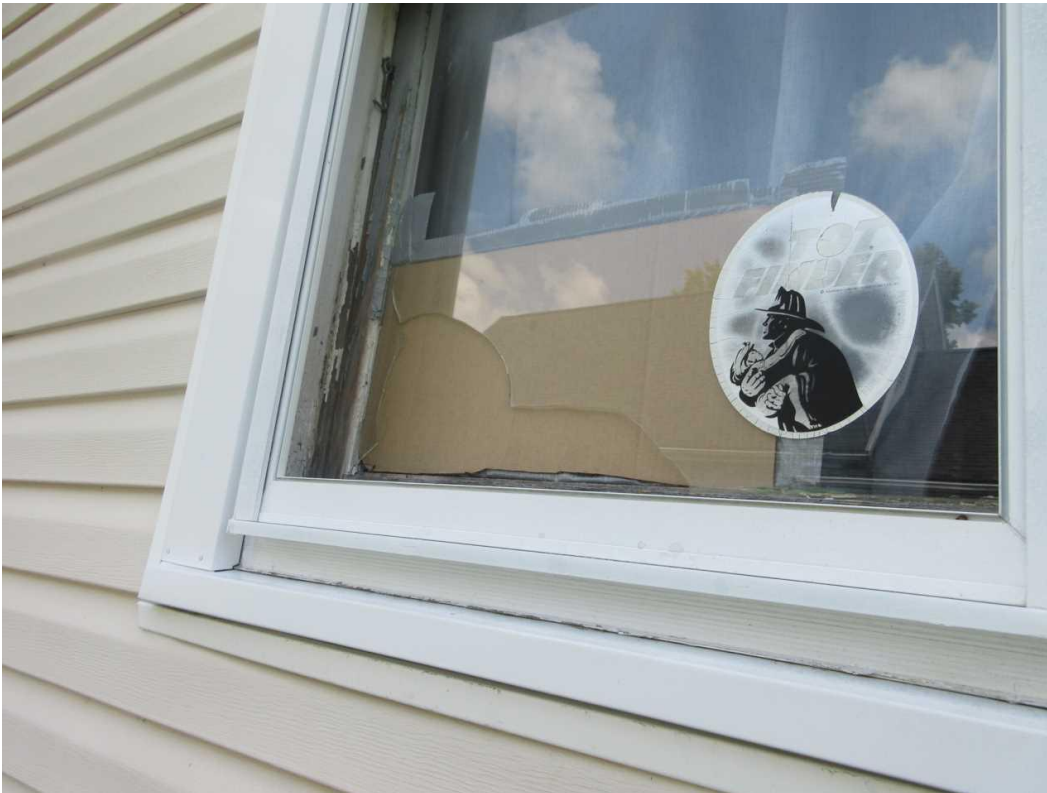
## 115-W Right Elevation

Hail damage to window screen.

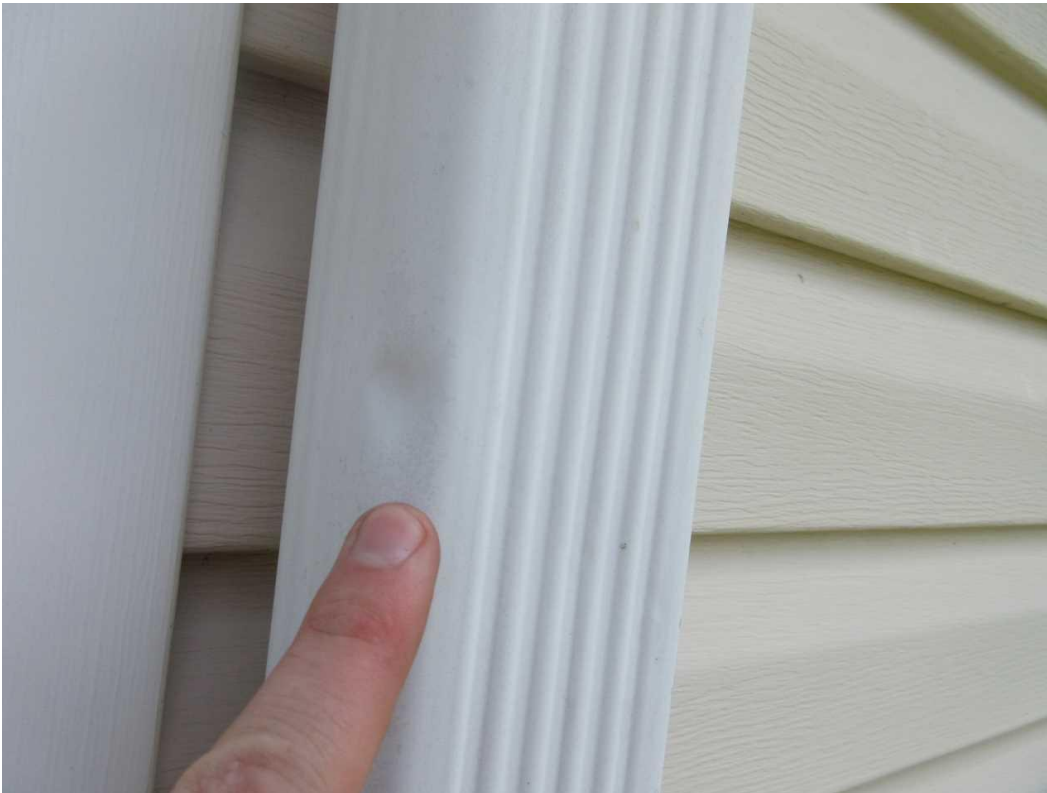
## 117-S Rear Elevation

Hail damage to downspout.

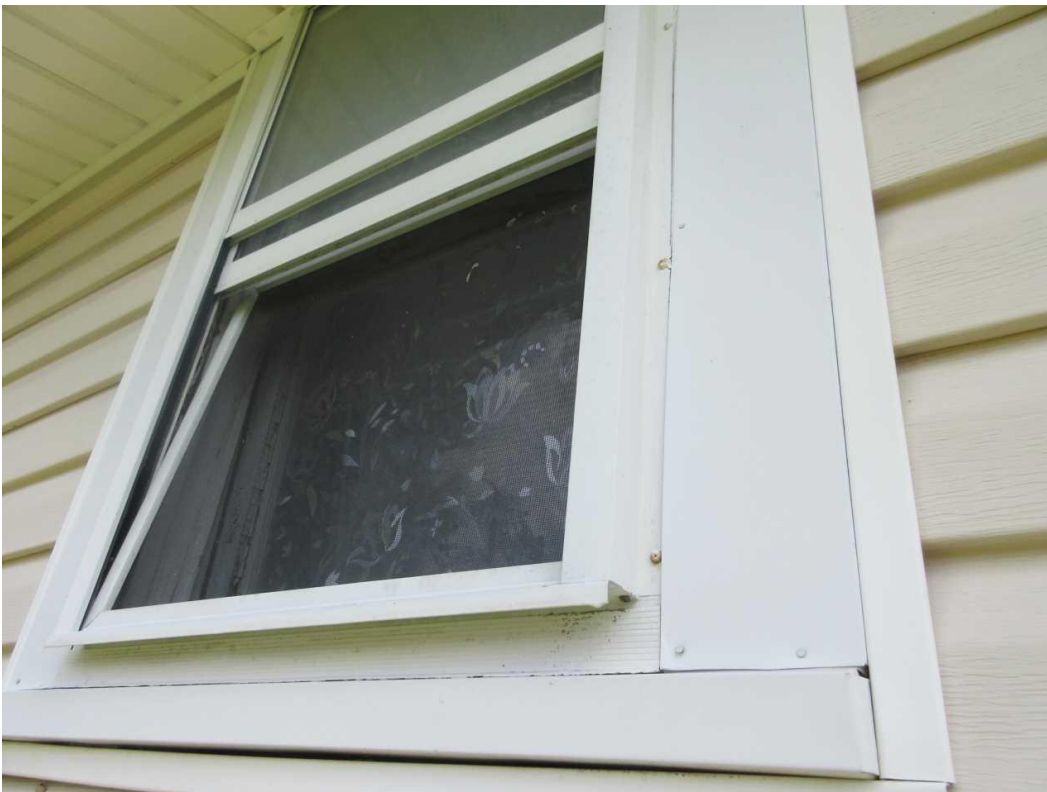
## 118-S Rear Elevation

Pre-existing condition of window screen.

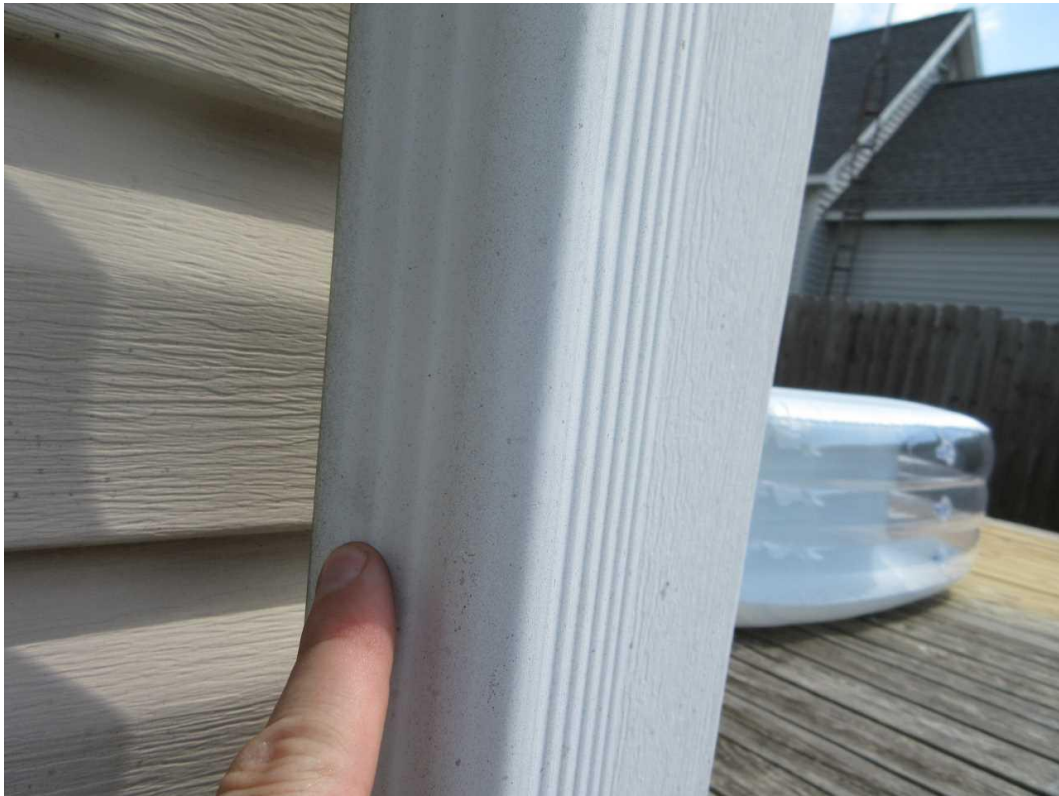
## 121-S Rear Elevation

Hail damage to downspout.
