File # R192712  
 Claim # 300- [REDACTED]-2025  
 Insured [REDACTED] Automotive Services

## LOSS REPORT

Cause of Loss: Hail

Damaged items include: Location 1 Building 1 Roof/Elevations, Location 3 Building 1 Roof/Elevations, Location 3 Building 2 Roof, Location 5 Building 1 Roof/Elevations, Location 6 Building 1 Roof/Elevations, Location 6 Building 2 Roof/Elevations

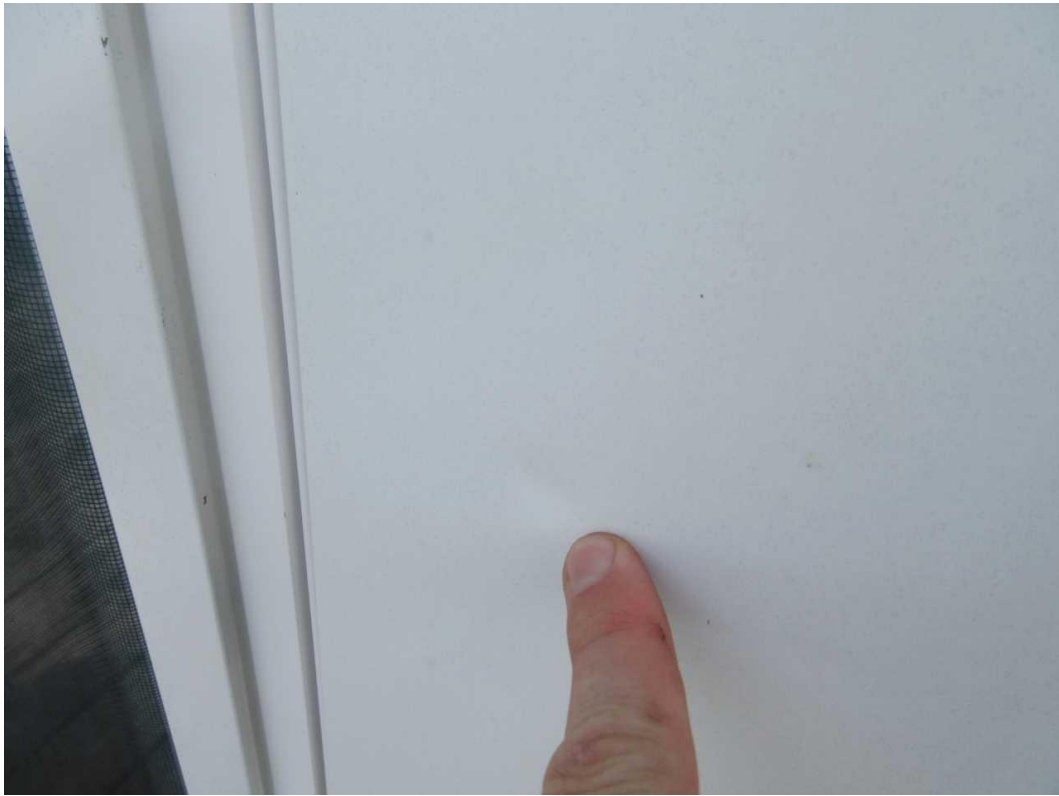
## 122-S Rear Elevation

Hail damage to sliding door wrap.

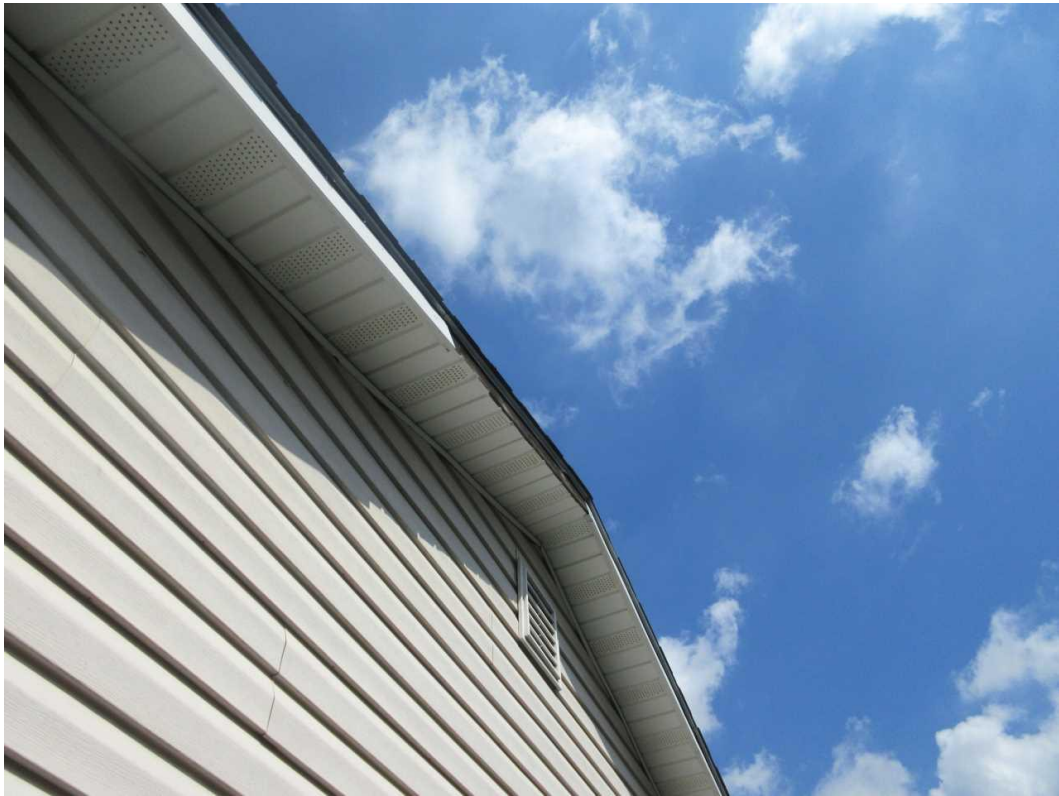
**125-E Left Elevation**  
Date Taken: 6/27/2025  
Taken By: Michael Wallen  
Wind damage to fascia.

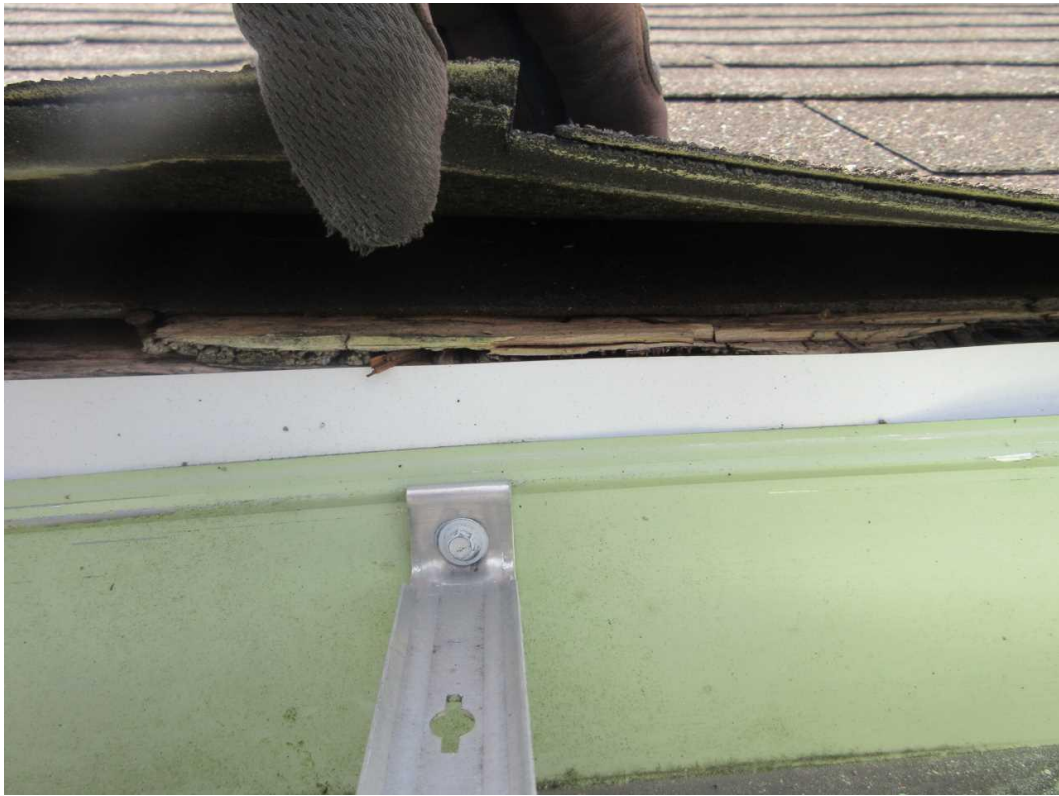
**126-Layer**  
Date Taken: 6/27/2025  
Taken By: Michael Wallen  
1 layer, no drip on eaves.

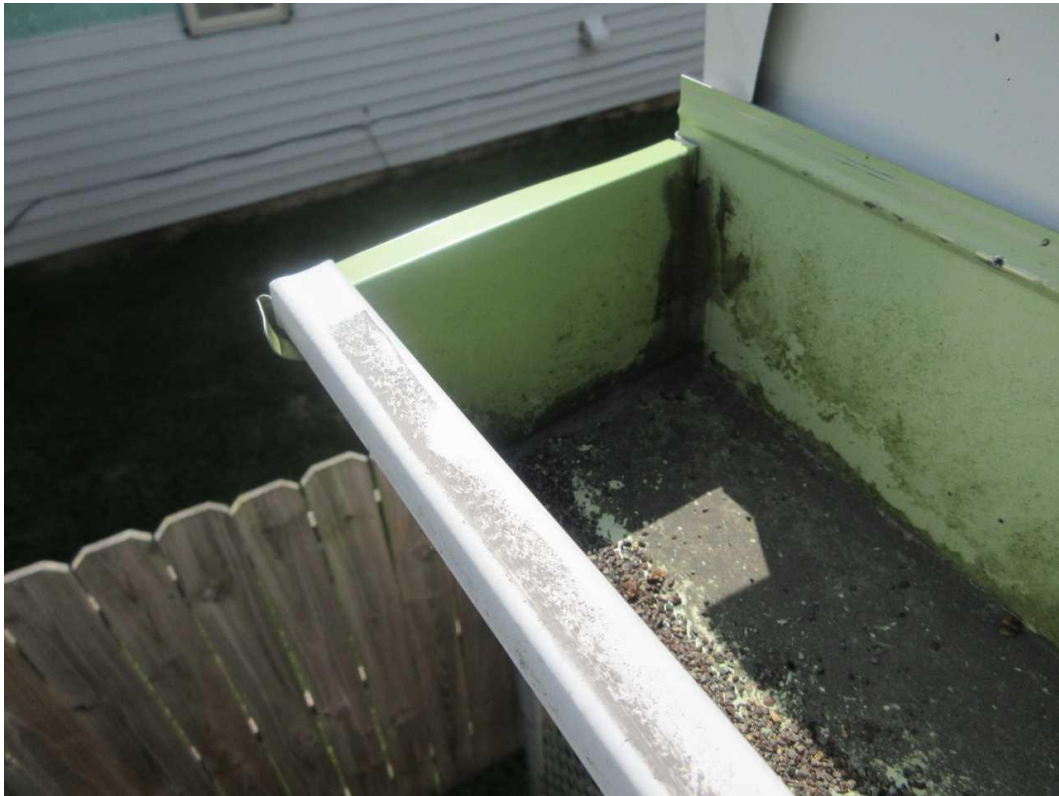
## 129-Gutters

Hail damaged.

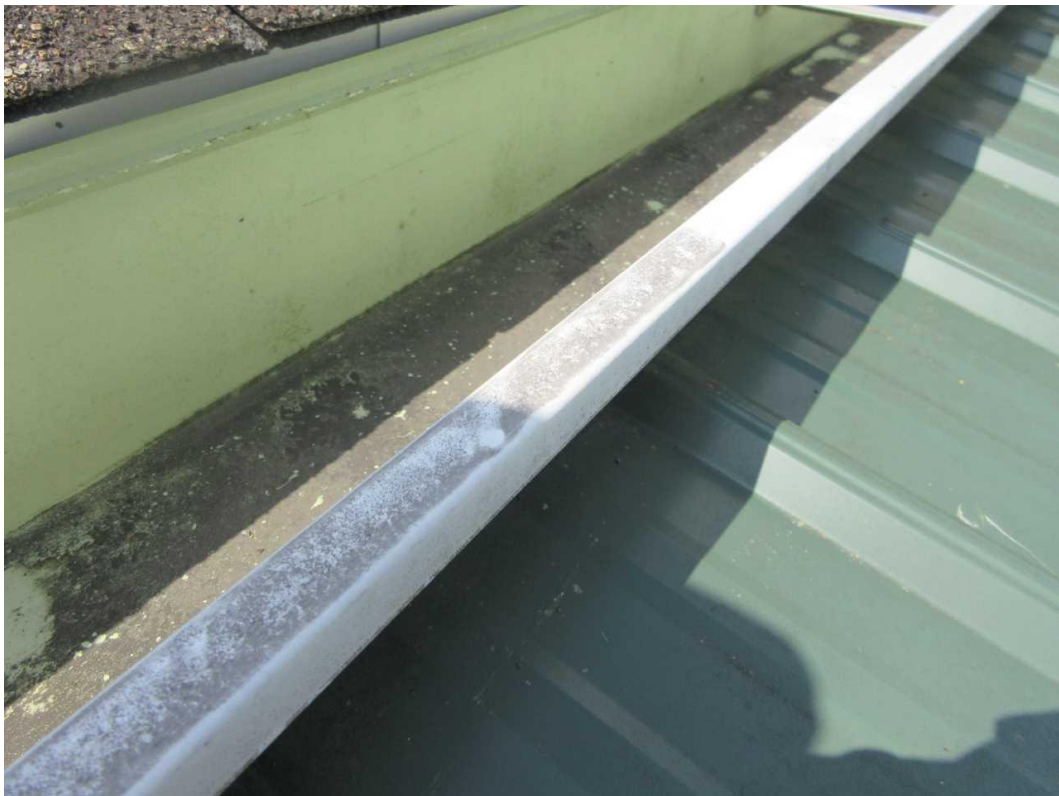
## 130-Gutters

Hail damaged.

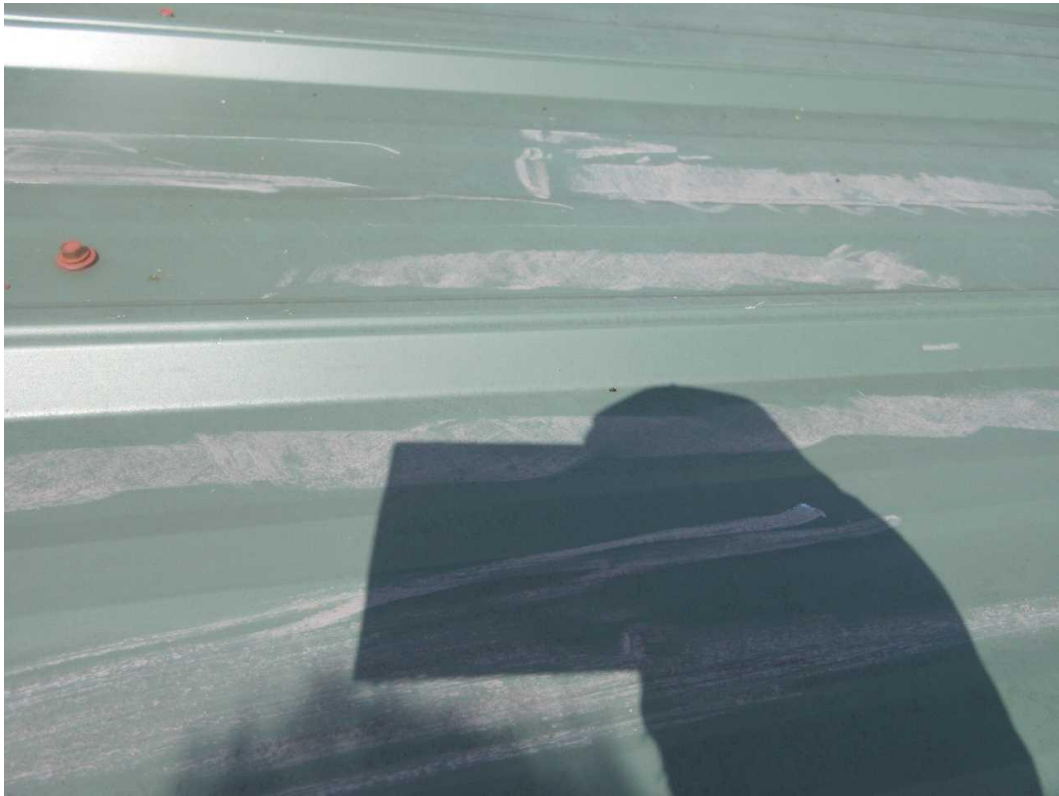
**133-Ribbed Metal Roof**  
Date Taken: 6/27/2025  
Taken By: Michael Wallen  
Hail damaged.

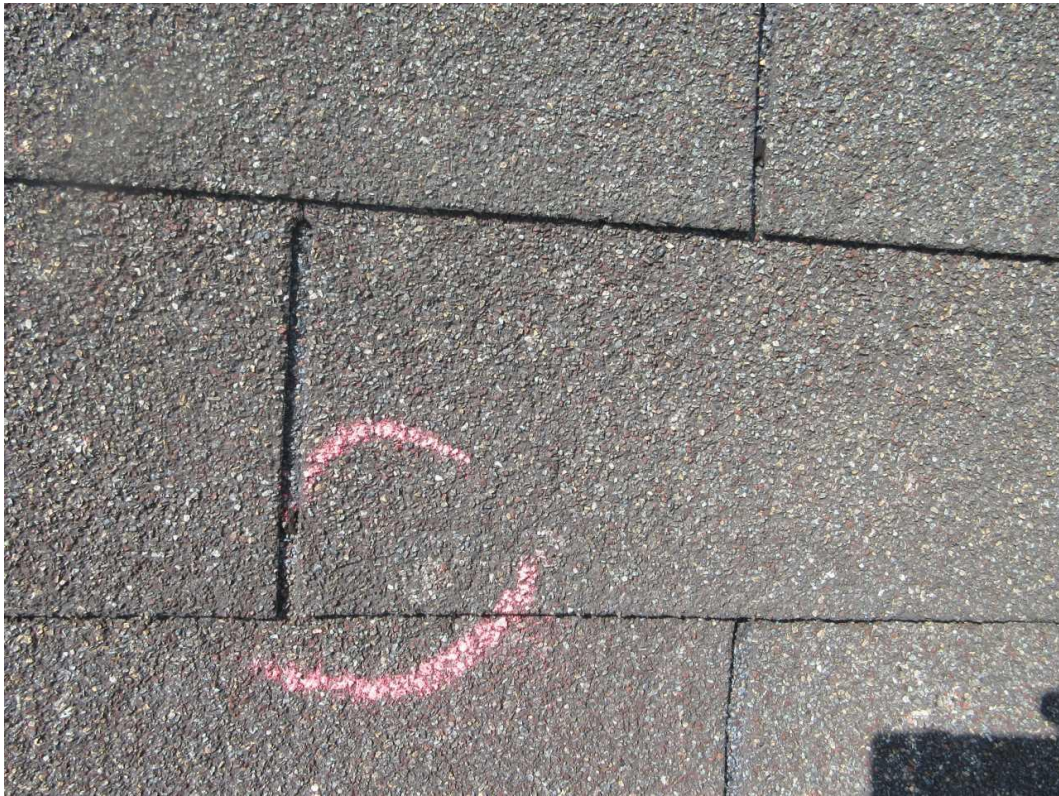
**135-N Front Slope**

Close up of hail damage inside the test square.

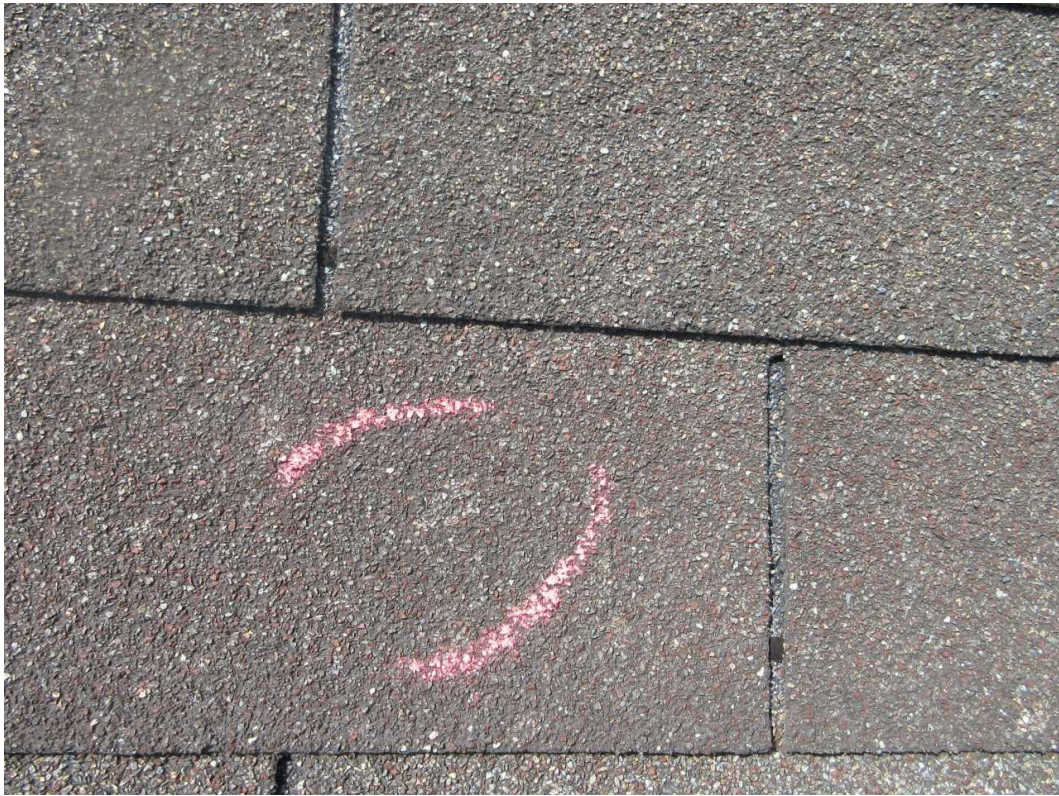
**136-N Front Slope**

Close up of hail damage inside the test square.

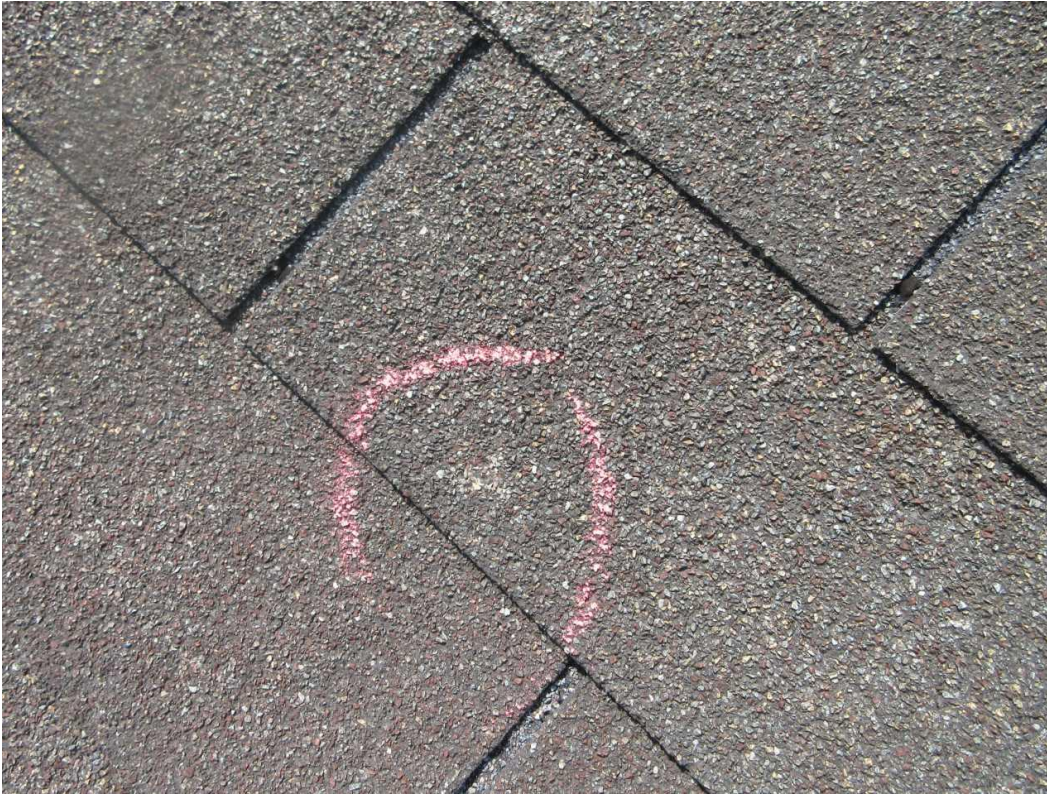
## 137-N Front Slope

Close up of hail damage inside the test square.

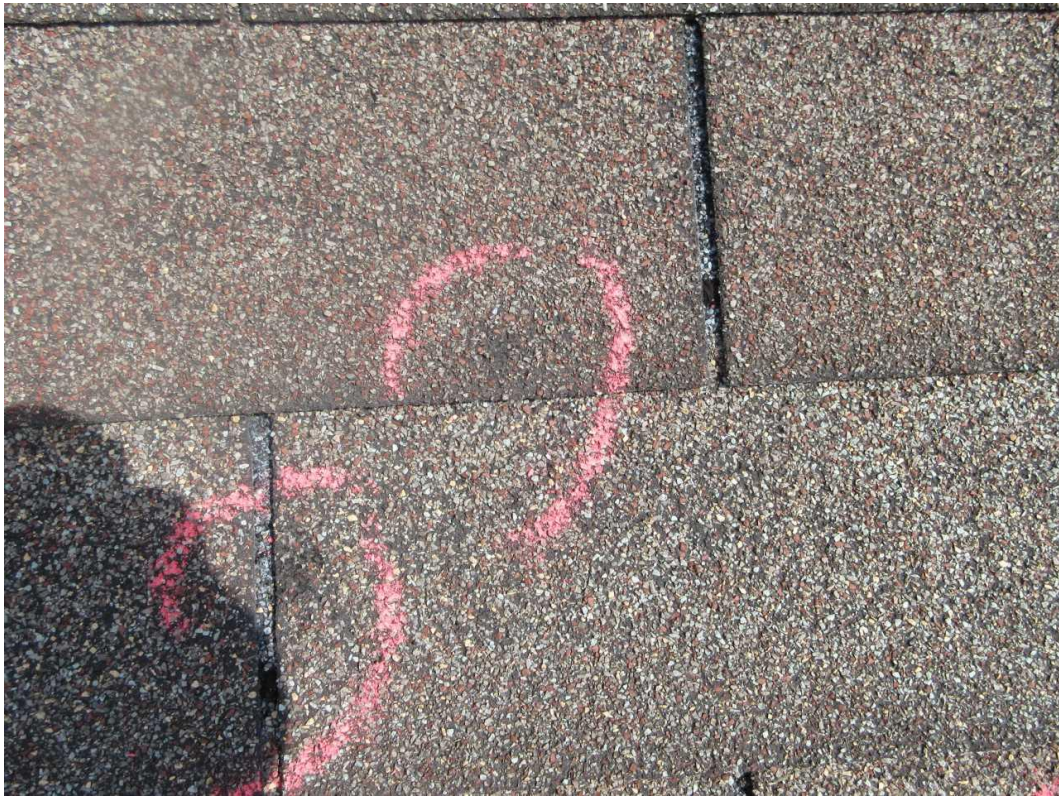
**139-S Back Slope**

Close up of hail damage inside the test square.

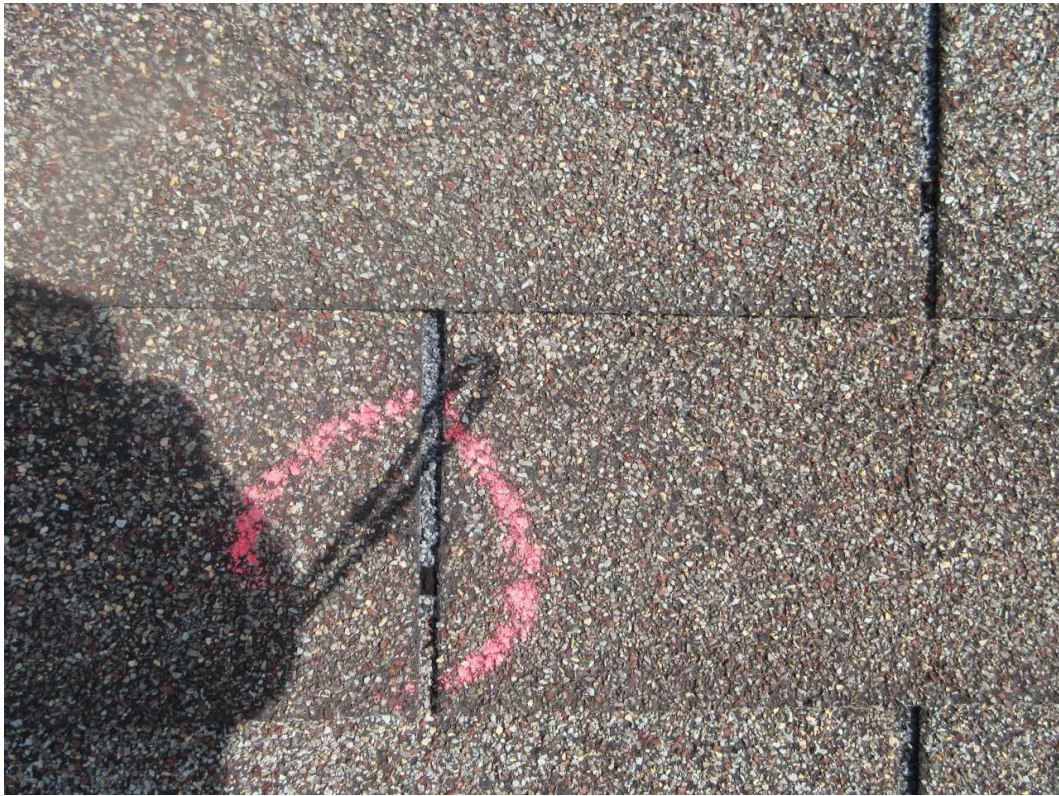
**140-S Back Slope**

Close up of hail damage inside the test square.

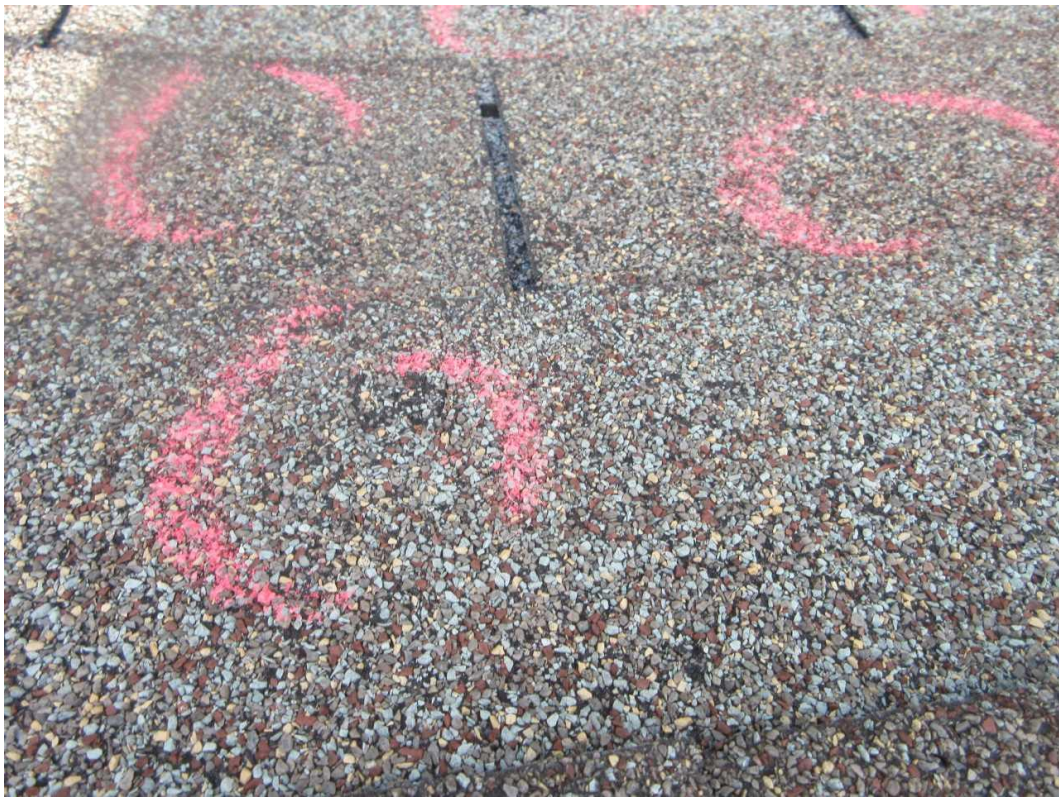
## 142-W Right Slope

Close up of hail damage inside the test square.

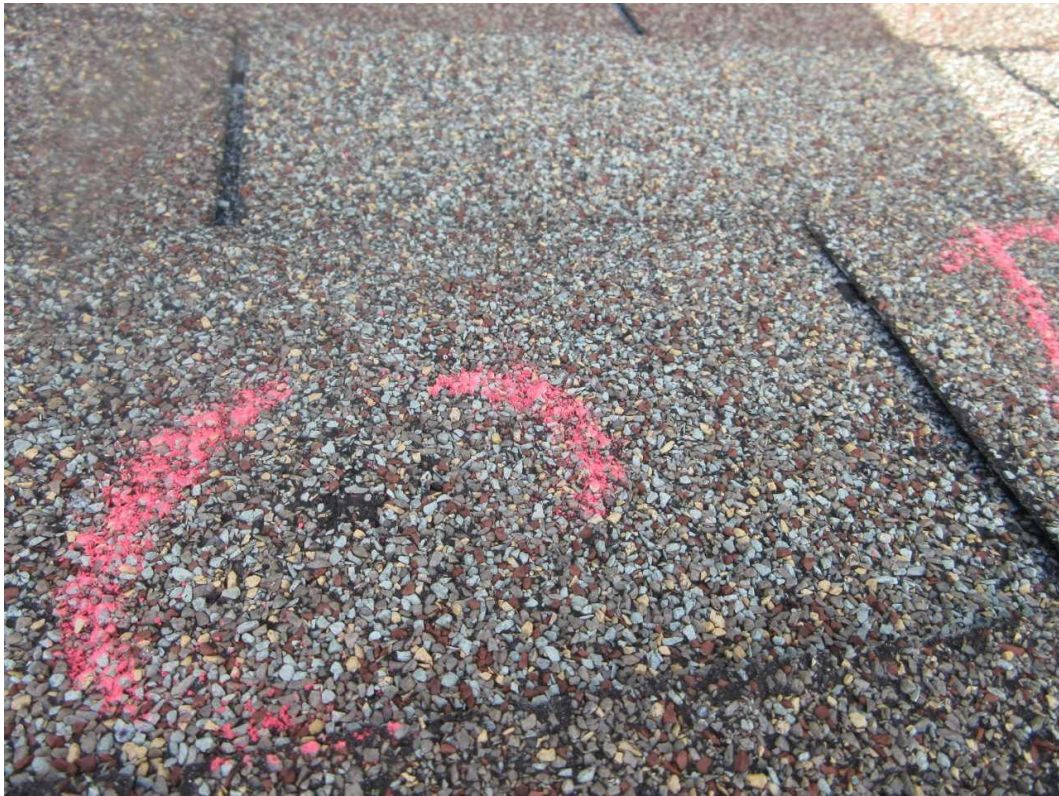
**143-W Right Slope**

Close up of hail damage inside the test square.

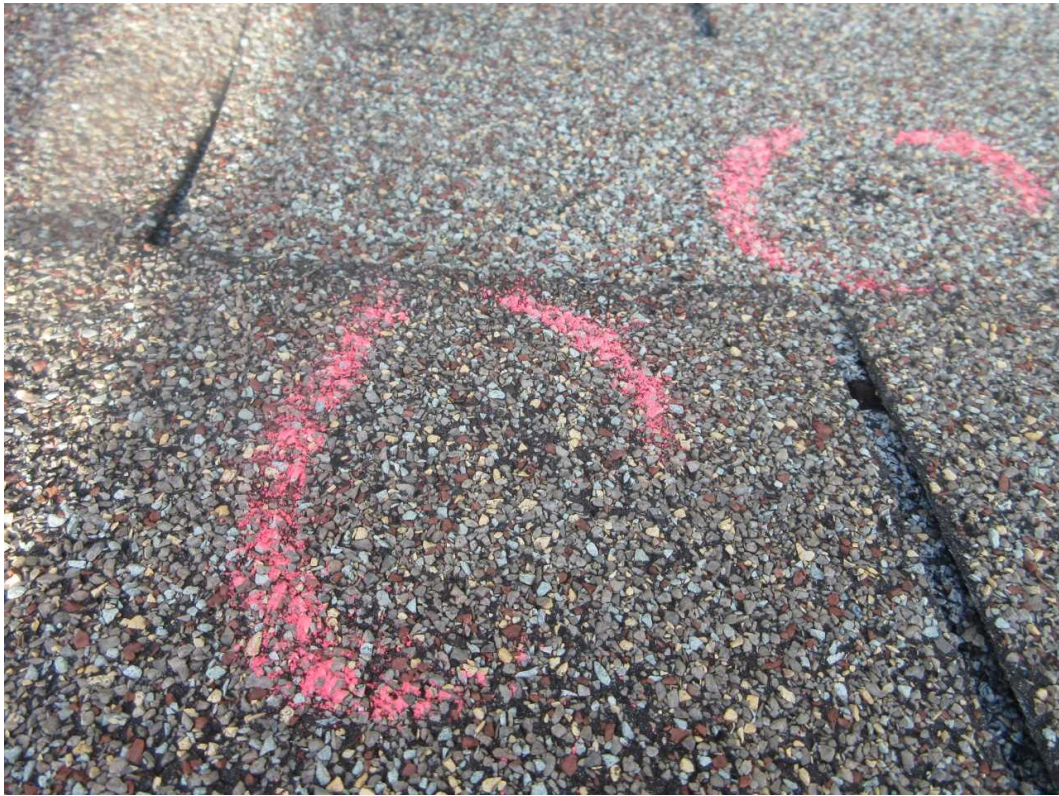
**144-W Right Slope**

Close up of hail damage inside the test square.

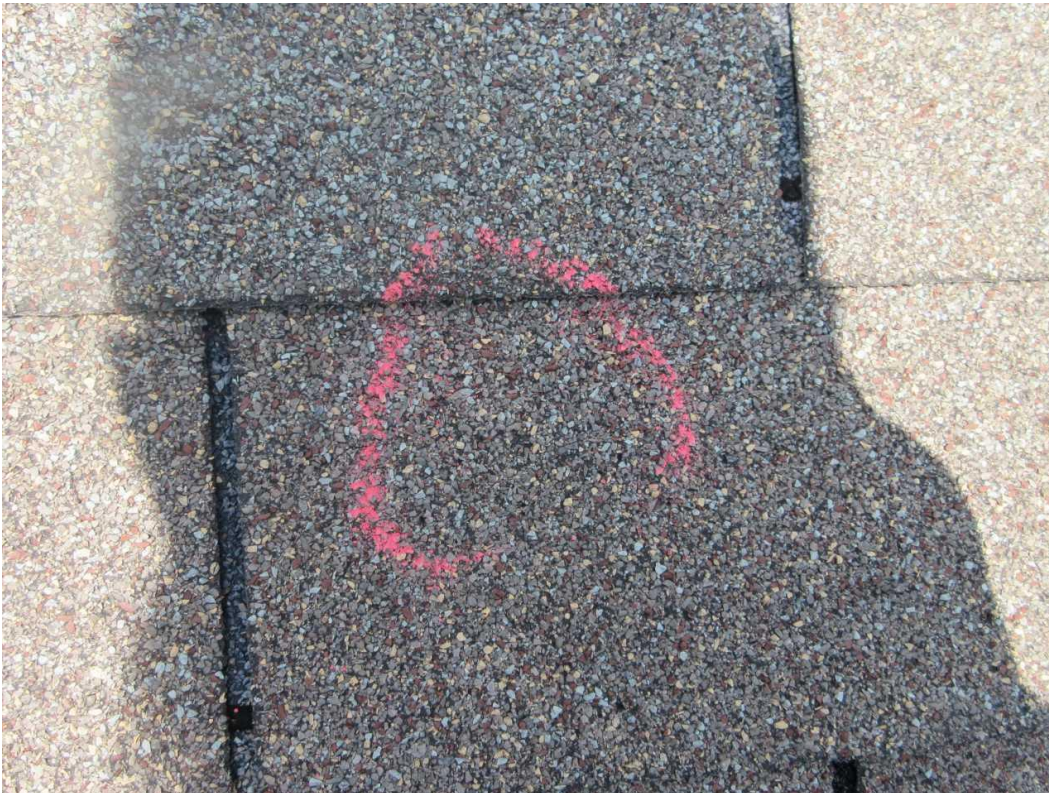
## 147-E Left Slope

Close up of hail damage inside the test square.

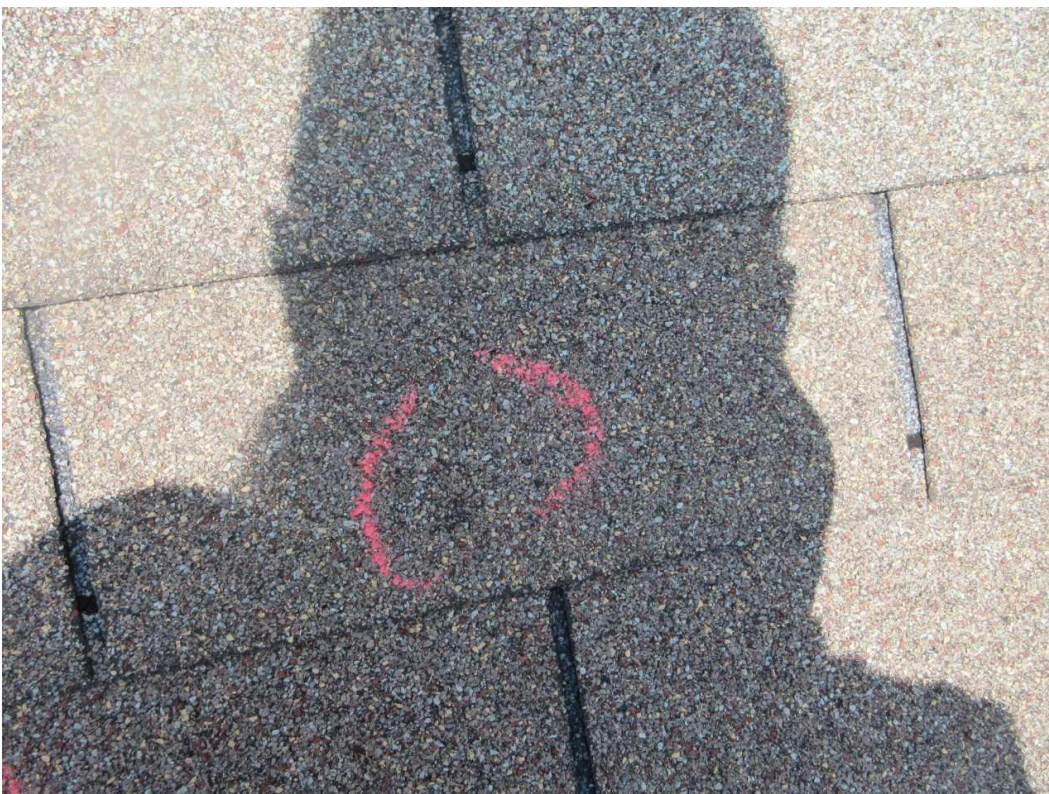
## 148-E Left Slope

Close up of hail damage inside the test square.

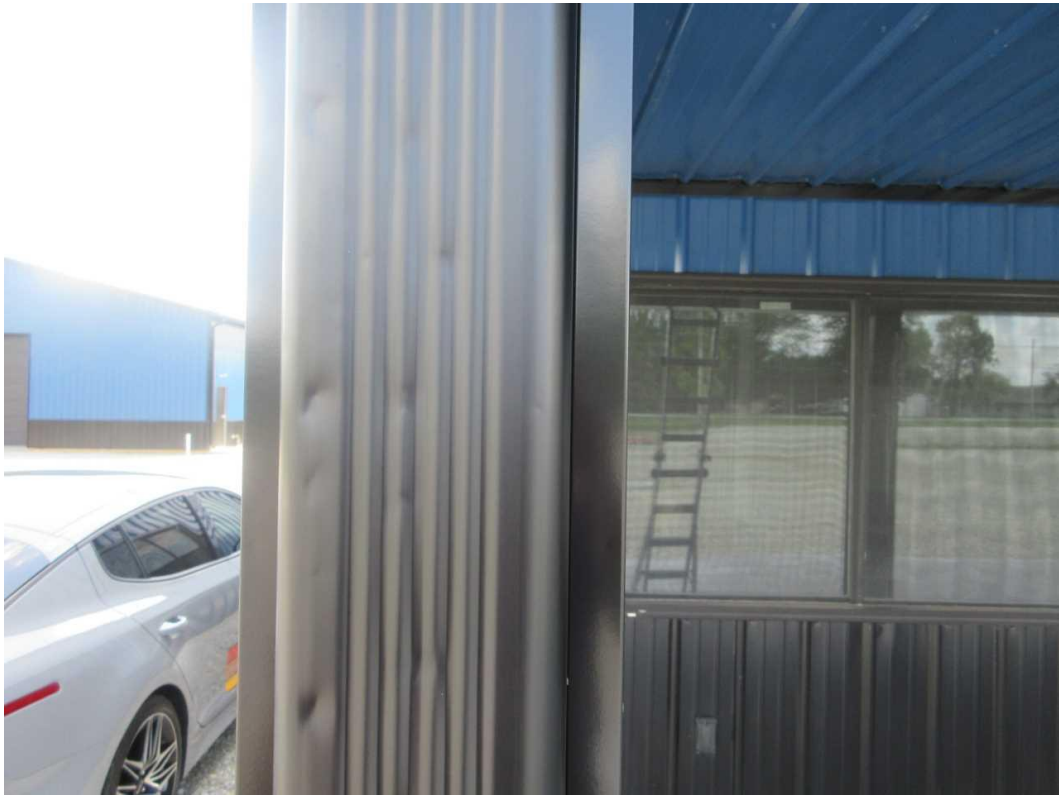
**150-W Front Elevation**  
Date Taken: 6/27/2025  
Taken By: Michael Wallen  
Hail damage to downspout

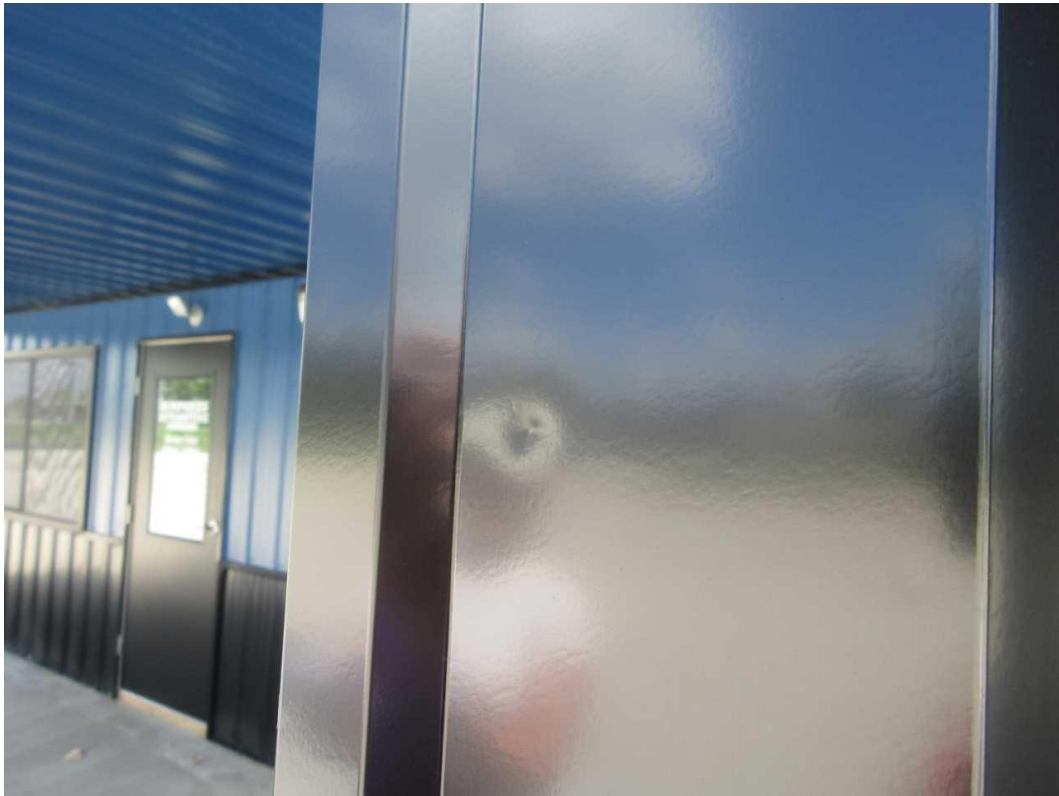
**151-W Front Elevation**  
Date Taken: 6/27/2025  
Taken By: Michael Wallen  
Hail damage to post wraps.

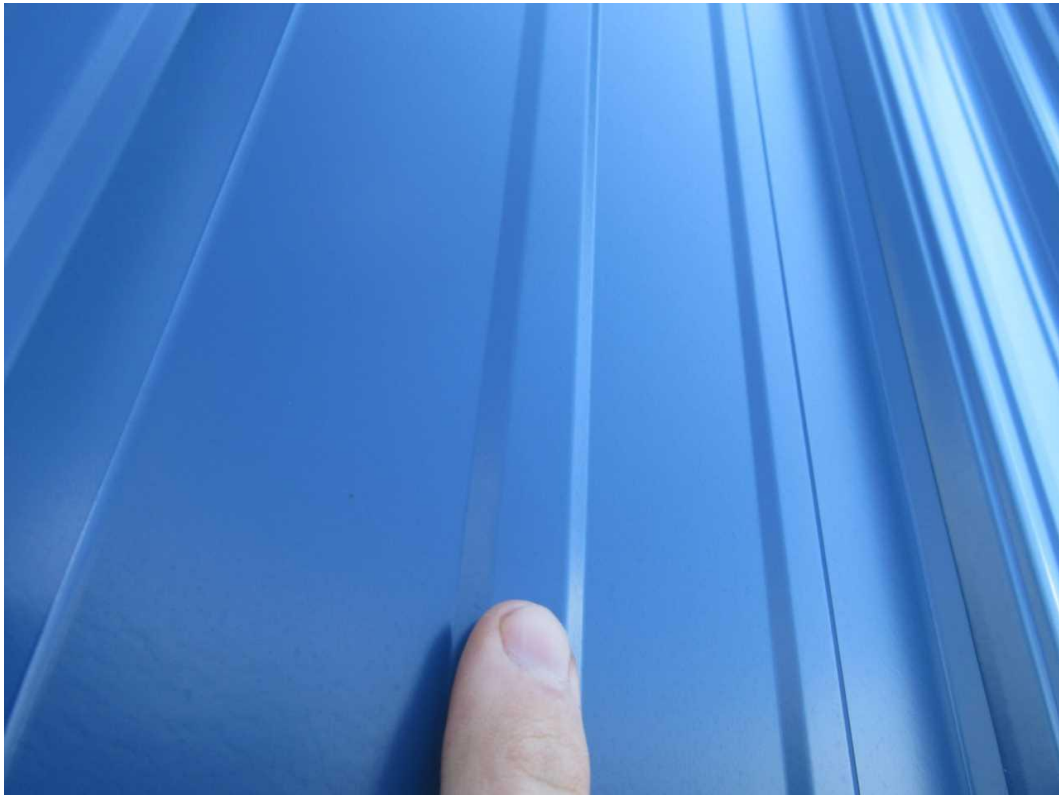
**152-W Front Elevation**  
Date Taken: 6/27/2025  
Taken By: Michael Wallen  
Hail damage to metal siding.

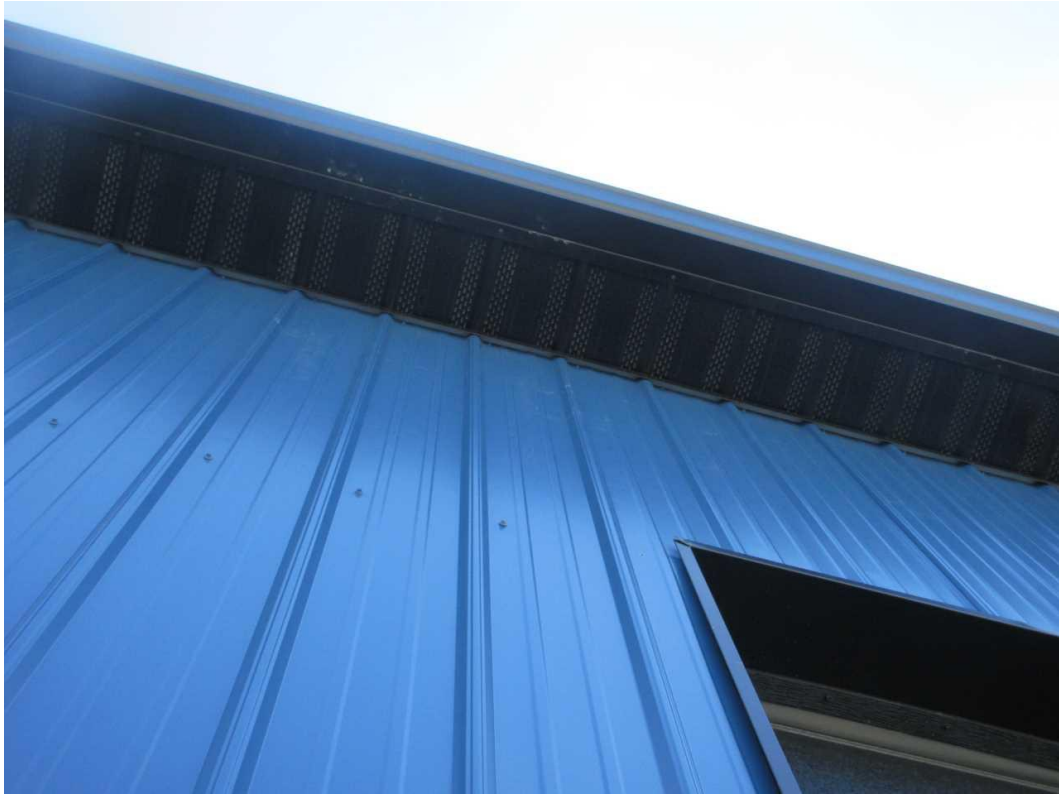
**153-W Front Elevation**  
Date Taken: 6/27/2025  
Taken By: Michael Wallen  
Hail damage to metal siding.

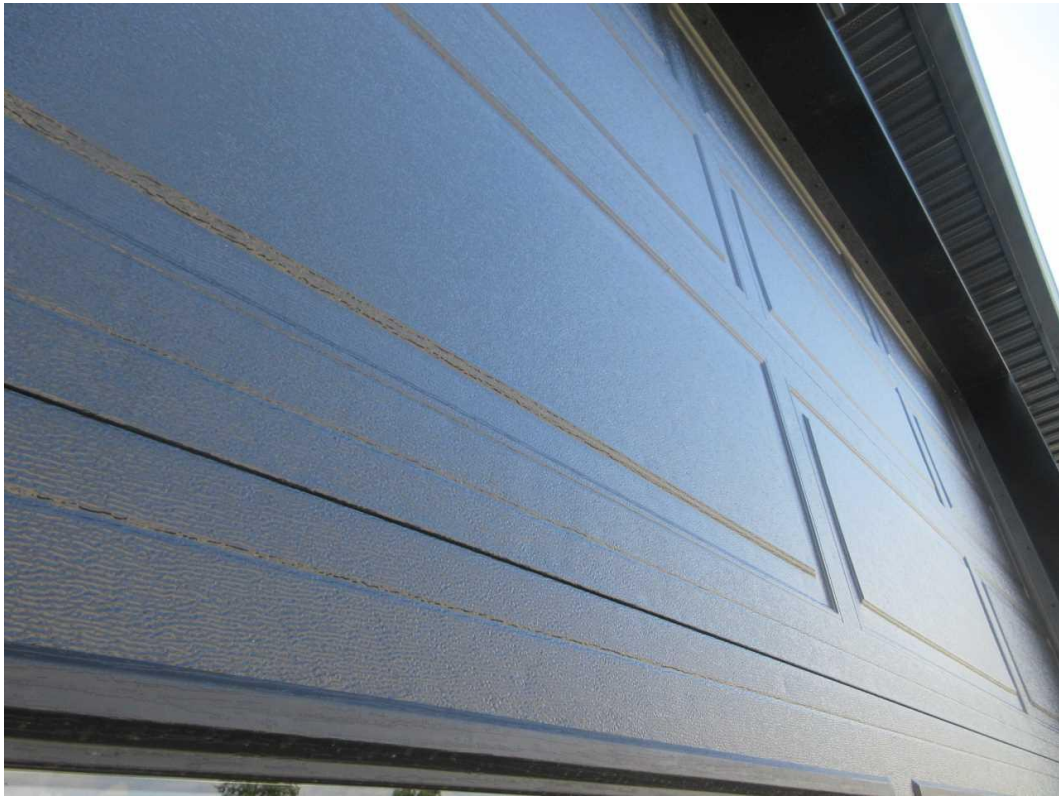
**155-W Front Elevation**  
Date Taken: 6/27/2025  
Taken By: Michael Wallen  
Hail damage to overhead door.

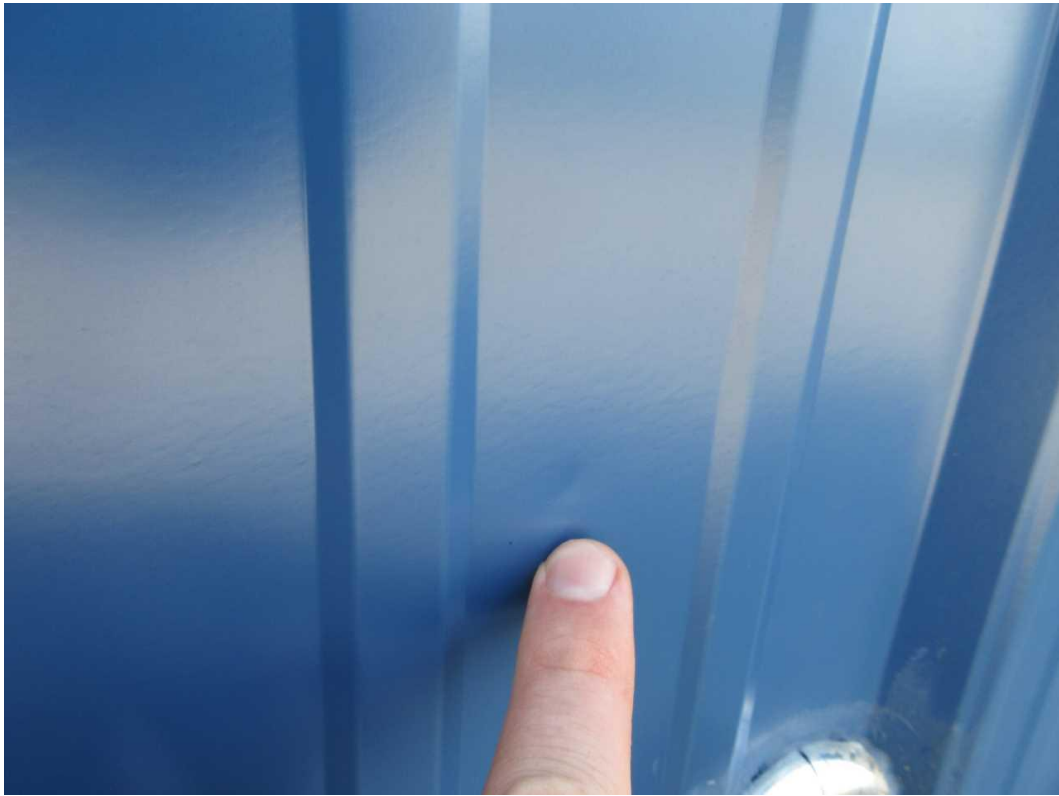
**156-W Front Elevation**  
Date Taken: 6/27/2025  
Taken By: Michael Wallen  
Hail damage to metal siding.

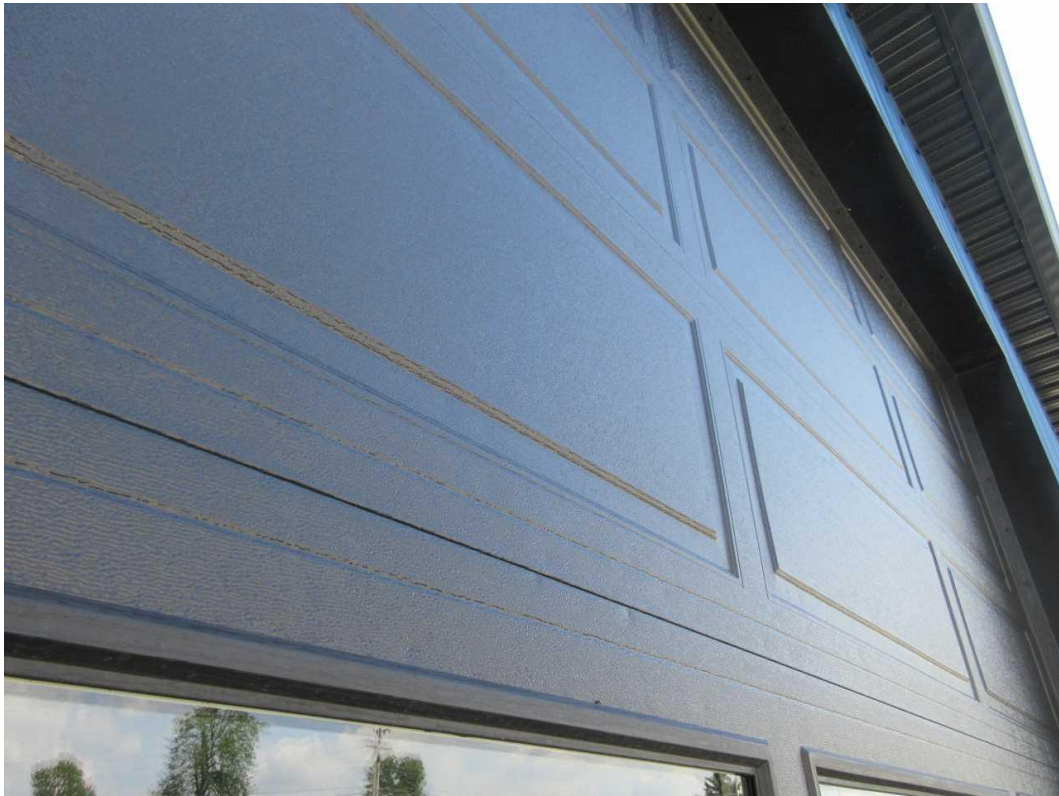
**157-W Front Elevation**

Hail damage to overhead door.

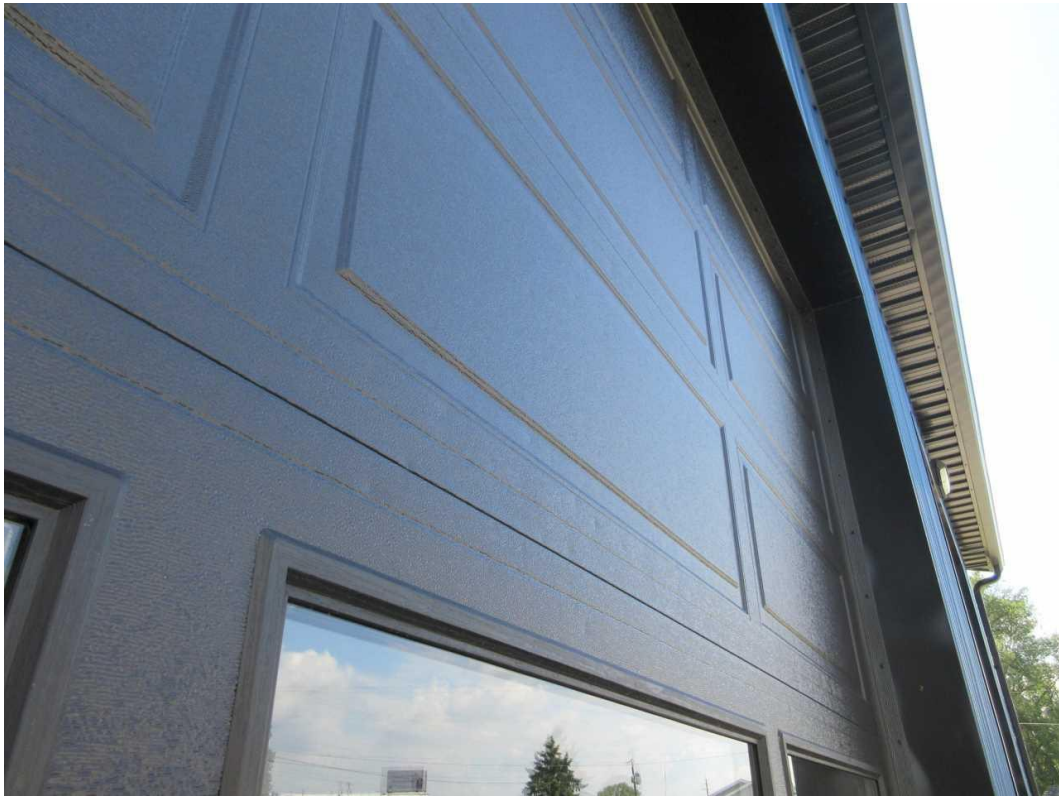
**159-W Front Elevation**  
Date Taken: 6/27/2025  
Taken By: Michael Wallen  
Hail damage to overhead door.

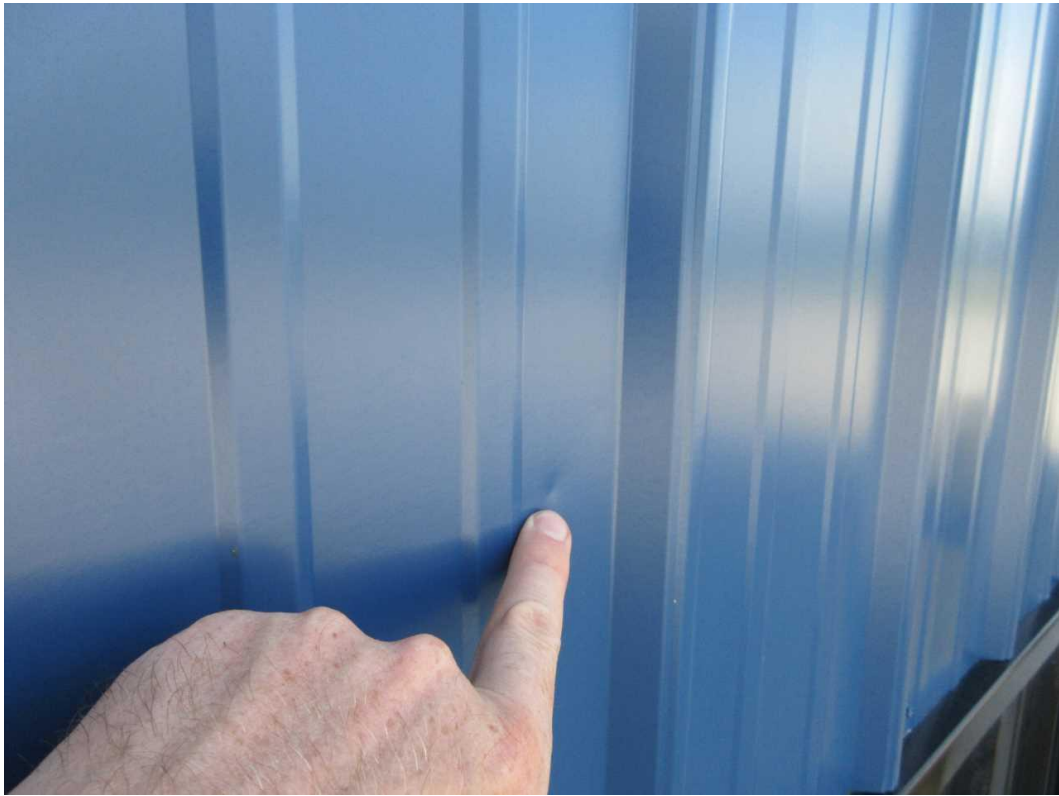
**160-W Front Elevation**  
Date Taken: 6/27/2025  
Taken By: Michael Wallen  
Hail damage to metal siding.

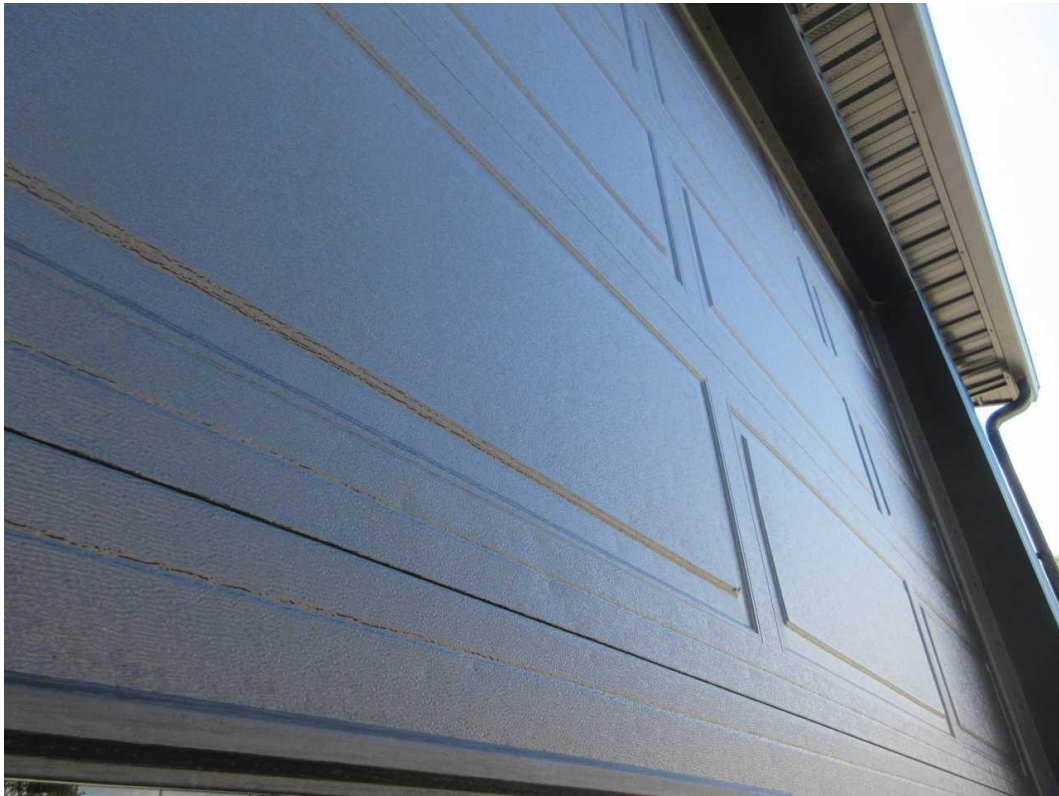
**161-W Front Elevation**

Hail damage to overhead door.
