File # R192712  
 Claim # 300- [REDACTED]-2025  
 Insured [REDACTED] Automotive Services

## LOSS REPORT

Cause of Loss: Hail

Damaged items include: Location 1 Building 1 Roof/Elevations, Location 3 Building 1 Roof/Elevations, Location 3 Building 2 Roof, Location 5 Building 1 Roof/Elevations, Location 6 Building 1 Roof/Elevations, Location 6 Building 2 Roof/Elevations

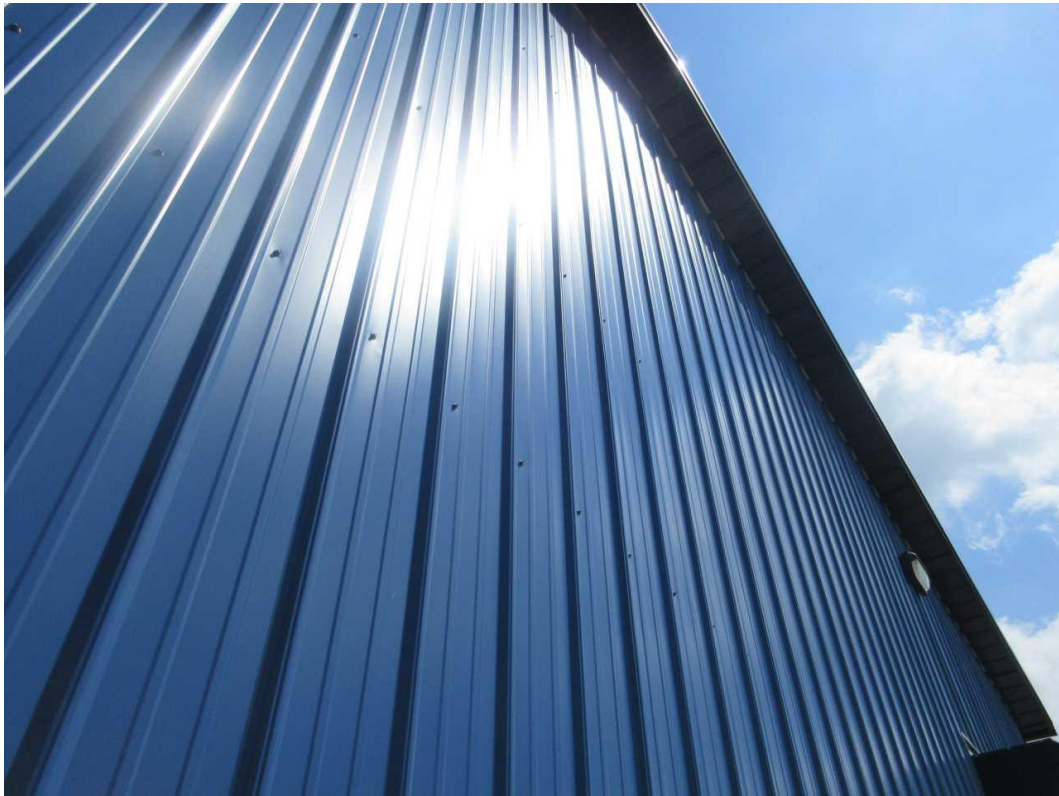
**165-S Right Elevation**

No storm damage to siding from the  
claimed date of loss.

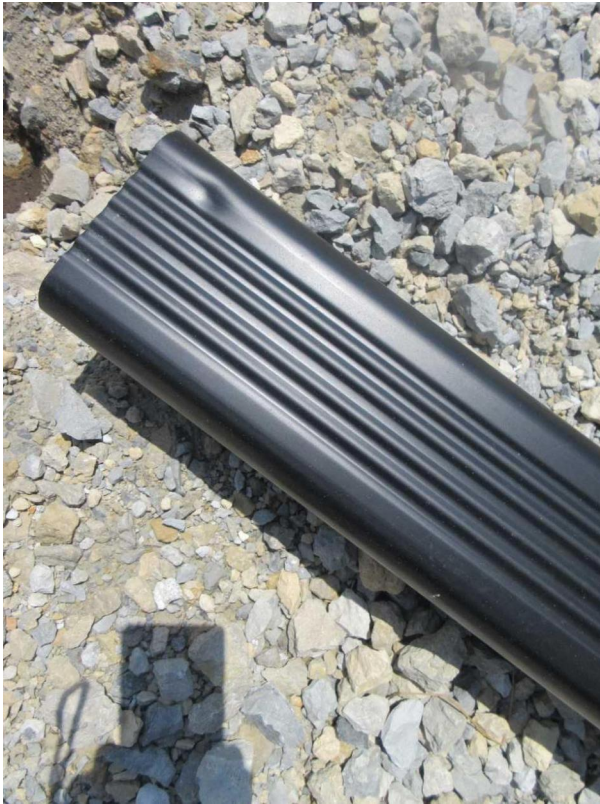
## 167-E Rear Elevation

Hail damage to downspout

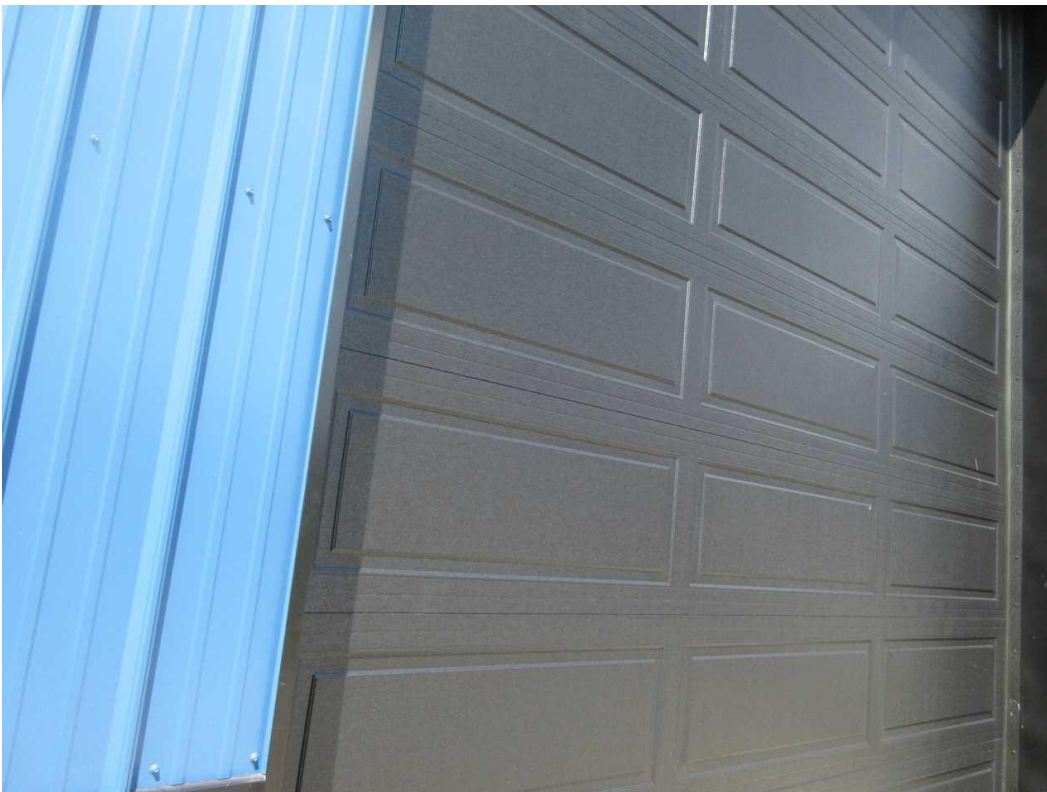
## 168-E Rear Elevation

No storm damage to overhead door from  
the claimed date of loss.

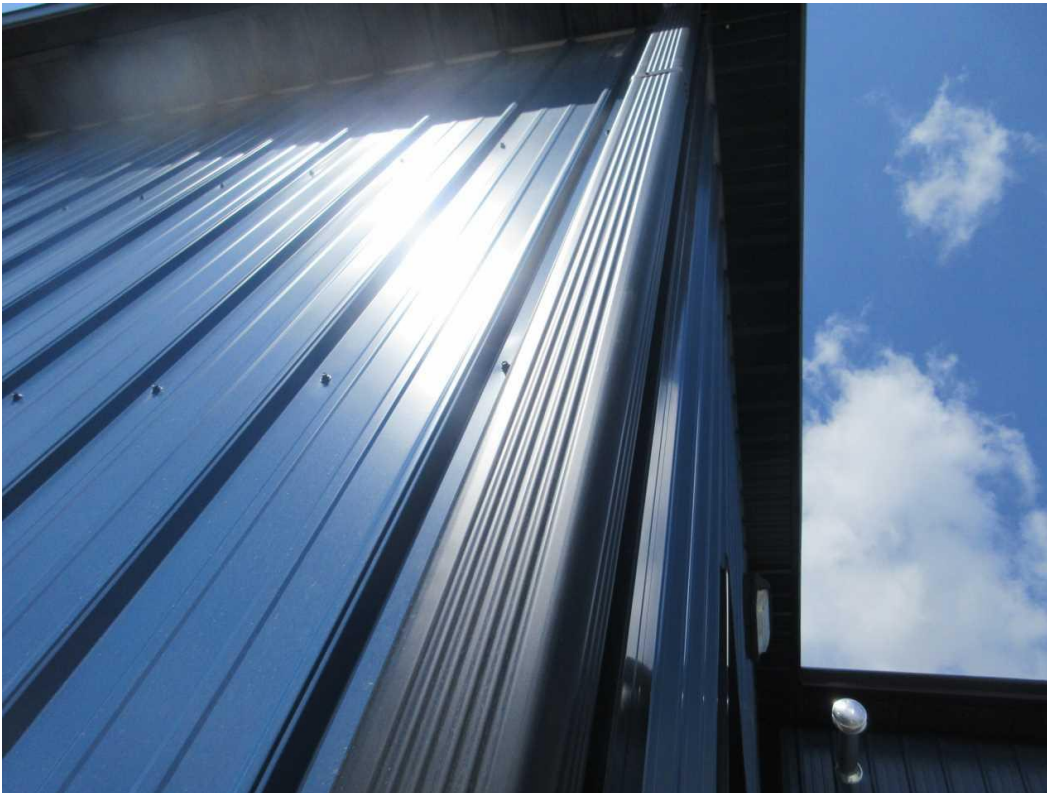
## 169-E Rear Elevation

No storm damage to downspout from the claimed date of loss.

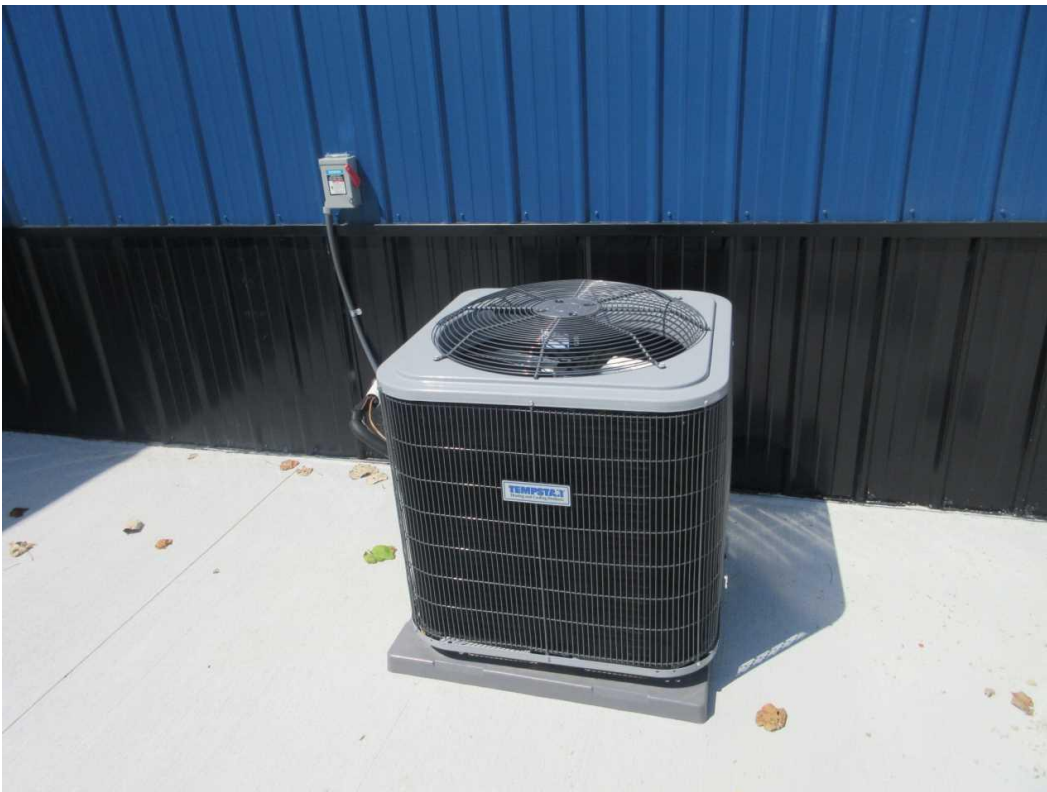
## 170-E Rear Elevation

No storm damage to A/C unit from the claimed date of loss.

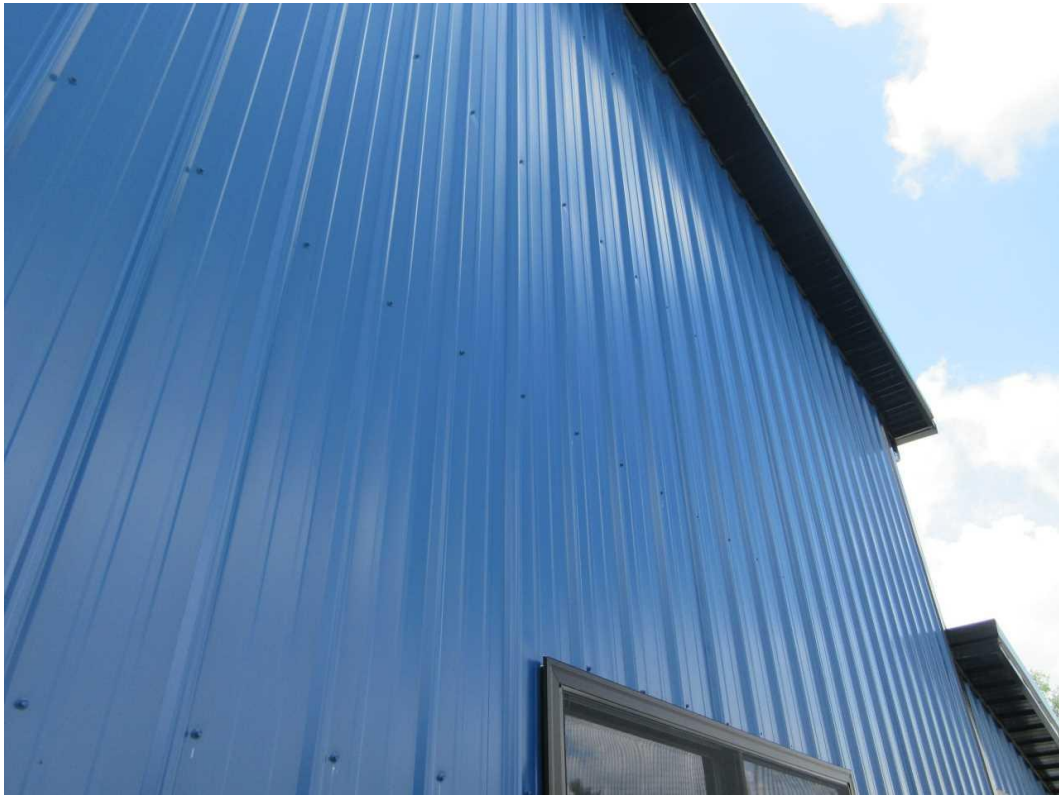
**174-N Left Elevation**  
Date Taken: 6/27/2025  
Taken By: Michael Wallen  
No storm damage to siding from the  
claimed date of loss.

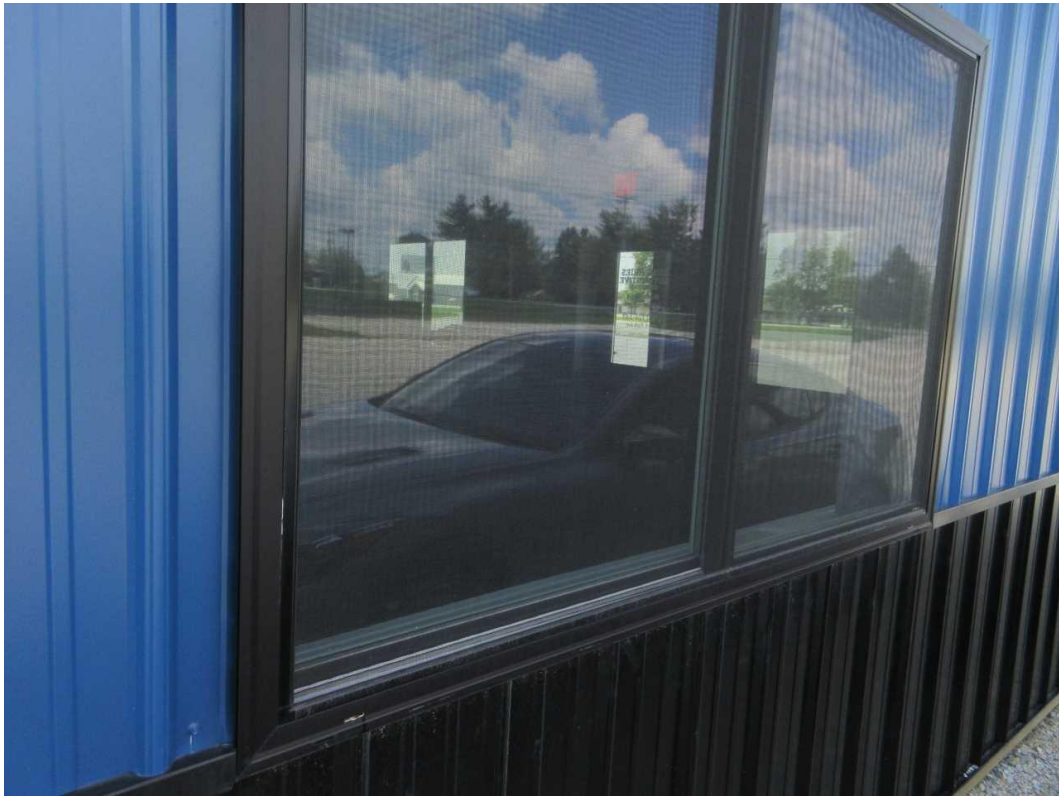
**175-N Left Elevation**  
Date Taken: 6/27/2025  
Taken By: Michael Wallen  
No storm damage to windows from the  
claimed date of loss.

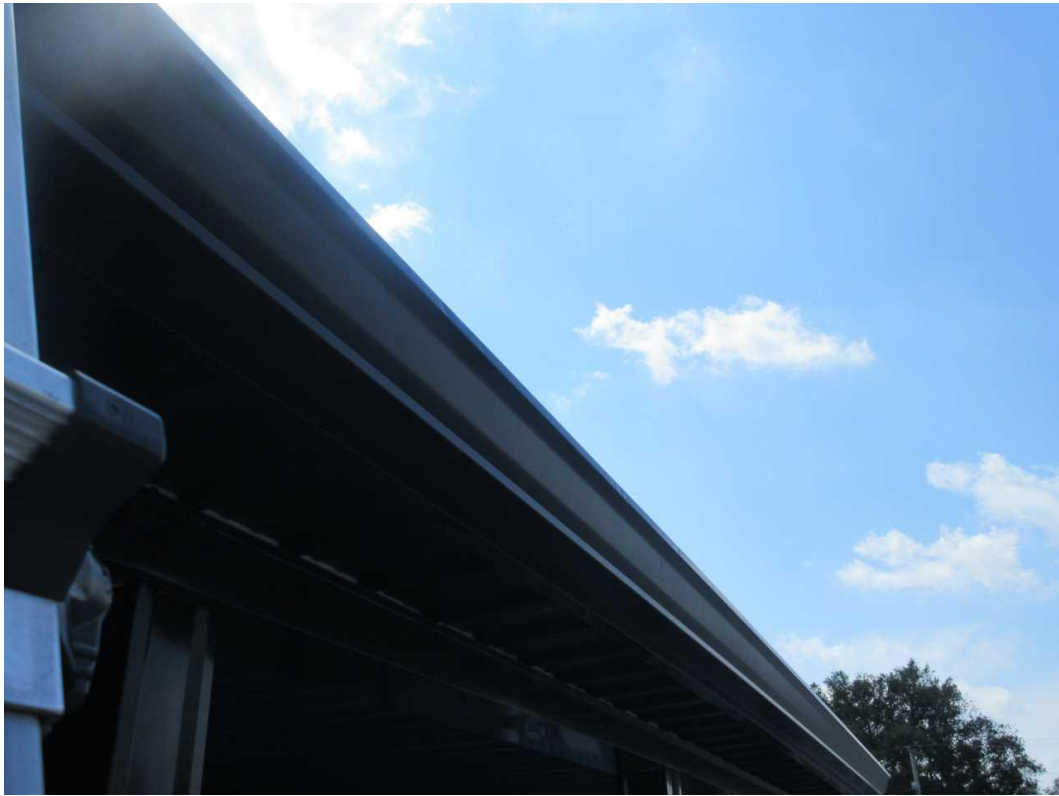
**178-Gutters**  
Date Taken: 6/27/2025  
Taken By: Michael Wallen  
Hail damage to gutters.

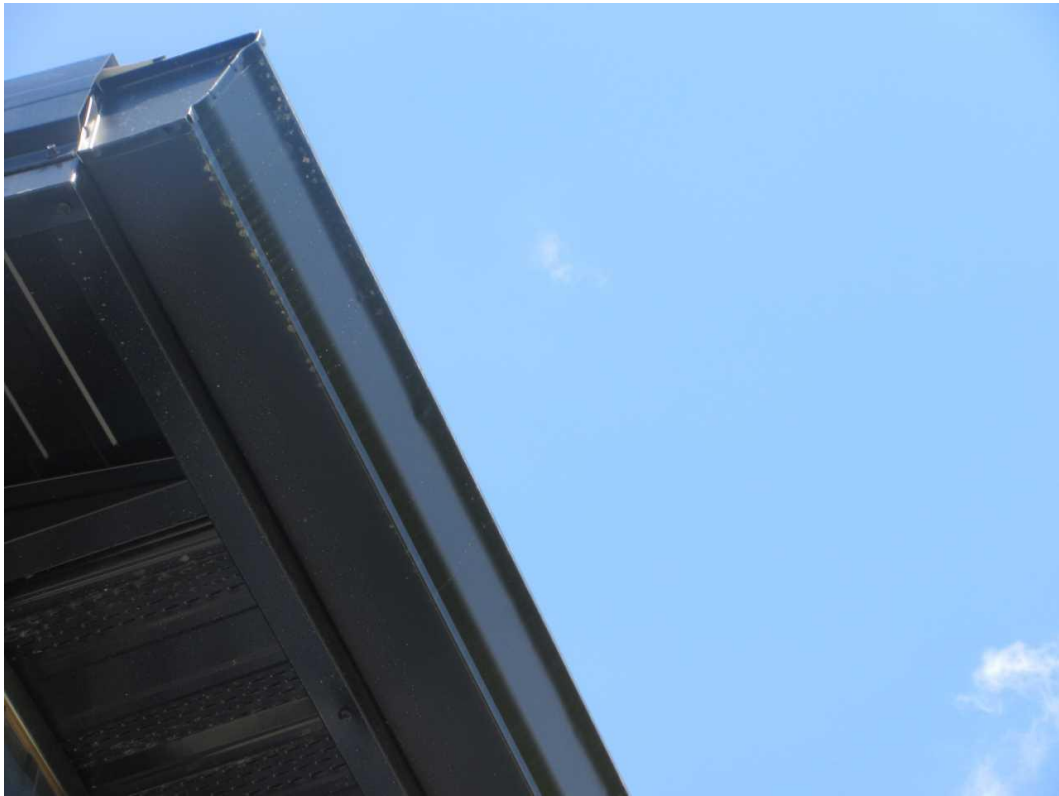
## 179-Gutters

Hail damage to gutters.

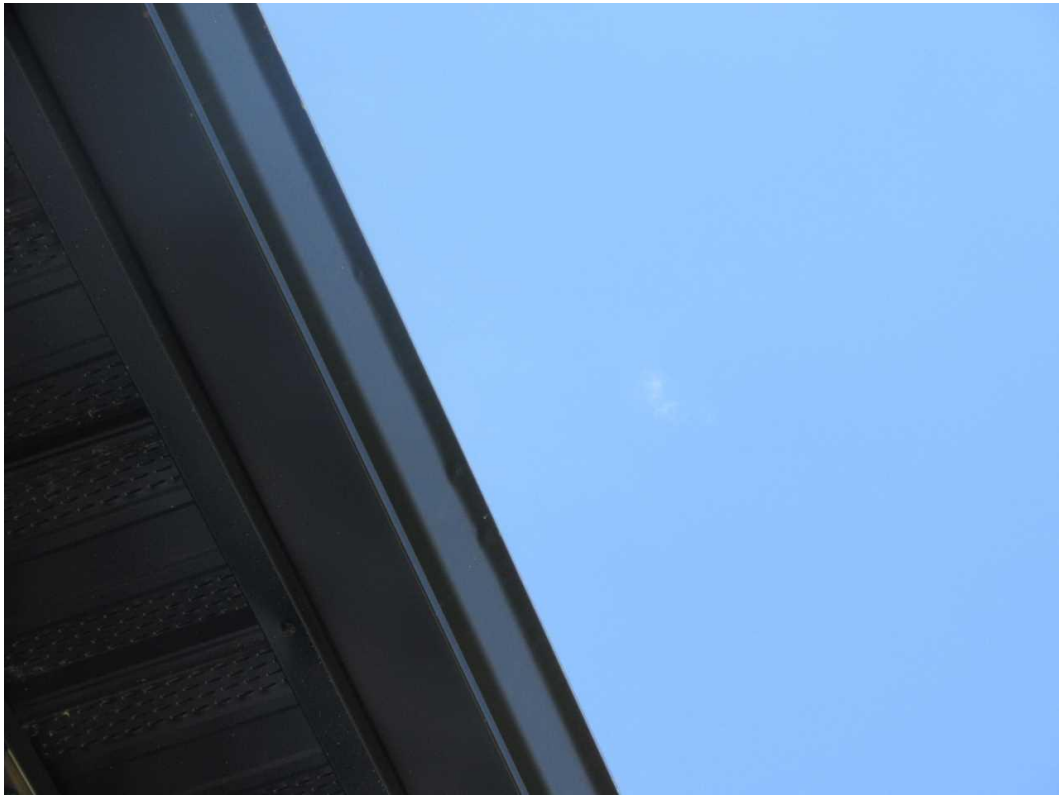
## 180-Gutters

Hail damage to gutters.

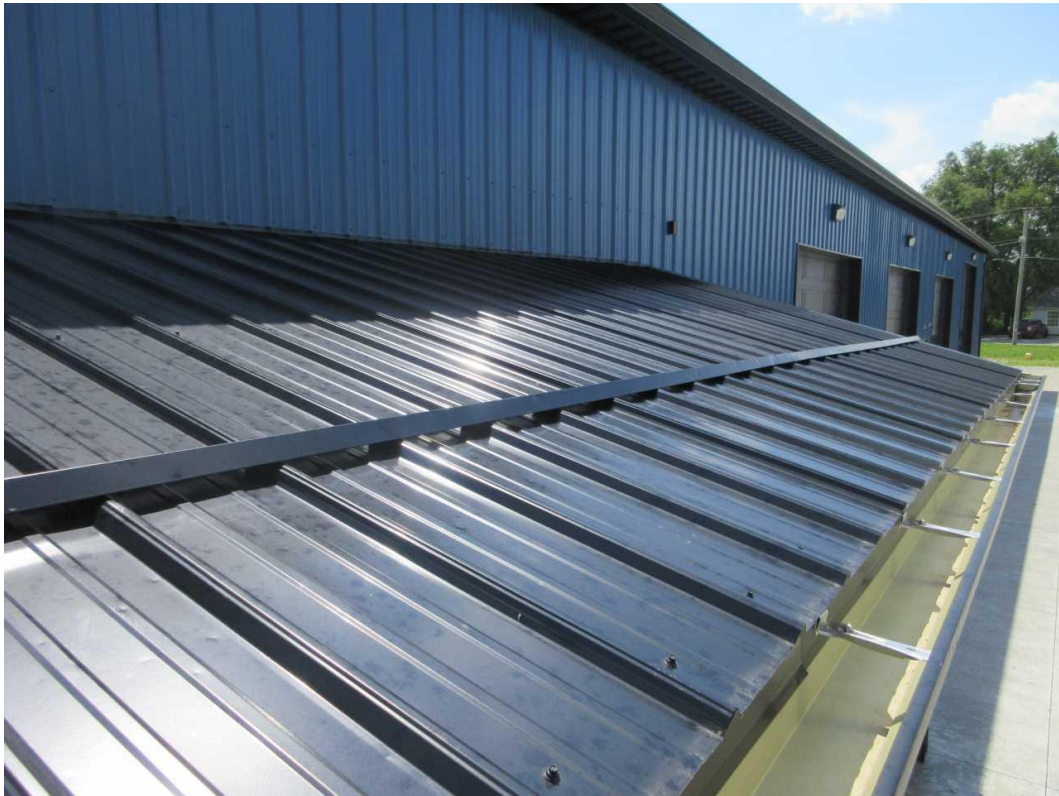
**181-Roof**  
Date Taken: 6/27/2025  
Taken By: Michael Wallen  
Hail damage to ribbed metal roofing.

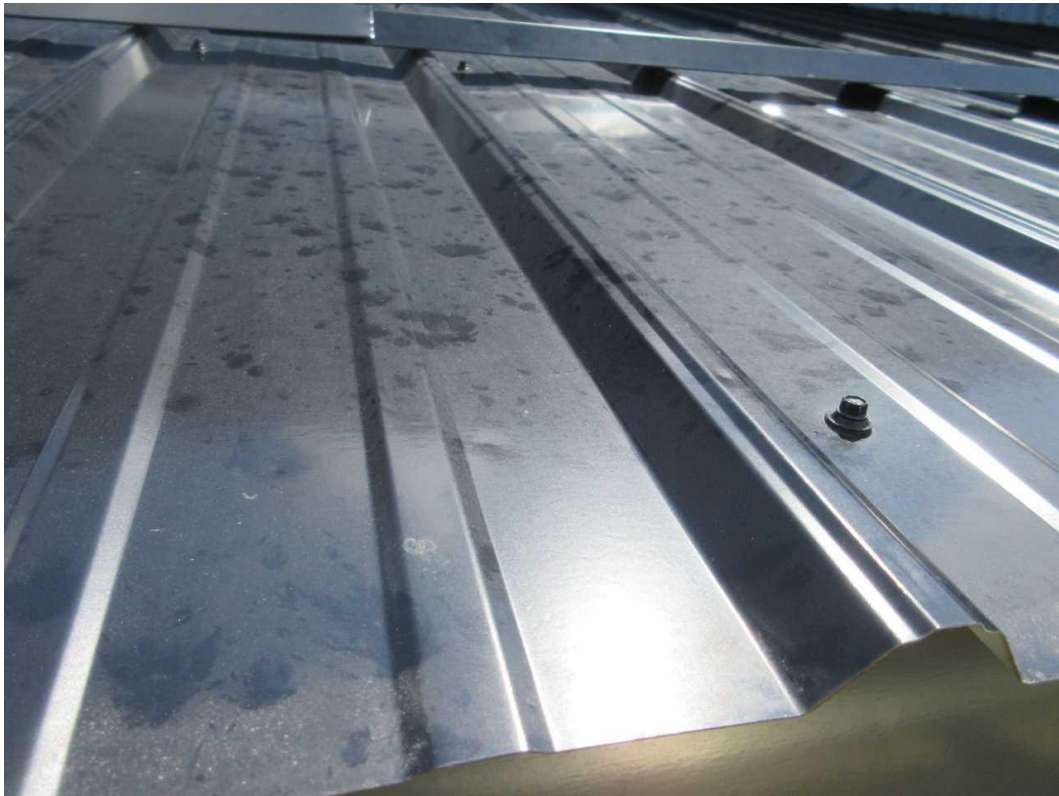
**183-Roof**  
Date Taken: 6/27/2025  
Taken By: Michael Wallen  
Hail damage to ribbed metal roofing.

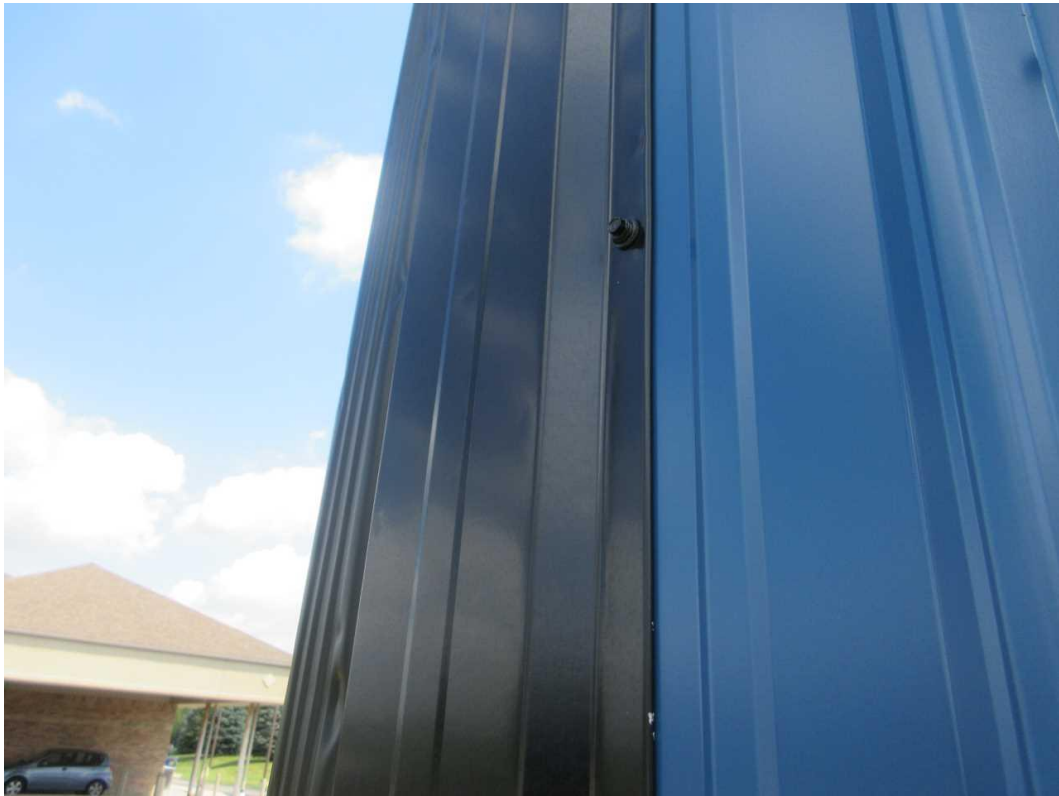
**187-W Front Elevation**  
Date Taken: 6/27/2025  
Taken By: Michael Wallen  
Hail damage to downspout.

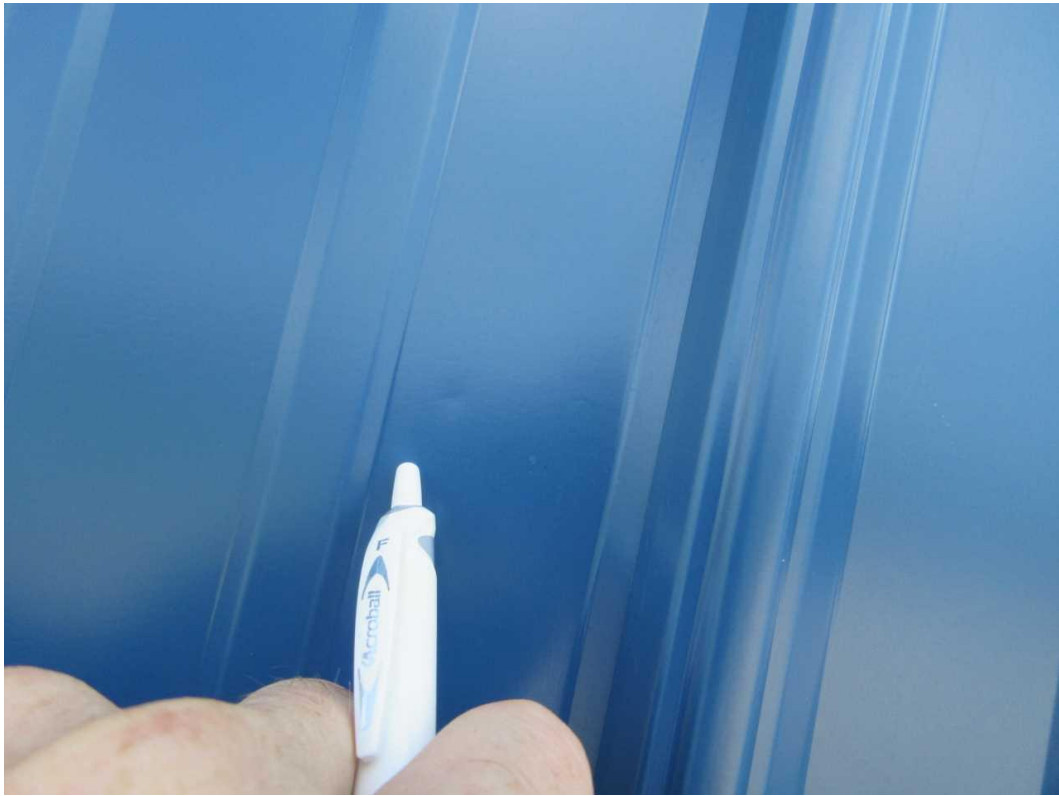
**188-W Front Elevation**  
Date Taken: 6/27/2025  
Taken By: Michael Wallen  
Hail damage to metal siding.

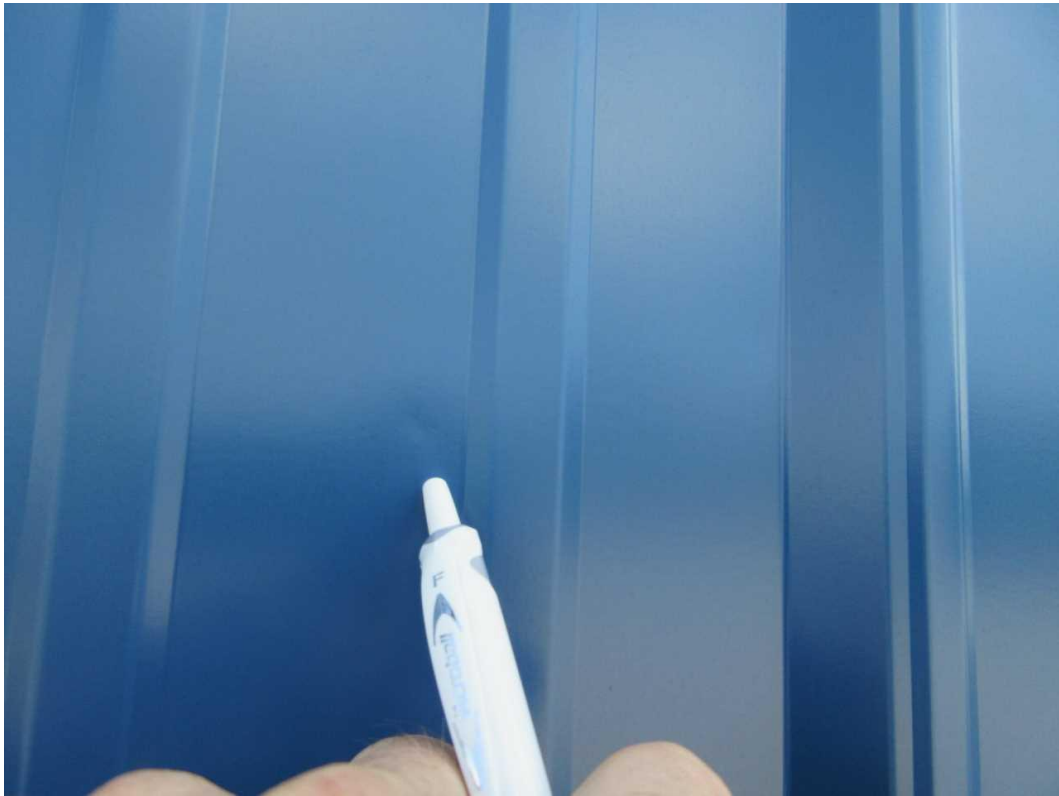
**189-W Front Elevation**  
Date Taken: 6/27/2025  
Taken By: Michael Wallen  
Hail damage to metal siding.

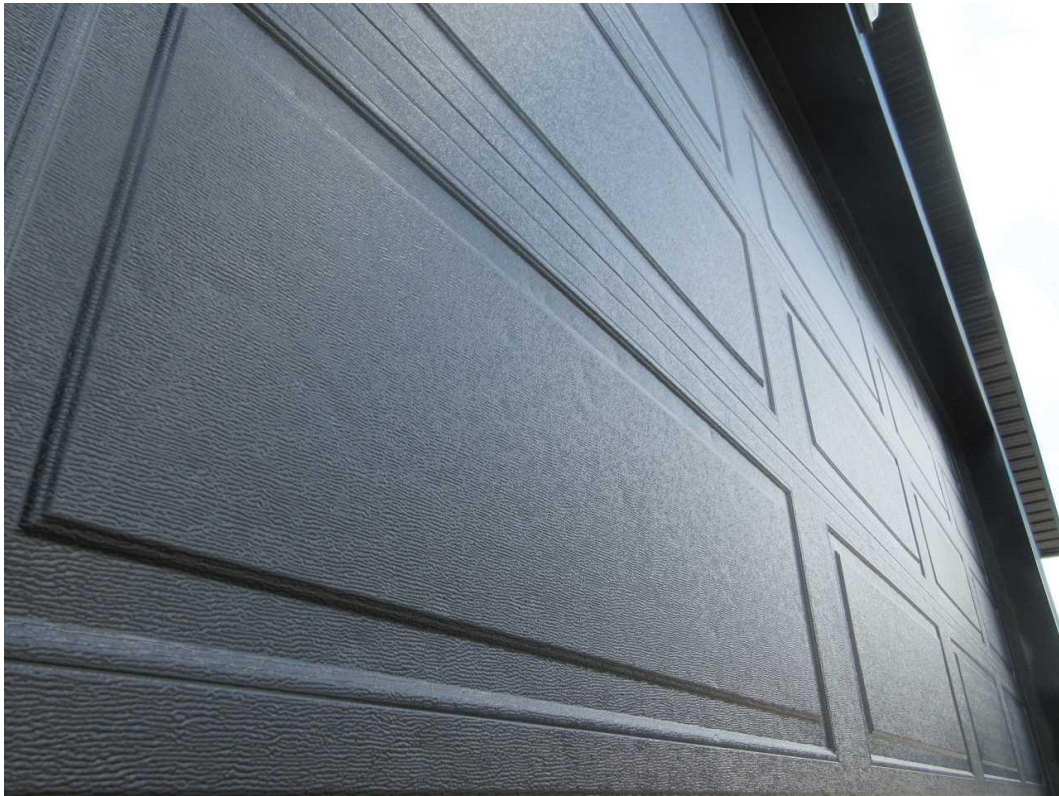
## 191-W Front Elevation

Hail damage to overhead door.

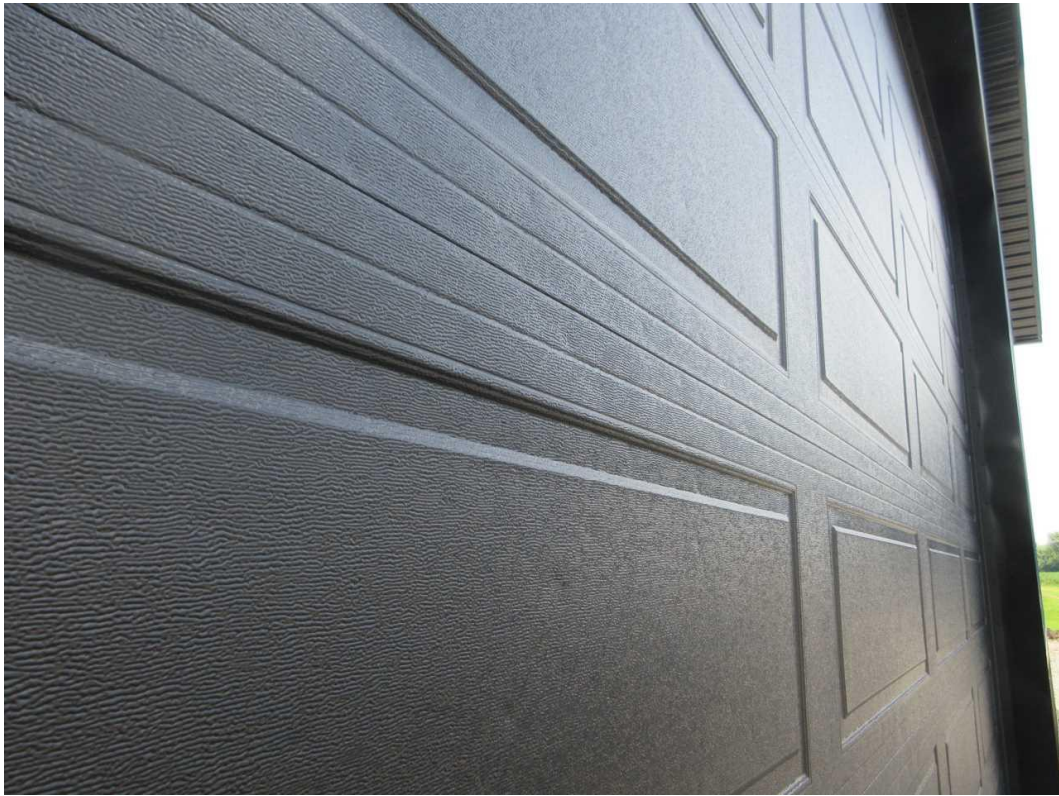
## 192-W Front Elevation

Hail damage to overhead door.

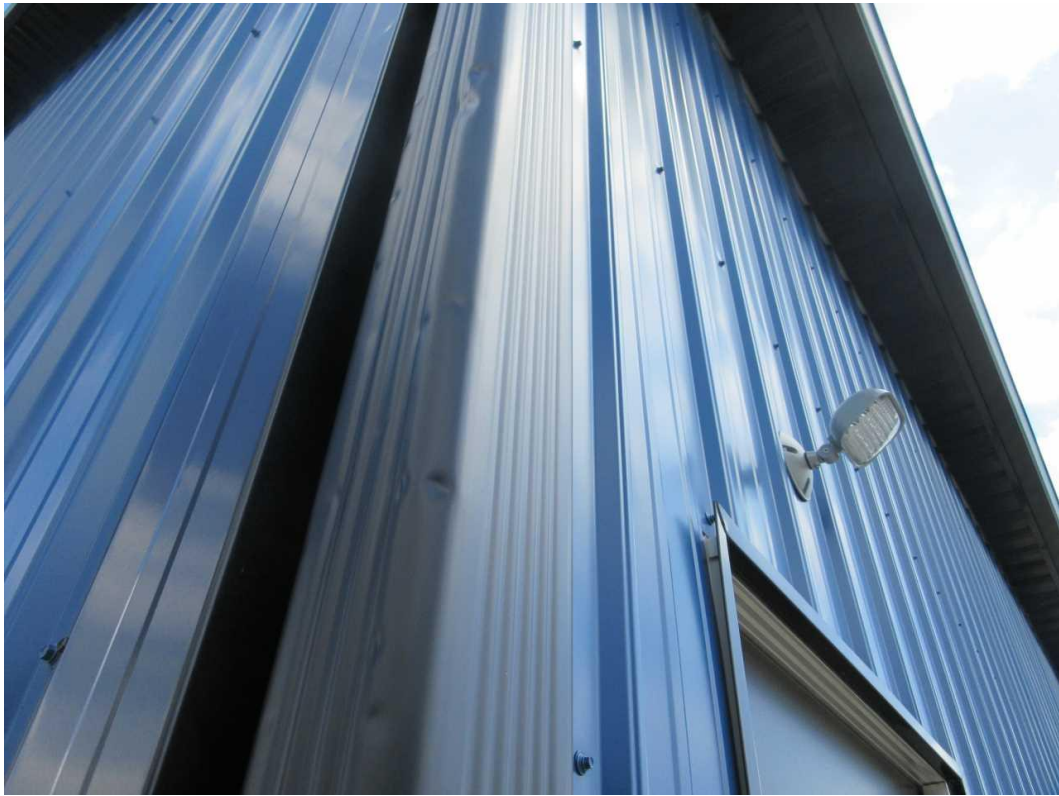
**194-S Right Elevation**  
Date Taken: 6/27/2025  
Taken By: Michael Wallen  
Hail damage to downspout.

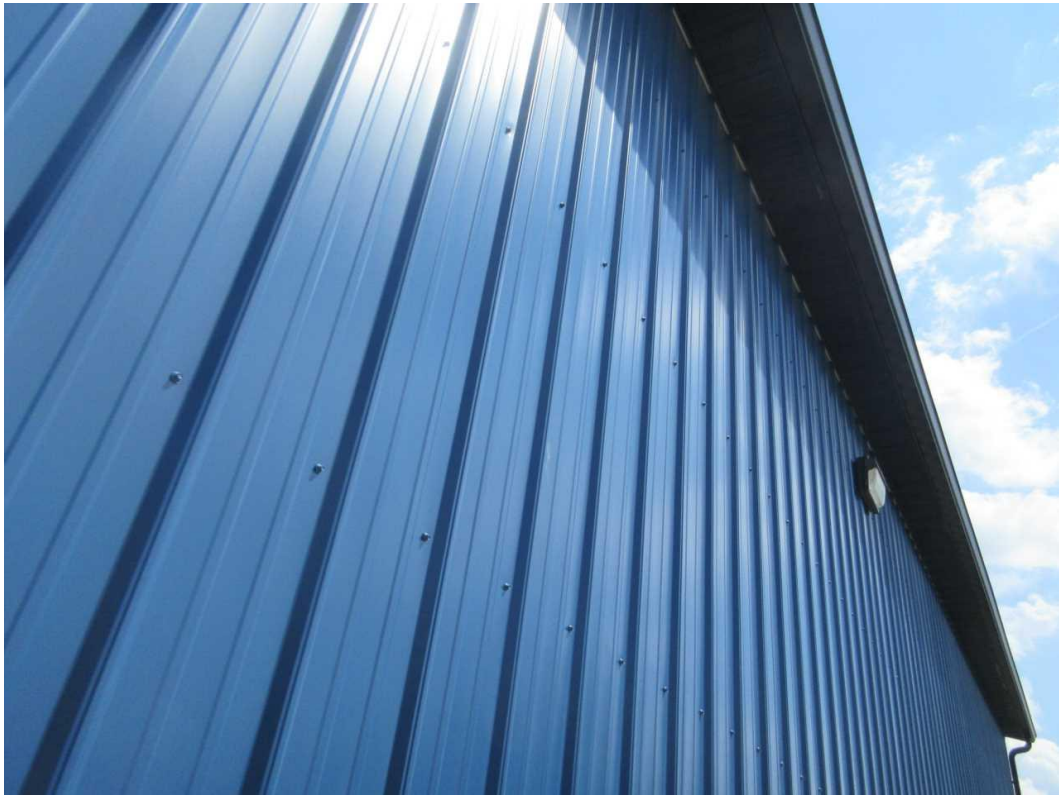
**196-S Right Elevation**

No storm damage to siding from the claimed date of loss.

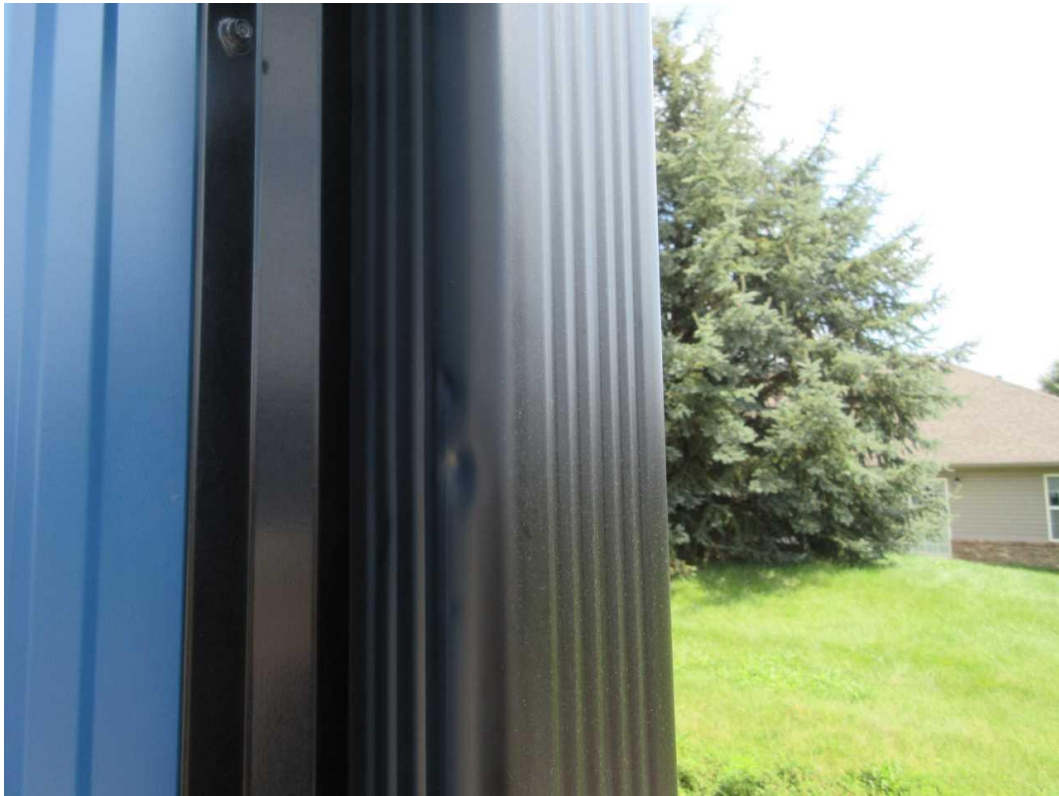
**197-S Right Elevation**  
Date Taken: 6/27/2025  
Taken By: Michael Wallen  
Hail damage to downspout.

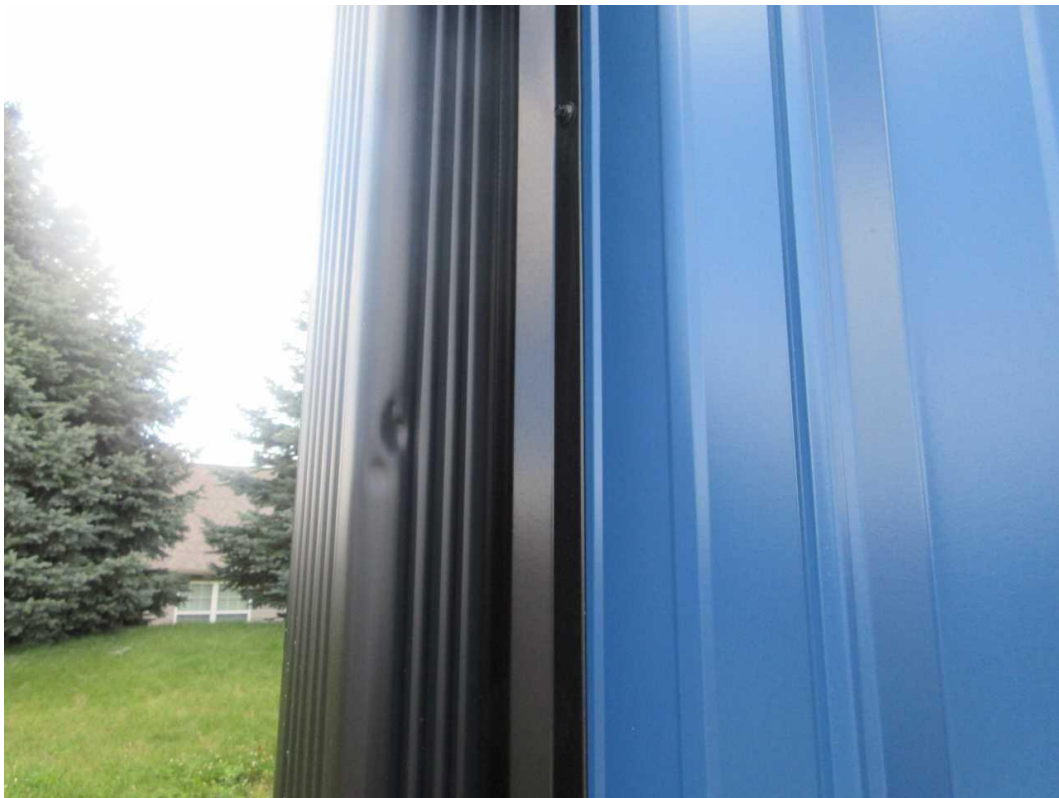
**201-N Left Elevation**

Mechanical damage to downspout on the NE corner.
